# Santa Rosa Dunes Condominium

Shoreline Stabilization Project

For the Santa Rosa Dunes Homeowners Association

By Heather Reed, Ecological Consulting Services

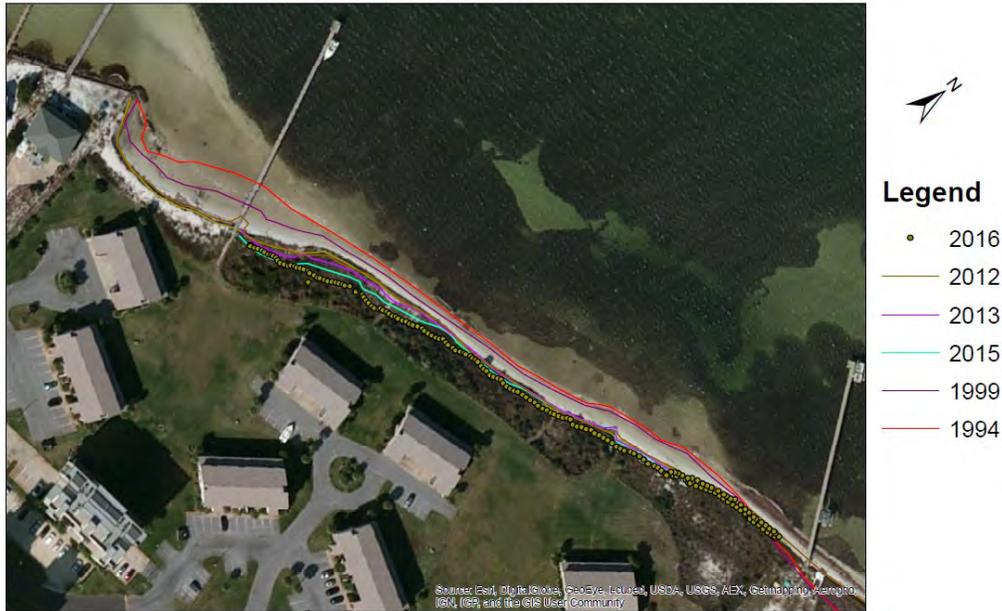
The shoreline change is represented by colored lines; each line has a date associated with it. For example, 1994 is red, 2012 is gold, etc. There were no legible aerials for 2010 and 2011. There is no readily available aerials of the same elevation to measure prior to 1994. The most erosion occurs from 1994 to 2012. The purple line for 2013 shows the location of the shoreline near the existing breakwater.

**FIGURE 2: SANTA ROSA DUNES SHORELINE CHANGE FROM 1994 TO 2016.**

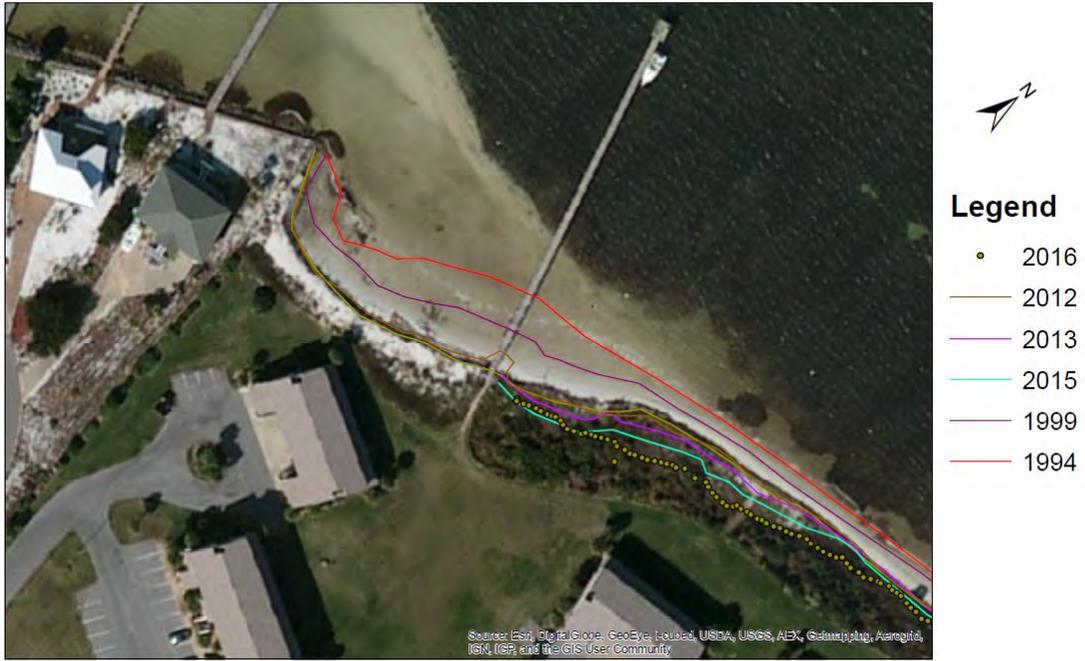
The riprap was affecting the shoreline from the topside and the bottom side. Overtime the riprap continued to slide down the slope of the western shoreline and scoured from the lower part of the tidal floor underneath the rip rap. As the scouring continued, the heavy rip rap on the western side slid down the bank and exposed the upland area on top of the slope, to wind erosion. The riprap located under the bridge was the end point of placement. This placement mosly caused the same affect of the adjacent seawall and continued to scour the property to the east.

FIGURE 3: SHORELINE CHANGE FROM 1994-2016 FOR SECTION A WESTERN SIDE

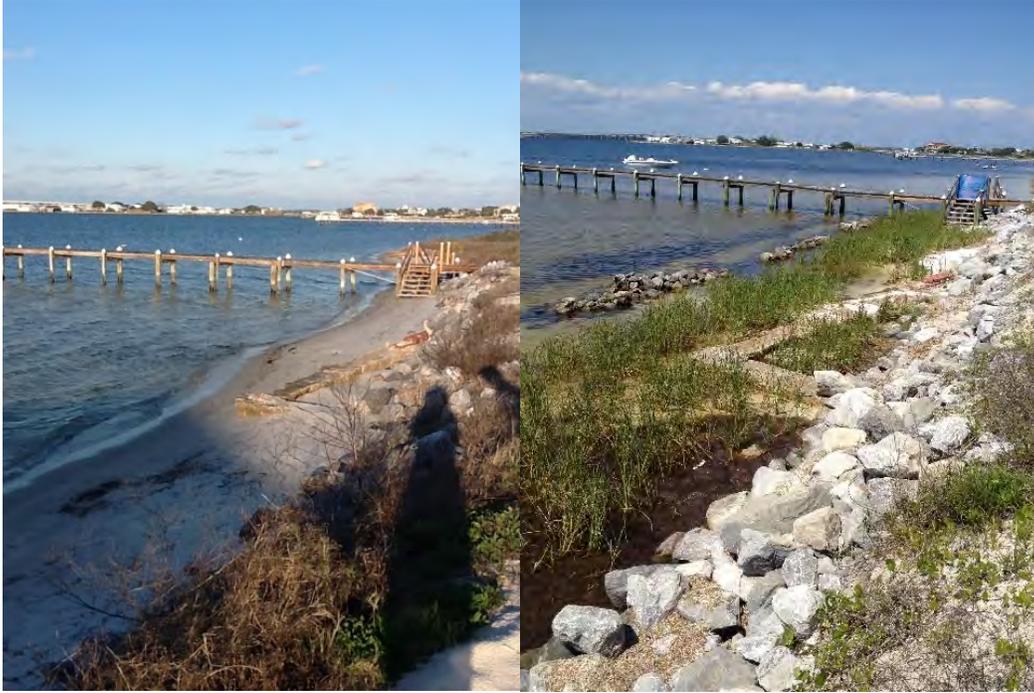
FIGURE 6: BEFORE PHOTO OF PHASE 1 2011 AND AFTER PHOTO 2015

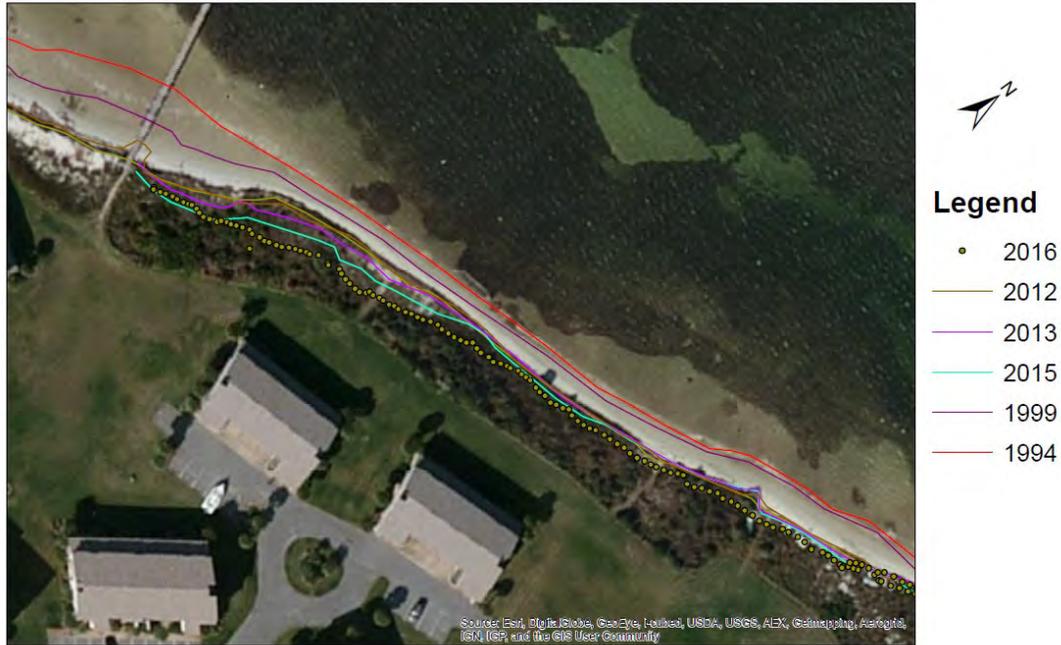
FIGURE 8: SHORELINE CHANGE FOR SECTION B IS EAST OF THE EXISTING DOCK FROM 1994- 2016

In Section B, east of the dock, if the root system of the current marsh dries out, it is imperative to replant a new marsh with the appropriate plants. This will double the reinforcement of shoreline from storm surge. Currently, the restoration of the wetland seems to have recovered.

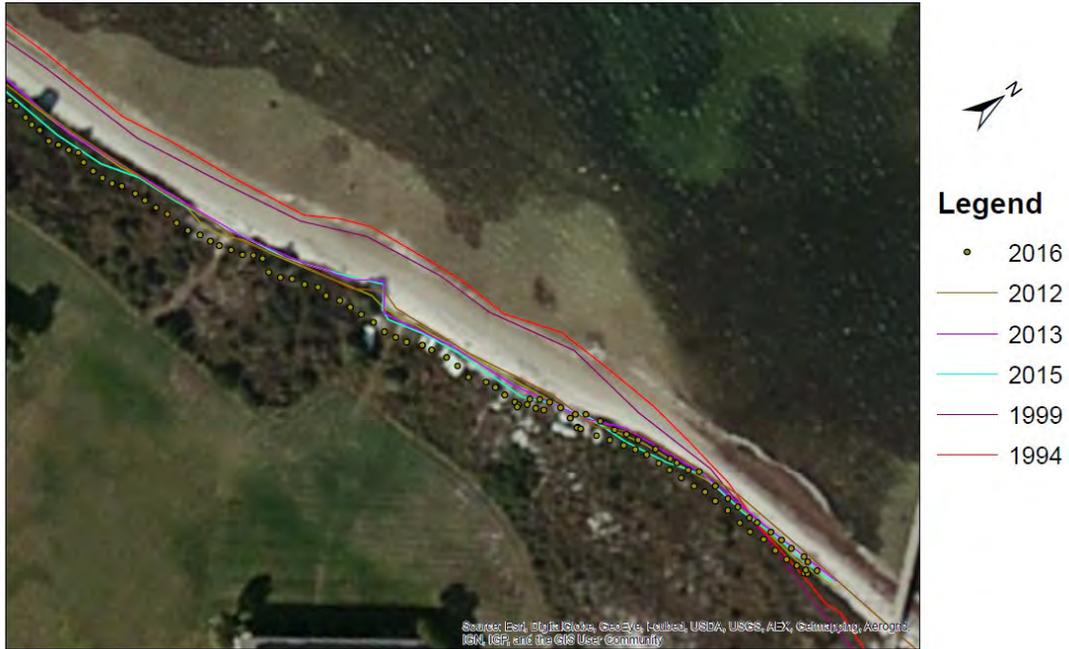
Seagrass is a natural stabilizer. Notice in Section C (Figure. 10). The only real erosion is the beach area to the east. The shoreline in front of the seagrass has changed VERY little over the years. Once again this is because of underwater seagrass root system stabilizing the shoreline. If the seagrass ever gets destroyed and boaters keep anchoring in the seagrass, this shoreline area will also face erosion. If the beach recreational area sandy area becomes larger, the sand may also erode, reducing the shoreline.

FIGURE 10: SHORELINE CHANGE OF THE EASTERN SECTION OF THE PROPERTY

Section C shows a stable shoreline, but the current salt tolerant plants along the shore need reinforcement, waterward, by wetland plants that can tolerate the saltwater. It is recommended to plant only new wetland vegetation in front of the existing vegetation. This vegetation will help trap sand. Behind this shoreline, it is recommended to remove the dead vegetation by cutting only and replanting more soil appropriate bushes and plants.

The east end of Section C (Fig. 10), is where the property's beach area is. This beach will eventually erode more over time from the lack of stabilization of the root system. To keep the beach area the same size, and prevent any further vegetative stress from trampling, it is important to create a nice vegetative border of bushes to maintain the boundaries of the beach. The bushes are less likely to get trampled and will protect the shoreline grasses. Section C East, is also the highest area of boat anchorings in the seagrass. Distributing educational pamphlets and signs about seagrass and the importance of keeping the root system intact, enforcing the mooring buoys and discouraging anchoring, may help alleviate any impact to the rare inshore grass beds.

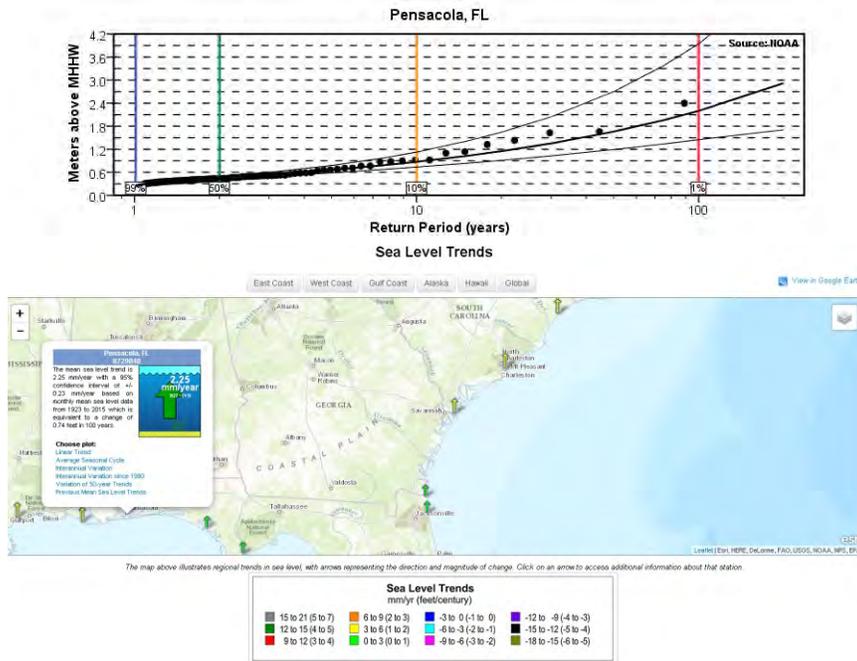
After carefully studying the National Oceanographic Atmospheric Administration (NOAA) database of the Pensacola Beach area, the answer is very abnormally high tides (Fig. 11).

**FIGURE 11: SEA LEVEL TREND FOR PENSACOLA BEACH 2.25 MM/YEAR IS PREDICTED WITH A CHANGE OF 0.74 FEET OVER A 100 YEAR PERIOD.**

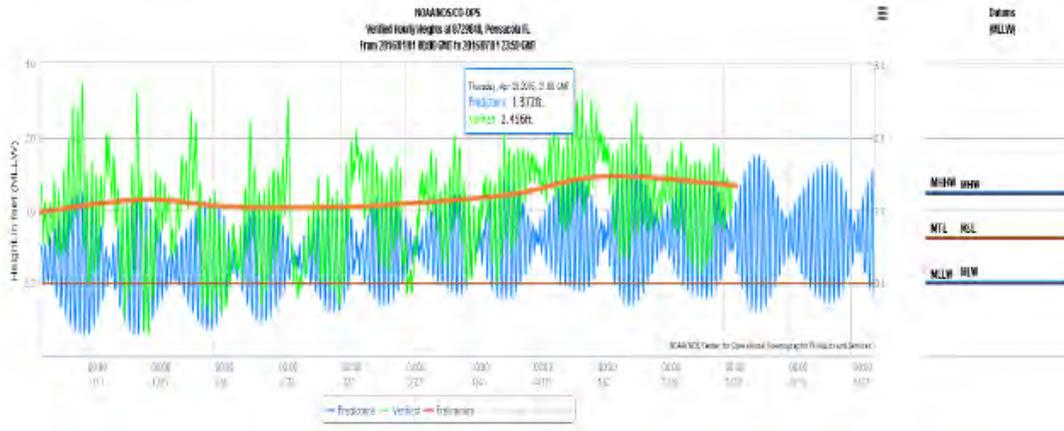
**FIGURE 12: THE 2016 HISTORIC TIDES DATA FROM STATION # 8729840.** THE BLUE LINES ARE THE PREDICTED TIDES GIVEN, AND THE GREEN LINES ARE THE VERIFIED TIDES WHICH WERE THE ACTUAL TIDES. THE ORANGE LINES SHOW THE DIFFERENCE BETWEEN THE VERIFIED AND THE PREDICTED. IN SOME CASES FROM JANUARY TO JULY, THE TIDES WERE 1.3 FEET HIGHER THAN NORMAL TIDE. FROM JULY TO DECEMBER THE TIDES WERE ALSO APPROXIMATE 1.2 FEET ABOVE NORMAL EXCEPT A FEW STORMS IN OCTOBER AND NOVEMBER RAISING TO 2.09 FEET ABOVE NORMAL.

The green color represents the actual tides for that day or month. The actual high tides were much higher than the predicted tides through out the entire year. The predicted tides are from models based on the last 100 years. In most cases, not only was the high tide greater than normal but the low tide in some months represented more of a high tide and remained above zero high water. In other words, the verified data, which is green, shows the low tide were absent at a time when salt tolerant plants needed to recover from the lengthy duration of high tides.

In the month of March through May, it shows the higher tides are 1.5 higher than the average. This boundary is indicated by the orange tideline. The lower tides are a half a foot higher than the average low tide. This suggests in the month of March through May the brackish vegetation along the shoreline may have suffered through out the Bay from salt-water inundation. This salt-water inundation would not allow the plants to recover from the extremely high tides for months.

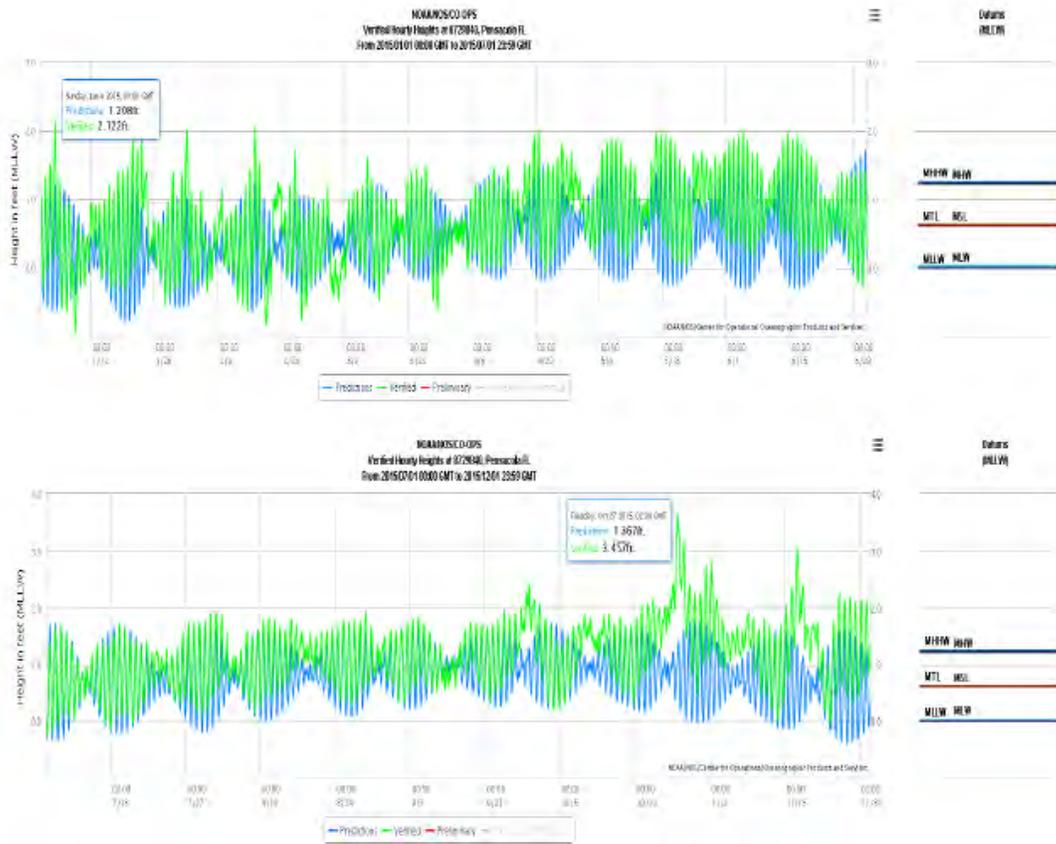
**FIGURE 13. 2015 HISTORIC TIDES DATA FROM STATION # 8729840.** THE BLUE LINES ARE THE PREDICTED TIDES GIVEN, AND THE GREEN LINES ARE THE VERIFIED TIDES WHICH WERE THE ACTUAL TIDES IN SOME CASES FROM JANUARY TO JULY, THE TIDES WERE .69 FEET HIGHER THAN NORMAL TIDE. FROM JULY TO DECEMBER THE TIDES WERE ALSO APPROXIMATE .85 FEET ABOVE NORMAL EXCEPT A FEW STORMS IN OCTOBER AND NOVEMBER RAISING TO 2.45 FEET ABOVE NORMAL.

In April, May and June 2015, low tides were also higher than normal and never actually allowed a normal low tide. In all months of 2015 after July, the verified high tides ranged from 1 to 2 1/2 feet above normal tide. In the months of November and December where we are supposed to have extreme low tides, this was an average summer tide, which was 1/2 to 1 foot higher than the normal low tide.

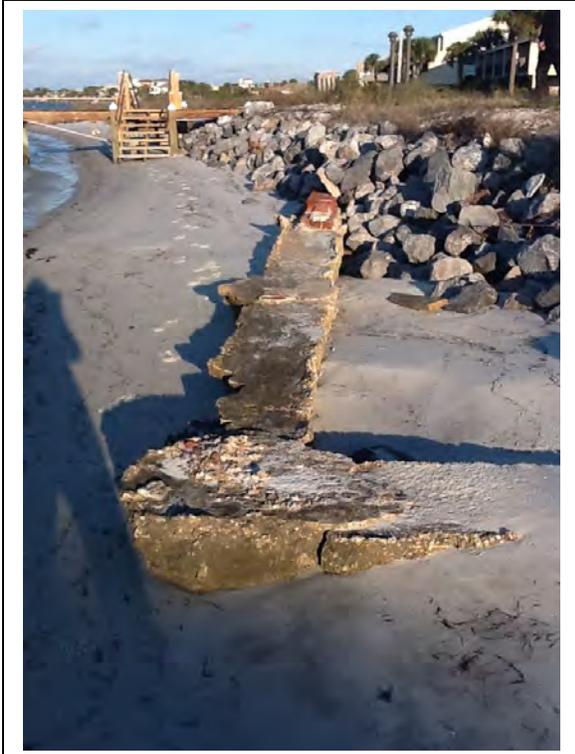
Fig. 1 -2011 Historic anomaly exposed

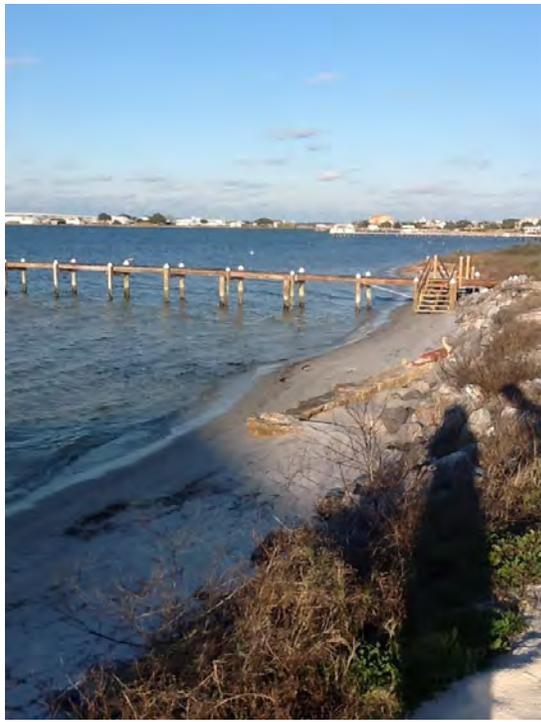
Fig. 9 -Before 2011

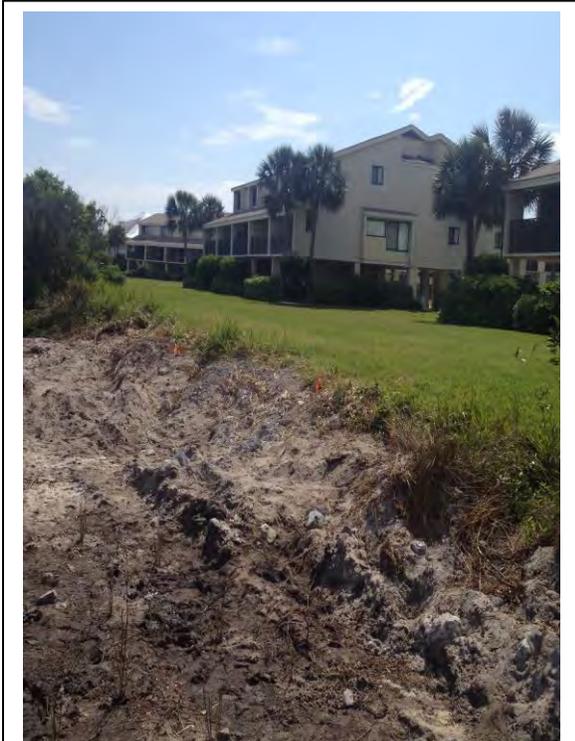
Fig. 23 Area containing rip rap- this area was replanted
