# Santa Rosa Dunes Condominium

Shoreline Stabilization Project

For the Santa Rosa Dunes Homeowners Association

By Heather Reed, Ecological Consulting Services

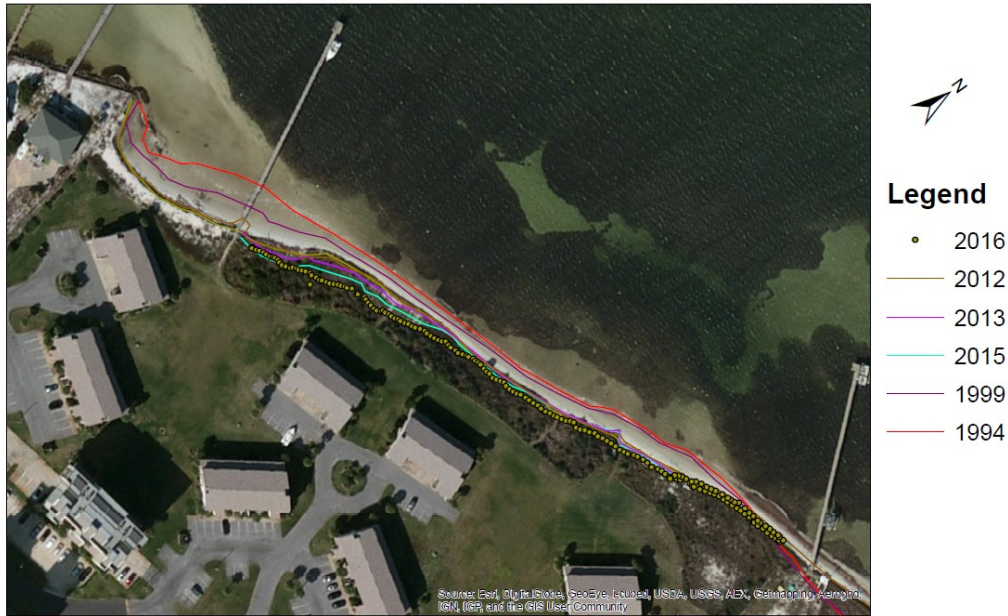
The shoreline change is represented by colored lines; each line has a date associated with it. For example, 1994 is red, 2012 is gold, etc. There were no legible aerials for 2010 and 2011. There is no readily available aerials of the same elevation to measure prior to 1994. The most erosion occurs from 1994 to 2012. The purple line for 2013 shows the location of the shoreline near the existing breakwater.

**FIGURE 2: SANTA ROSA DUNES SHORELINE CHANGE FROM 1994 TO 2016.**

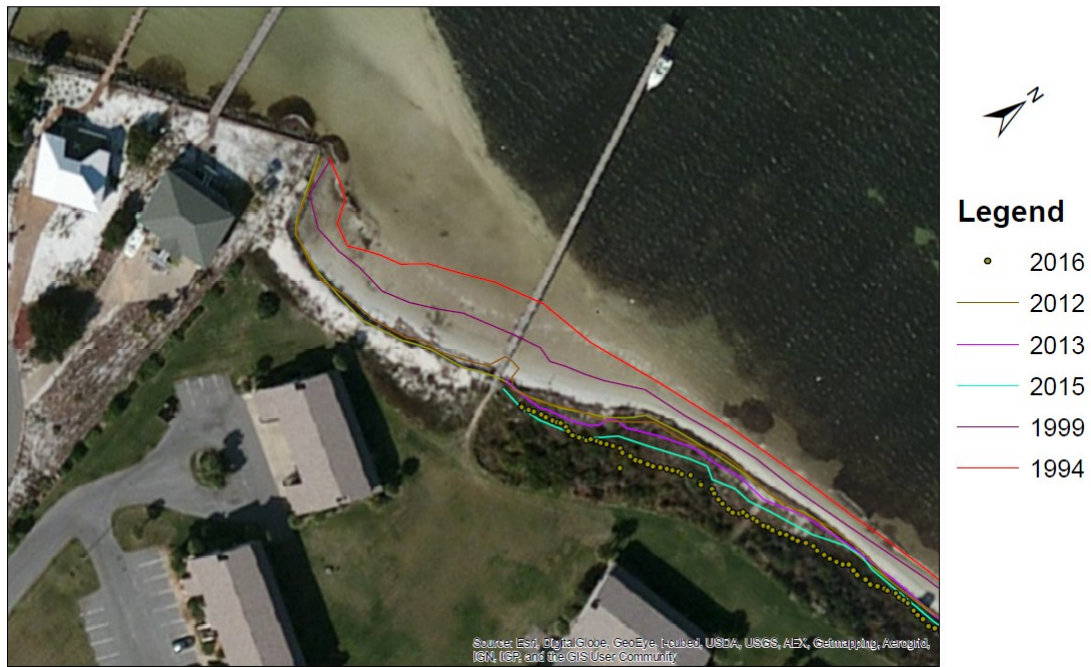
The riprap was affecting the shoreline from the topside and the bottom side. Overtime the riprap continued to slide down the slope of the western shoreline and scoured from the lower part of the tidal floor underneath the rip rap. As the scouring continued, the heavy rip rap on the western side slid down the bank and exposed the upland area on top of the slope, to wind erosion. The riprap located under the bridge was the end point of placement. This placement mosly caused the same affect of the adjacent seawall and continued to scour the property to the east.

FIGURE 3: SHORELINE CHANGE FROM 1994-2016 FOR SECTION A WESTERN SIDE

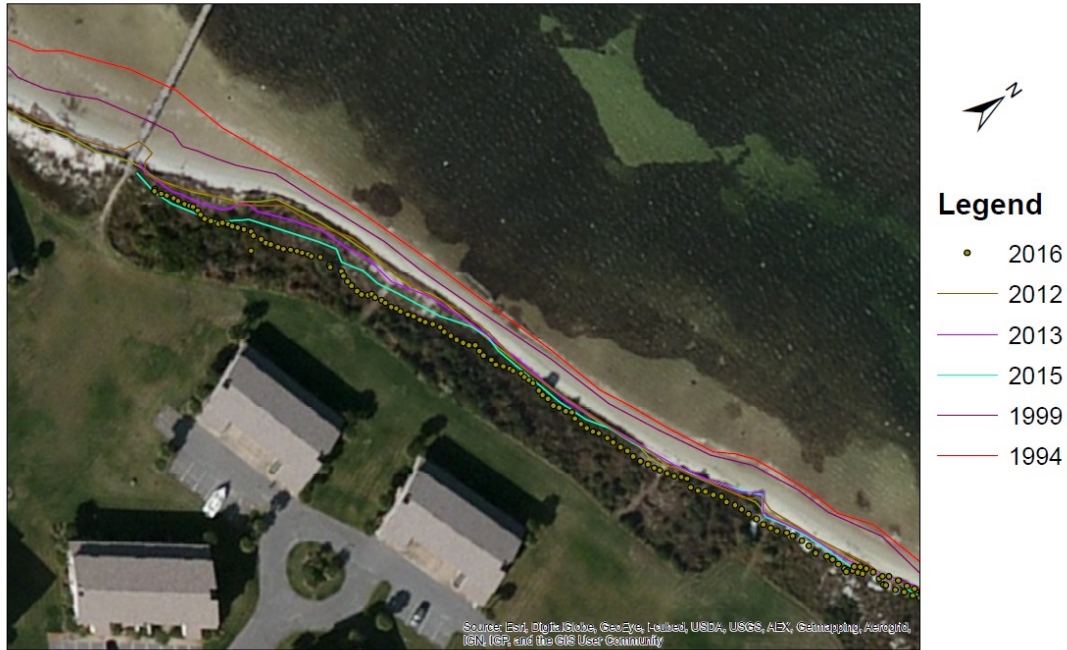
FIGURE 8: SHORELINE CHANGE FOR SECTION B IS EAST OF THE EXISTING DOCK FROM 1994- 2016

In Section B, east of the dock, if the root system of the current marsh dries out, it is imperative to replant a new marsh with the appropriate plants. This will double the reinforcement of shoreline from storm surge. Currently, the restoration of the wetland seems to have recovered.

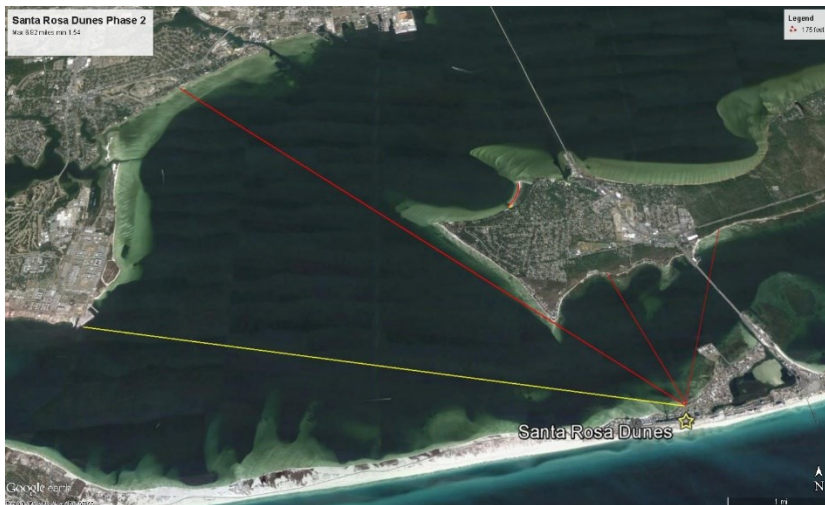
breakwater was placed offshore and designed in sections to block the 8 mile, fetch 6 mile fetch and two mile fetch.

**FIGURE 9. FETCH IMPACT TO SANTA ROSA DUNES PROJECT THE NORMAL FETCH DISTANCE IS 6 MILES (YELLOW), 7 MILES, 2MILES AND 2.5 MILES (RED)**

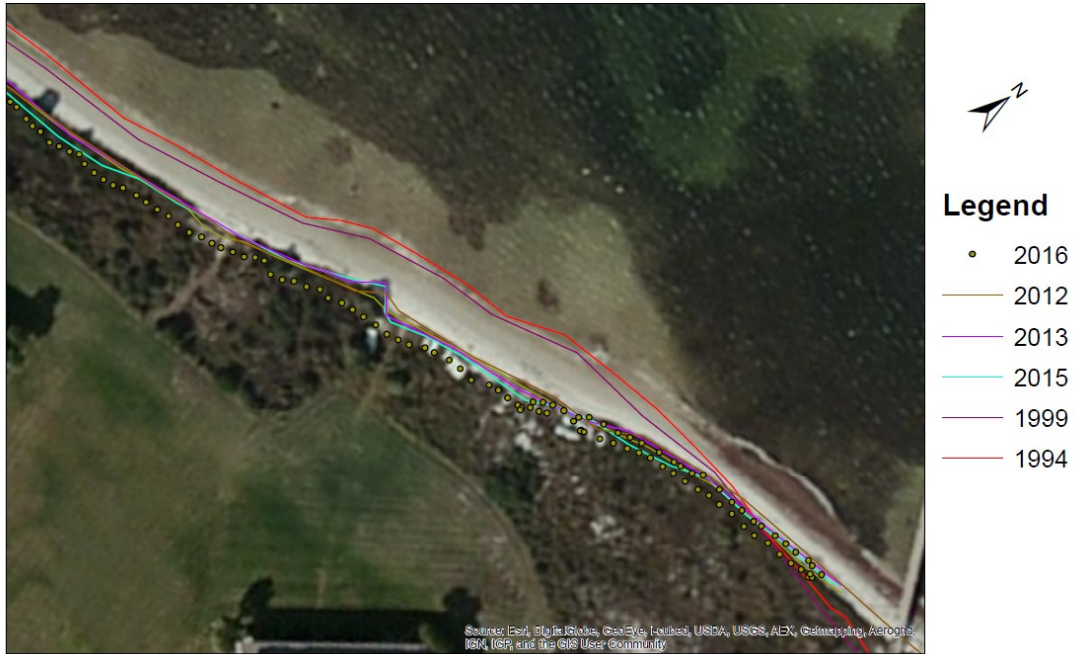
Seagrass is a natural stabilizer. Notice in Section C (Figure. 10). The only real erosion is the beach area to the east. The shoreline in front of the seagrass has changed VERY little over the years. Once again this is because of underwater seagrass root system stabilizing the shoreline. If the seagrass ever gets destroyed and boaters keep anchoring in the seagrass, this shoreline area will also face erosion. If the beach recreational area sandy area becomes larger, the sand may also erode, reducing the shoreline.

FIGURE 10: SHORELINE CHANGE OF THE EASTERN SECTION OF THE PROPERTY

Section C shows a stable shoreline, but the current salt tolerant plants along the shore need reinforcement, waterward, by wetland plants that can tolerate the saltwater. It is recommended to plant only new wetland vegetation in front of the existing vegetation. This vegetation will help trap sand. Behind this shoreline, it is recommended to remove the dead vegetation by cutting only and replanting more soil appropriate bushes and plants.

The east end of Section C (Fig. 10), is where the property's beach area is. This beach will eventually erode more over time from the lack of stabilization of the root system. To keep the beach area the same size, and prevent any further vegetative stress from trampling, it is important to create a nice vegetative border of bushes to maintain the boundaries of the beach. The bushes are less likely to get trampled and will protect the shoreline grasses. Section C East, is also the highest area of boat anchorings in the seagrass. Distributing educational pamphlets and signs about seagrass and the importance of keeping the root system intact, enforcing the mooring buoys and discouraging anchoring, may help alleviate any impact to the rare inshore grass beds.

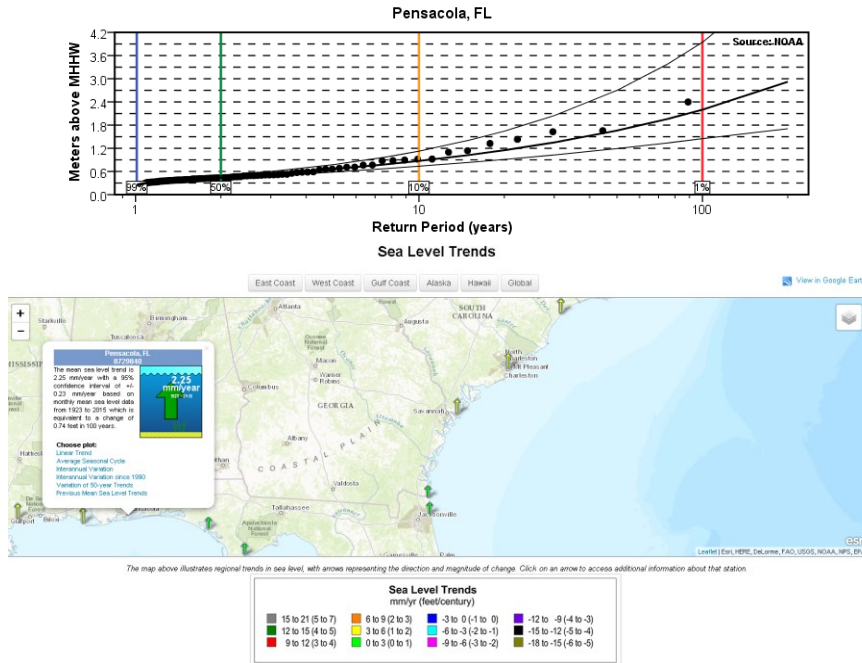
After carefully studying the National Oceanographic Atmospheric Administration (NOAA) database of the Pensacola Beach area, the answer is very abnormally high tides (Fig. 11).

**FIGURE 11: SEA LEVEL TREND FOR PENSACOLA BEACH 2.25 MM/YEAR IS PREDICTED WITH A CHANGE OF 0.74 FEET OVER A 100 YEAR PERIOD.**

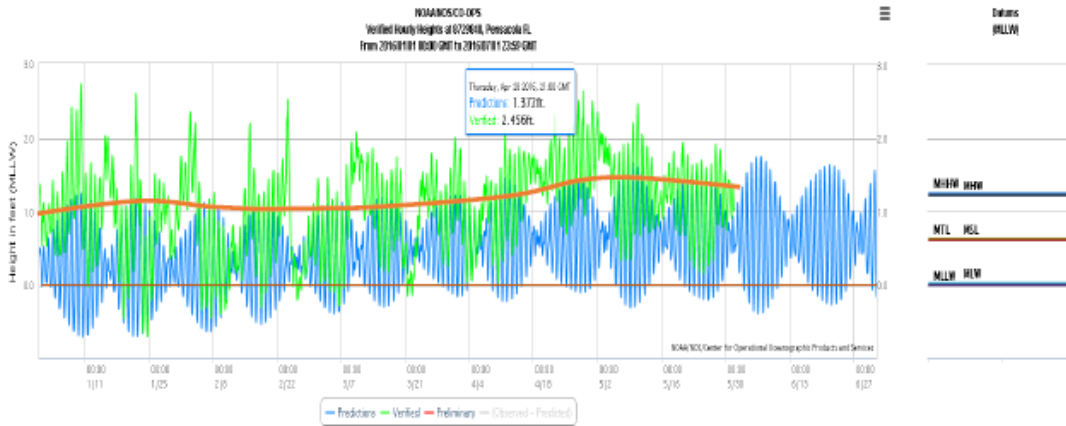
**FIGURE 12: THE 2016 HISTORIC TIDES DATA FROM STATION # 8729840.** THE BLUE LINES ARE THE PREDICTED TIDES GIVEN, AND THE GREEN LINES ARE THE VERIFIED TIDES WHICH WERE THE ACTUAL TIDES. THE ORANGE LINES SHOW THE DIFFERENCE BETWEEN THE VERIFIED AND THE PREDICTED. IN SOME CASES FROM JANUARY TO JULY, THE TIDES WERE 1.3 FEET HIGHER THAN NORMAL TIDE. FROM JULY TO DECEMBER THE TIDES WERE ALSO APPROXIMATE 1.2 FEET ABOVE NORMAL EXCEPT A FEW STORMS IN OCTOBER AND NOVEMBER RAISING TO 2.09 FEET ABOVE NORMAL.

The green color represents the actual tides for that day or month. The actual high tides were much higher than the predicted tides through out the entire year. The predicted tides are from models based on the last 100 years. In most cases, not only was the high tide greater than normal but the low tide in some months represented more of a high tide and remained above zero high water. In other words, the verified data, which is green, shows the low tide were absent at a time when salt tolerant plants needed to recover from the lengthy duration of high tides.

In the month of March through May, it shows the higher tides are 1.5 higher than the average. This boundary is indicated by the orange tideline. The lower tides are a half a foot higher than the average low tide. This suggests in the month of March through May the brackish vegetation along the shoreline may have suffered through out the Bay from salt-water inundation. This salt-water inundation would not allow the plants to recover from the extremely high tides for months.

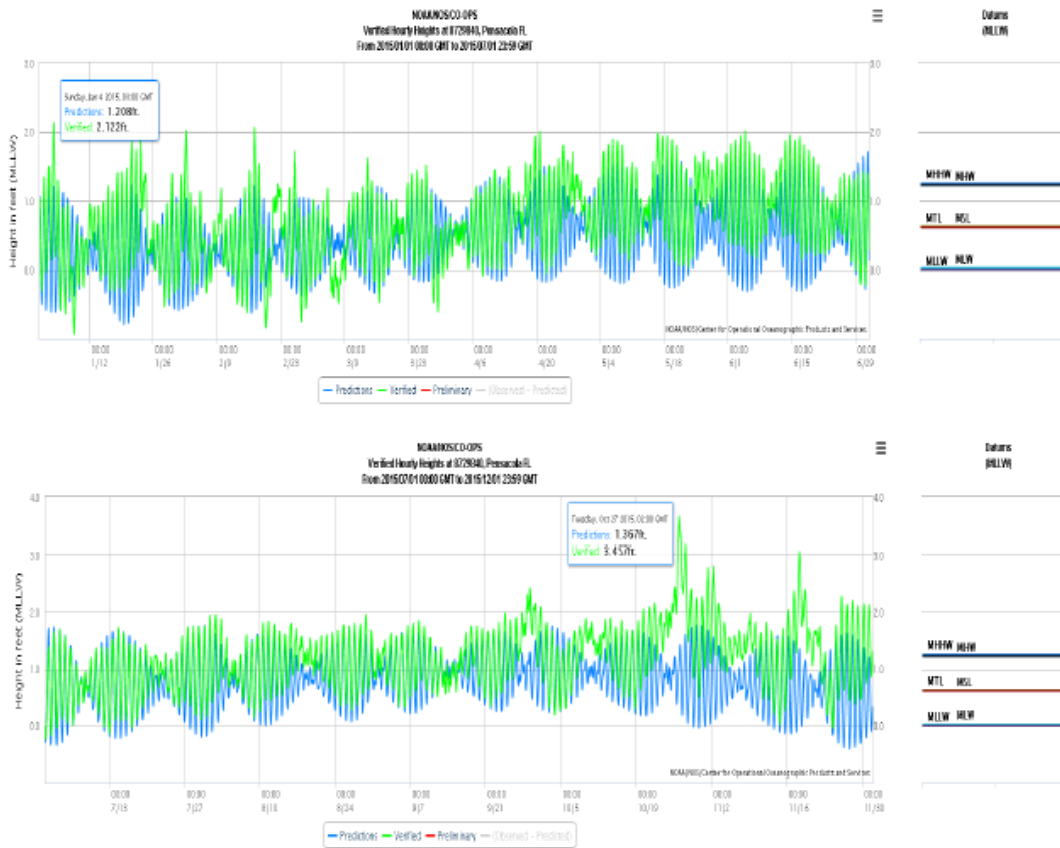
**FIGURE 13. 2015 HISTORIC TIDES DATA FROM STATION # 8729840.** THE BLUE LINES ARE THE PREDICTED TIDES GIVEN, AND THE GREEN LINES ARE THE VERIFIED TIDES WHICH WERE THE ACTUAL TIDES IN SOME CASES FROM JANUARY TO JULY, THE TIDES WERE .69 FEET HIGHER THAN NORMAL TIDE. FROM JULY TO DECEMBER THE TIDES WERE ALSO APPROXIMATE .85 FEET ABOVE NORMAL EXCEPT A FEW STORMS IN OCTOBER AND NOVEMBER RAISING TO 2.45 FEET ABOVE NORMAL.

In April, May and June 2015, low tides were also higher than normal and never actually allowed a normal low tide. In all months of 2015 after July, the verified high tides ranged from 1 to 2 1/2 feet above normal tide. In the months of November and December where we are supposed to have extreme low tides, this was an average summer tide, which was 1/2 to 1 foot higher than the normal low tide.

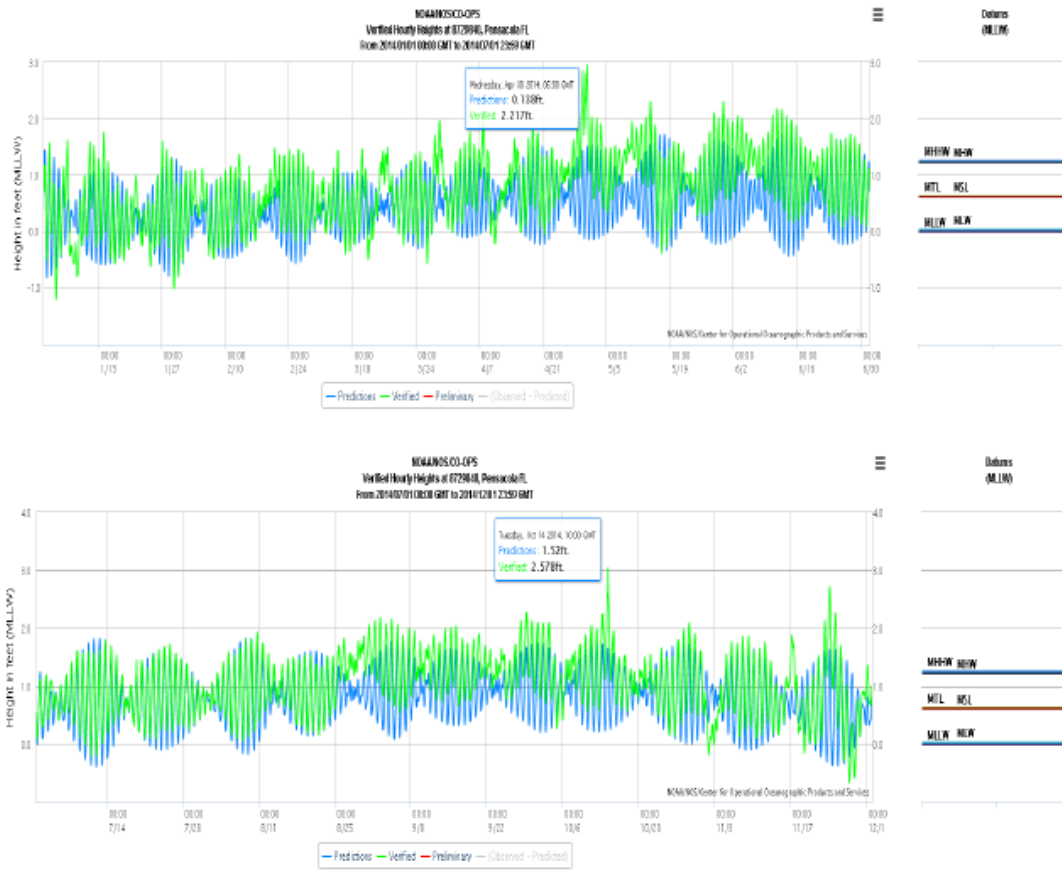
**FIGURE 14: 2014 HISTORIC TIDES DATA FROM STATION # 8729840.** THE BLUE LINES ARE THE PREDICTED TIDES GIVEN, AND THE GREEN LINES ARE THE VERIFIED TIDES WHICH WERE THE ACTUAL TIDES. IN SOME CASES FROM JANUARY TO JULY, THE TIDES WERE 2.079 FEET HIGHER THAN NORMAL TIDE. FROM JULY TO DECEMBER THE TIDES WERE ALSO APPROXIMATE 1.058 FEET ABOVE NORMAL.

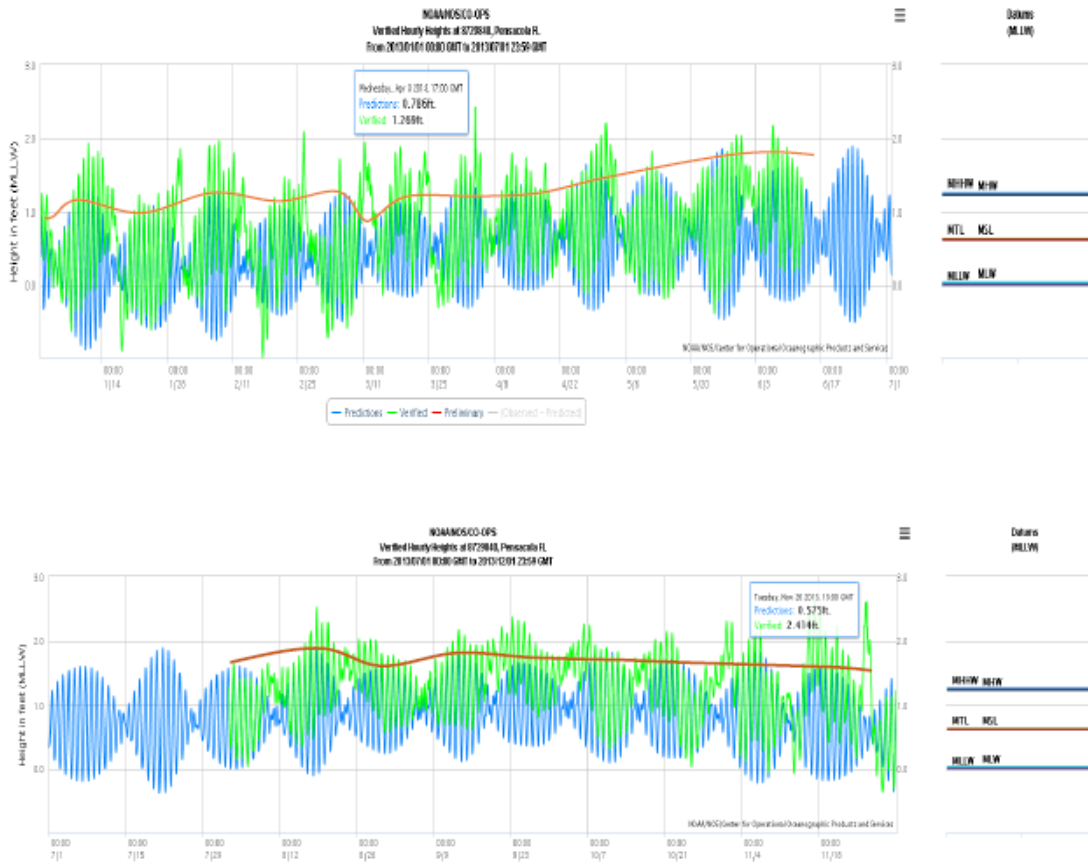
**FIGURE 15: 2013 HISTORIC TIDES DATA FROM STATION # 8729840. THE BLUE LINES ARE THE PREDICTED TIDES GIVEN AND THE GREEN LINES ARE THE VERIFIED TIDES WHICH WERE THE ACTUAL TIDES. THE ORANGE LINES SHOW THE DIFFERENCE BETWEEN THE VERIFIED AND THE PREDICTED. IN SOME CASES FROM JANUARY TO JULY, THE TIDES WERE 1.19 FEET HIGHER THAN THE NORMAL TIDE. FROM JULY TO DECEMBER THE TIDES WERE ALSO APPROXIMATE 1.839 FEET ABOVE NORMAL.**

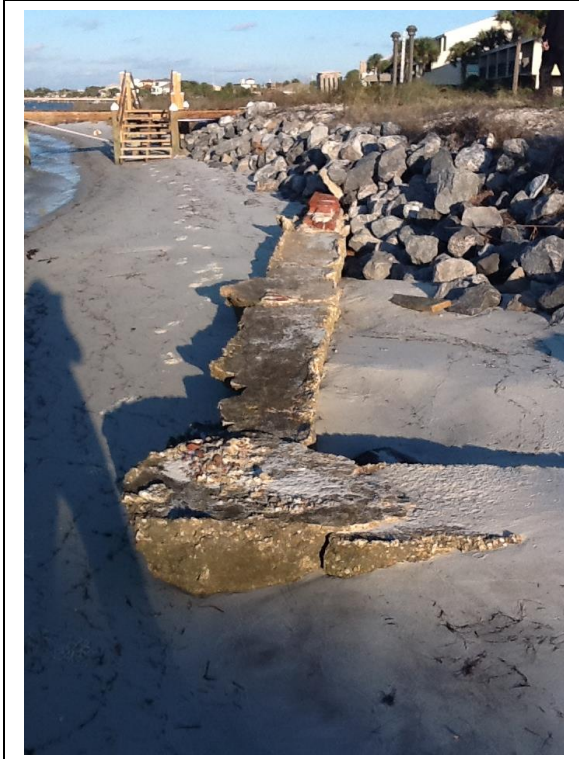
Fig. 1 -2011 Historic anomaly exposed

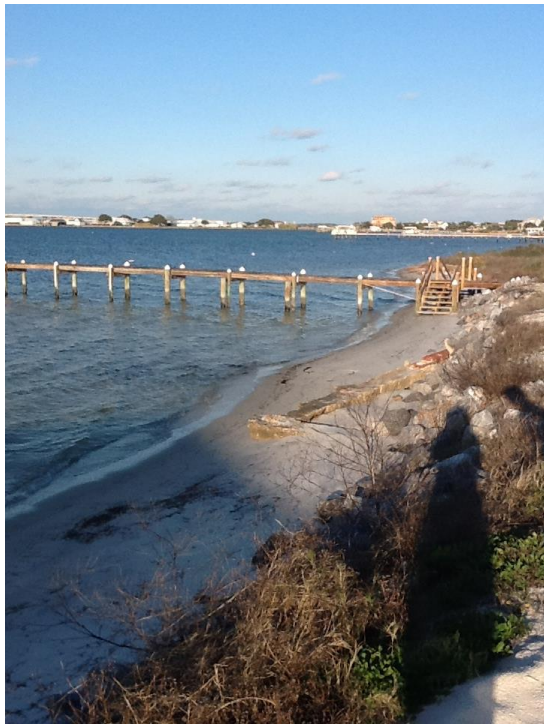
Fig. 9 -Before 2011

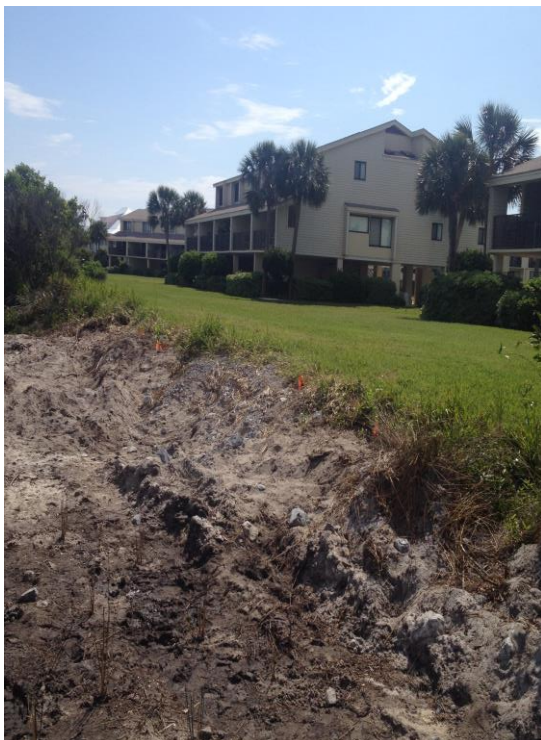
Fig. 23 Area containing rip rap- this area was replanted
