2020 Damage Assessment for Hurricane Sally and Monitoring Report

CITY OF GULF BREEZE DEADMAN'S ISLAND RESTORATION PROJECT

GULF BREEZE, SANTA ROSA COUNTY, FLORIDA

Ecological Consulting Services, Inc.

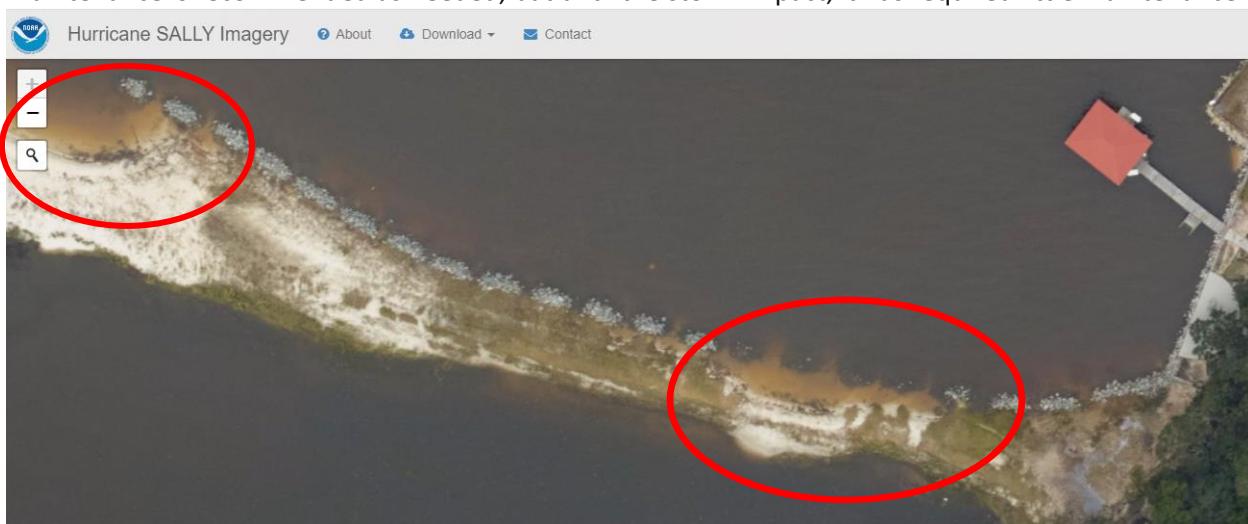
Figure 5: Section A- Isthmus Project - circled in red are areas of impact from Hurricane Sally September 16, 2020. Aerial photo taken September 19, 2020.

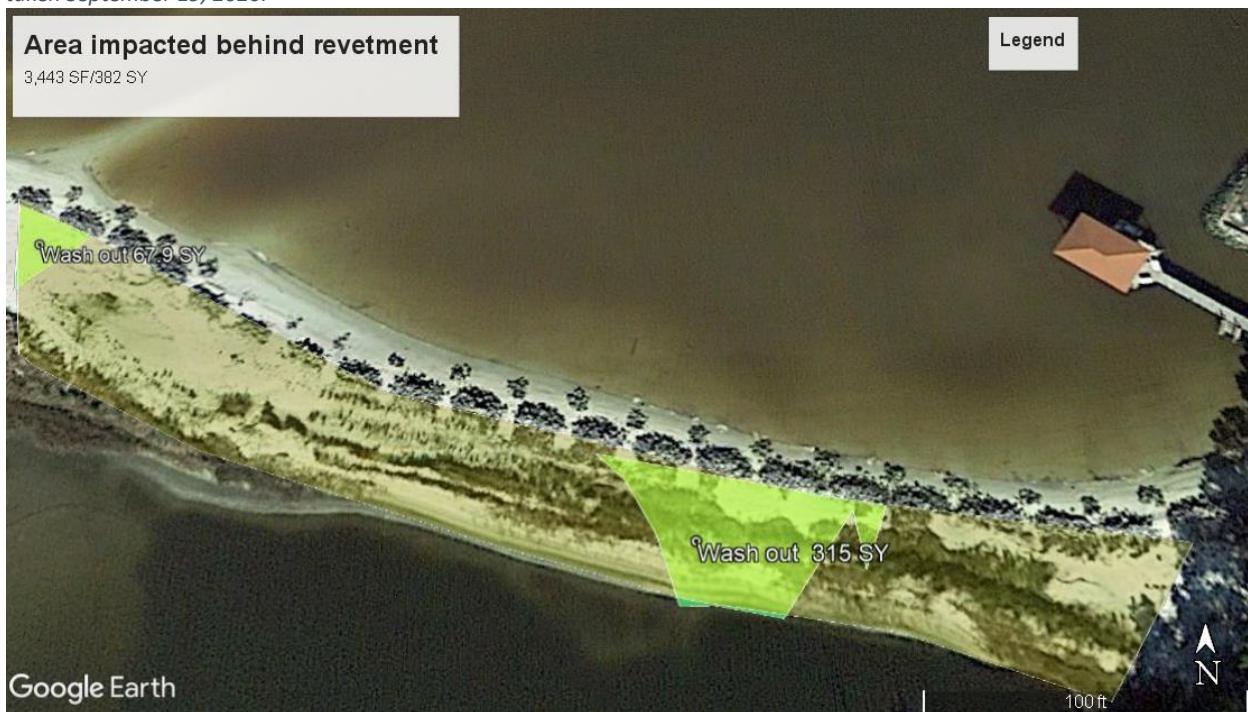
Figure 6:Section A- Area impacted behind the revetment (green) overall polygon of project area of Isthmus (Yellow), July 2019.

The first component of damage is the 500ft rock revetment on the east-west part of the isthmus (Figure 6). Prior to Hurricane Sally, the rock revetment stabilized the isthmus protecting homes with living shorelines and unique natural wildlife resources. The design consisted of class II riprap and sand, and plants. The rock revetment is 500 feet long from the east end (30.368035° , -87.184701°), and the west end was (30.368391° , -87.186174°). The storm impacted and destroyed approximately one hundred feet of the project. This replacement will restore the riprap to the existing footprint of 100 feet x 6 feet x 5 feet (30.368058° / -87.185266°). The City of Gulf Breeze will replace the riprap by placing 111 cubic yards (150 tons) of Class II riprap on top of the existing rock to bring back the project as pre-storm design.

The second component of damage is the mixed species of vegetation which stabilized the sand. This was also destroyed. The polygon plotted shows a total of 2,832 SF/315 SY (30.367978° , -87.185314°) and 611 SF/67.9 SY (30.368310° , -87.186115°) area impacted behind the revetment. One hundred and twenty-seven cubic yards ($3,443/27 = 127$ CY) of sand was also lost along with numerous plants that helped stabilize the area. The total area of sand and vegetation loss was 3,443 SF/382.9 SY (Figure 6).

The berm will need repair. The City of Gulf Breeze is responsible for the repair of the isthmus since this was not part of the Deadman's Island Part I or II project that the U.S. Army Corps of Engineers funded. Additional riprap will be required to secure the isthmus once again. Scattered riprap is sinking in the sand and the water. We know from previous work that it is more costly to remove than to replace the riprap. This type of hazard mitigation would be considered an emergency action since the environmental, historical, and residential property is threatened if the isthmus is fully breached. It would be more cost-effective to repair the damage now than wait for a similar situation and more costly solution in 2016. Hurricane Zeta increased the tide height for about 16 hours, but overall, the water level did not rise as high as Hurricane Sally.

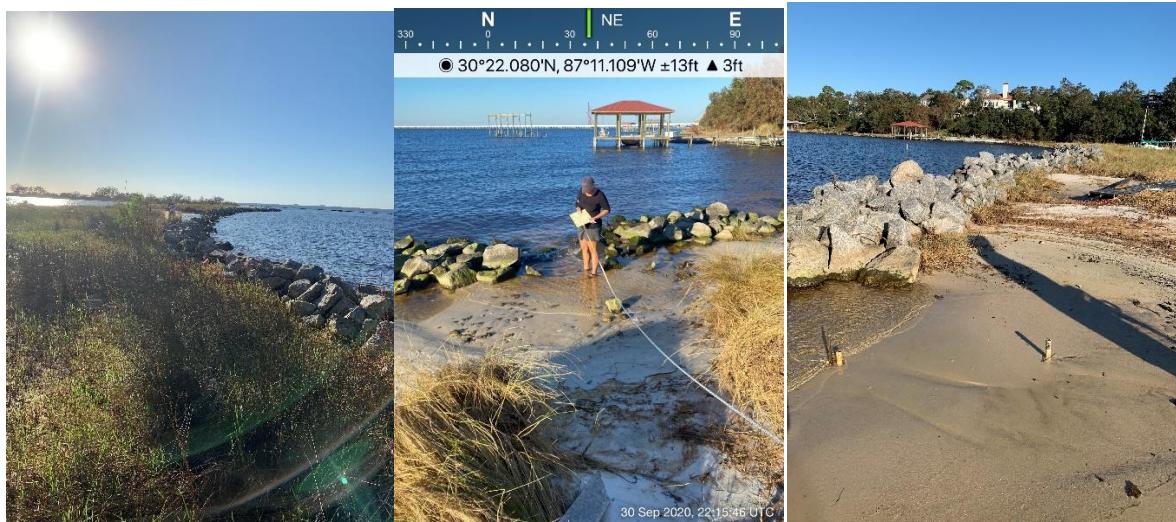
Overall, this project held up exceptionally well during Hurricane Sally considering the strength and duration of the storm. However, during Hurricane Sally, 100 feet of the isthmus rocks restacked from Hurricane Michael scattered and blew out. (Figure 6). In 2017, the riprap was placed upland (Figure 7) to anticipate additional erosion from the lack of sediment transport (starvation of sand) from the bridge construction project nearby. The gap in the riprap and loss of riprap has caused scarping behind the rocks, created a “washing machine” effect, and caused significant loss in vegetation and sand. The erosion pins used before construction and were buried two feet below the surface are now exposed (Figure 8).

Figure 7: Isthmus project -Left: The ~800FT project is mostly undisturbed by Hurricane Sally. Middle: 100 FT of Riprap was impacted and scarped and eroded the vegetation and protective berm. Right: Horizontal scarping reduced the elevation and exposed the original 2017 pre-construction sediment markers.

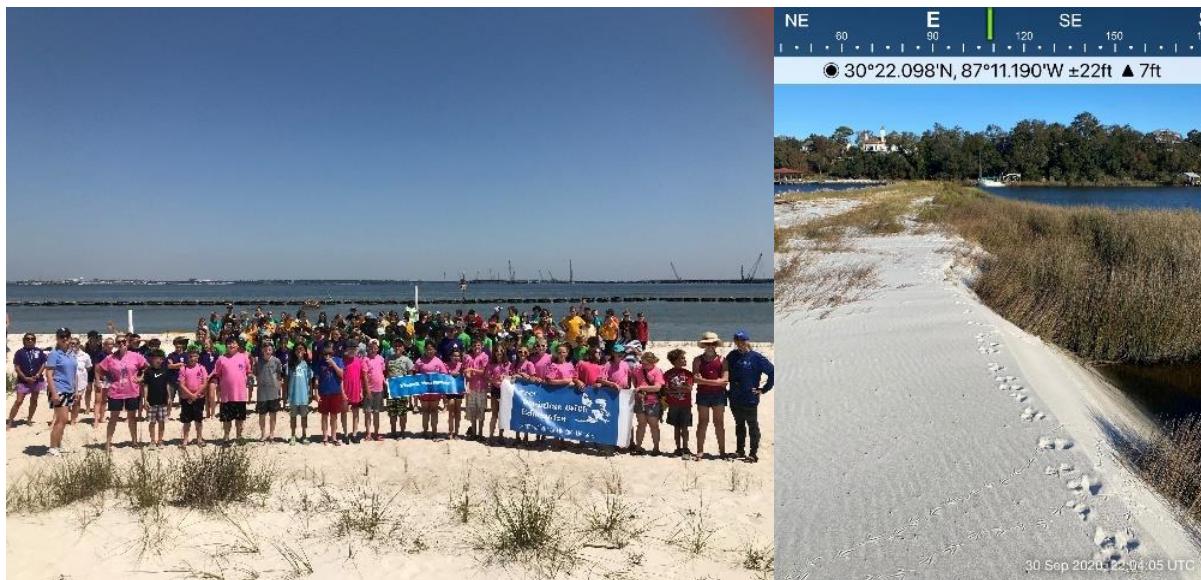
Figure 8: Community outreach volunteer have restored this area over time to the 1976 shoreline. Right: Hurricane Sally displaced and deposited sand in a juncus salt marsh hence smothering the saltmarsh.

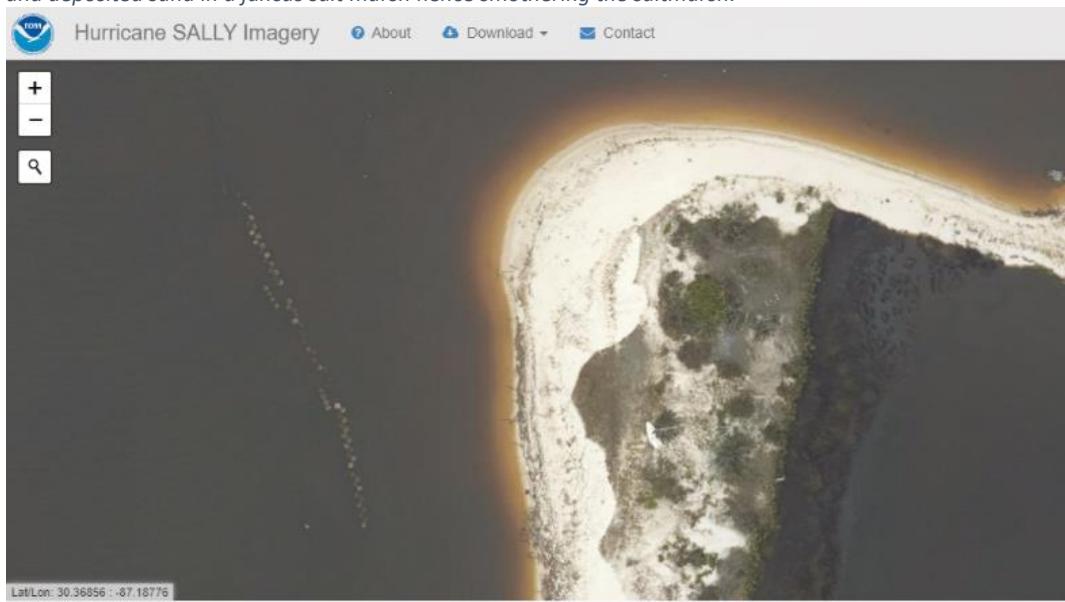
Hurricane Sally impacted the north end beach causing some erosion but mainly displacing the sand (See Figure 9). Hurricane Zeta repositioned sand lost from Hurricane Sally and caused a minimum washout of sand on onshore. During Hurricane Sally, the north end lost the elevation of sand but mostly maintained the original placement's shape. Vegetation was not uprooted but covered with sand. In the past, when sand is displaced over plants past the height of 2 feet it is less likely these plants will survive unless the wind blows the sand off the smothered vegetation.

Figure 9: North end (Section B) After hurricane Sally via NOAA Sept 18, 2020

Short term recommendations for the impact to the plants is to pay for the labor to uncover the buried vegetation using shovels and hand rakes. The vegetation needs some exposure to the sun for photosynthesis to recover. Raking the sand and exposing the plants to sunlight will help in the recovery process.

The second recommendation is to replant any areas that cannot be recovered.

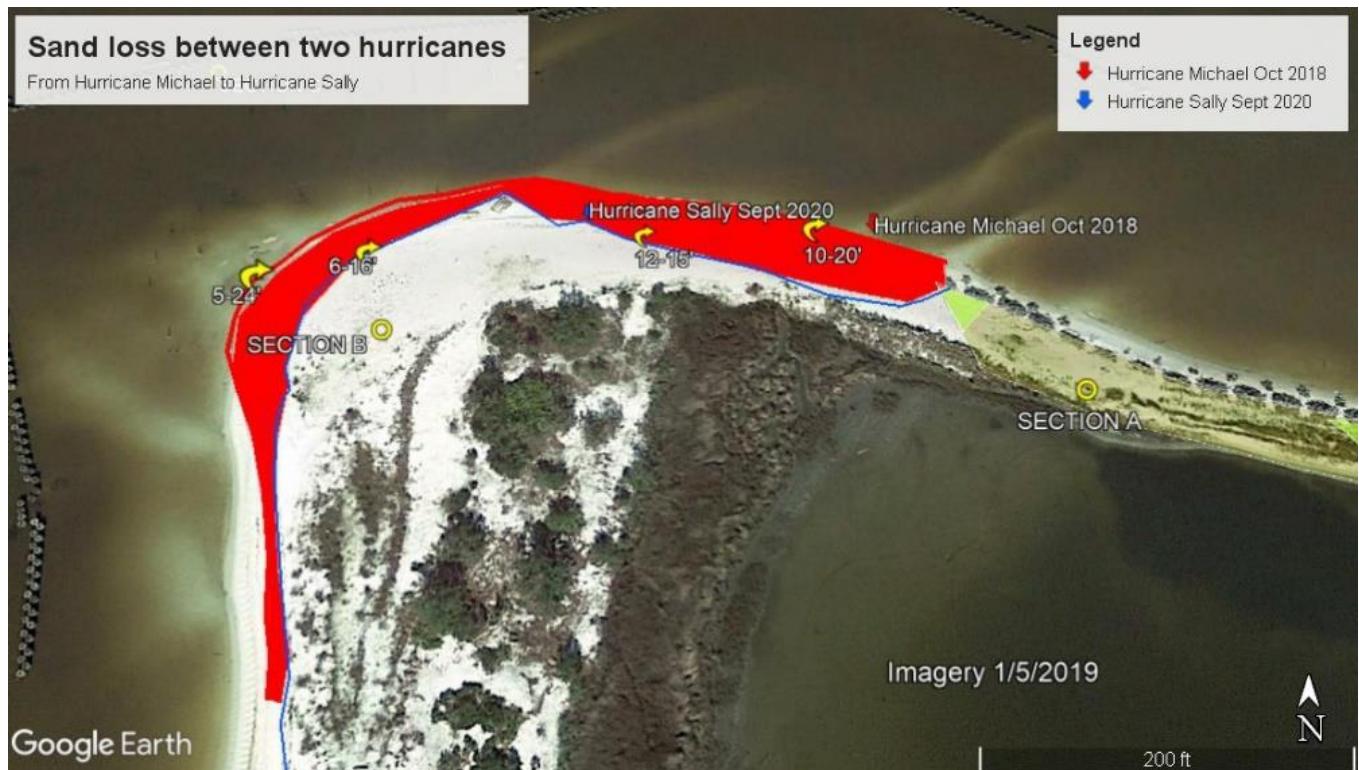
Figure 10: Sand loss between Hurricane Michael and Hurricane Sally

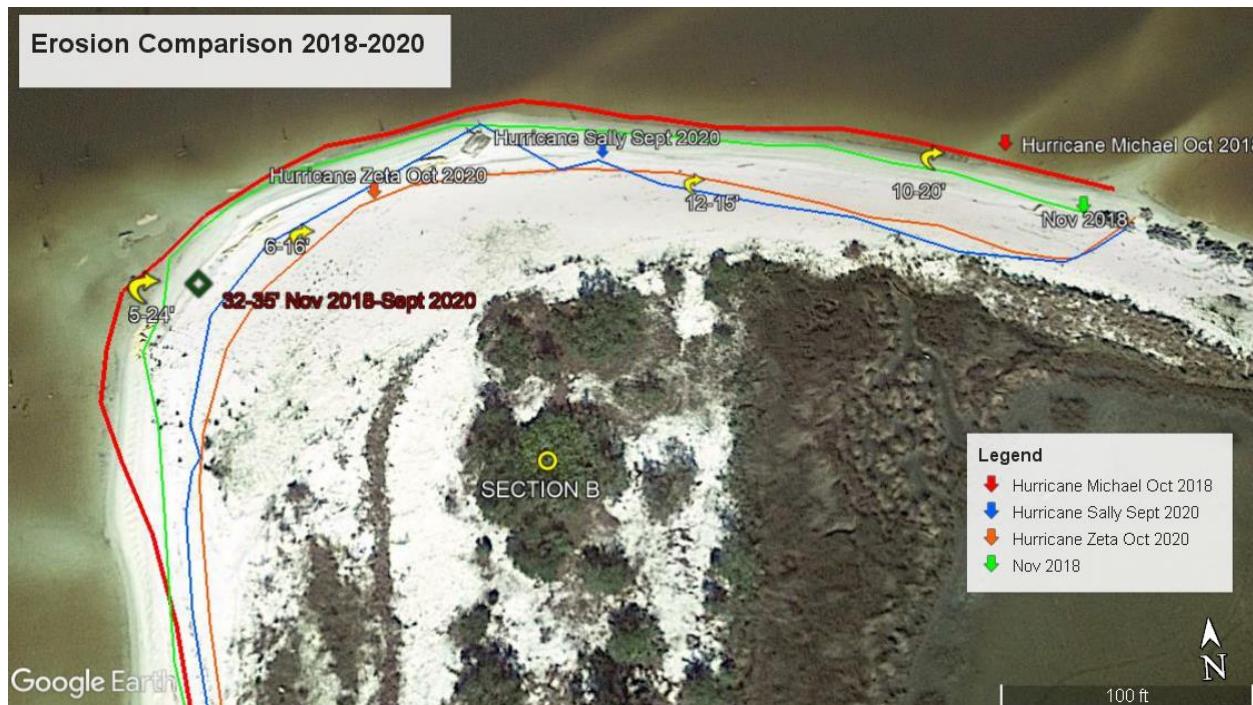
Figure 11:Erosion comparison from 2018-2020

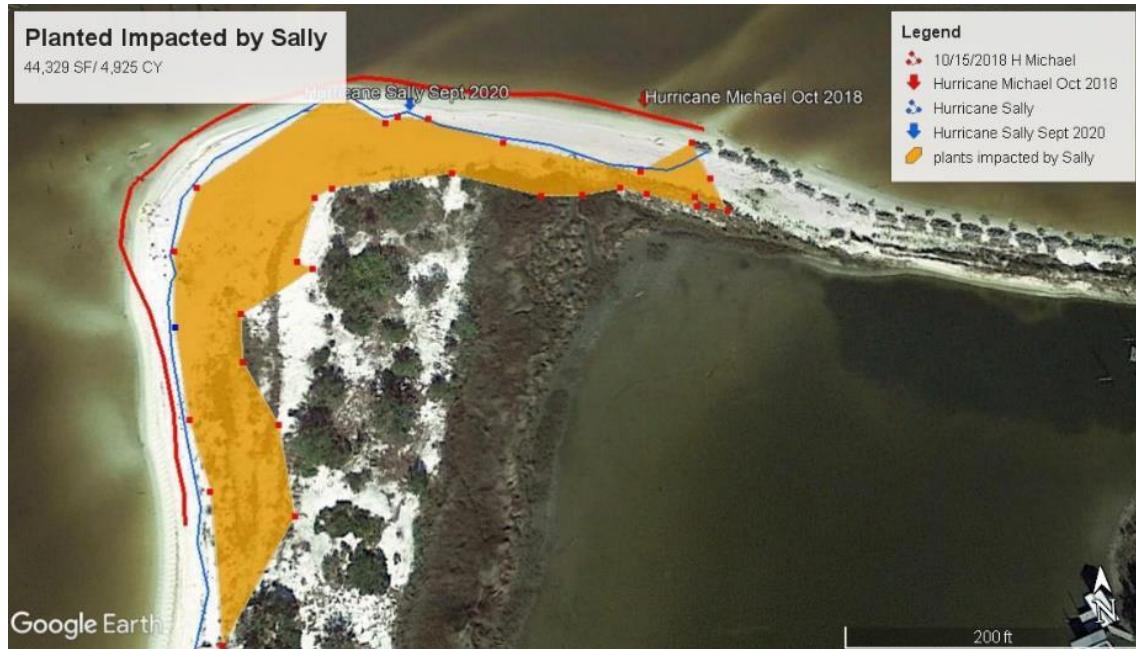
Figure 12:Vegetation impacted by Hurricane Sally

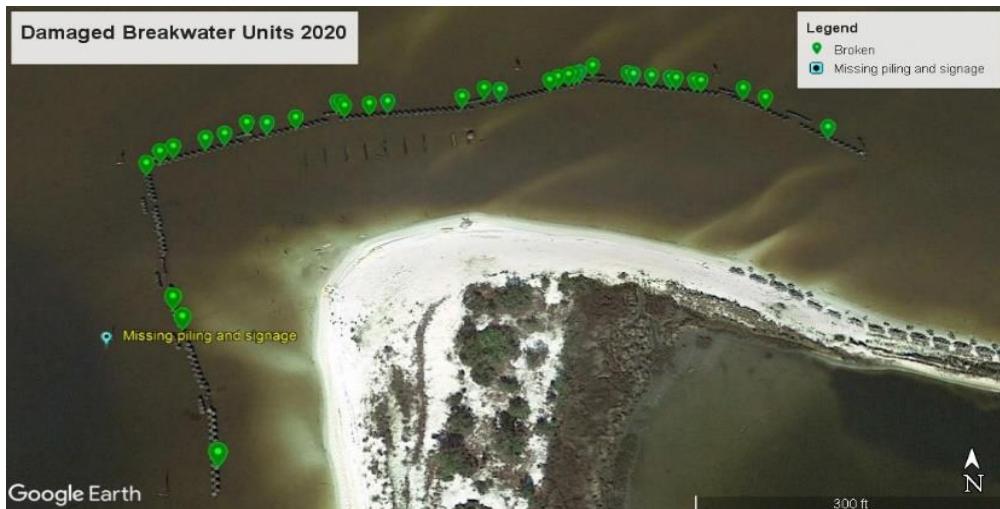
Hurricane Sally brought in high winds, rising tides, and massive storm surges and impacted 35 breakwater units and 140 tiers from these units. **Critical condition** is defined as "very advanced deterioration, overstressing, or breakage has resulted in localized failure(s) of primary structural elements," and typically warrants replacement to be carried out on a high priority basis with strong urgency (ASCE 2015). Deadman's Island is currently at this point. This urgency is due to the shoreline's vulnerability, where a missing portion of the offshore breakwater (Ecosystems) can allow massive wave surge to impact the shoreline and cause erosion. In addition to the breakwater damage, the storm damaged (6) solar lights and caused a large piling with navigational aid signage to break up and wash onshore.

least two tiers are completely broken and the pilings are exposed. These units were placed in 2011, and the final section was completed in 2015. These units sustained more damage during Hurricane Sally than Hurricane Michael. Hurricane Michael damaged 32 units but did not break off the individual tiers.

Figure 18: Section C- Damaged reef units after Hurricane Sally

Replace the reef units damaged by Hurricane Sally. Lessons learned from Hurricane Michael showed that we needed to increase the height of the reef by adding more breakwater units.

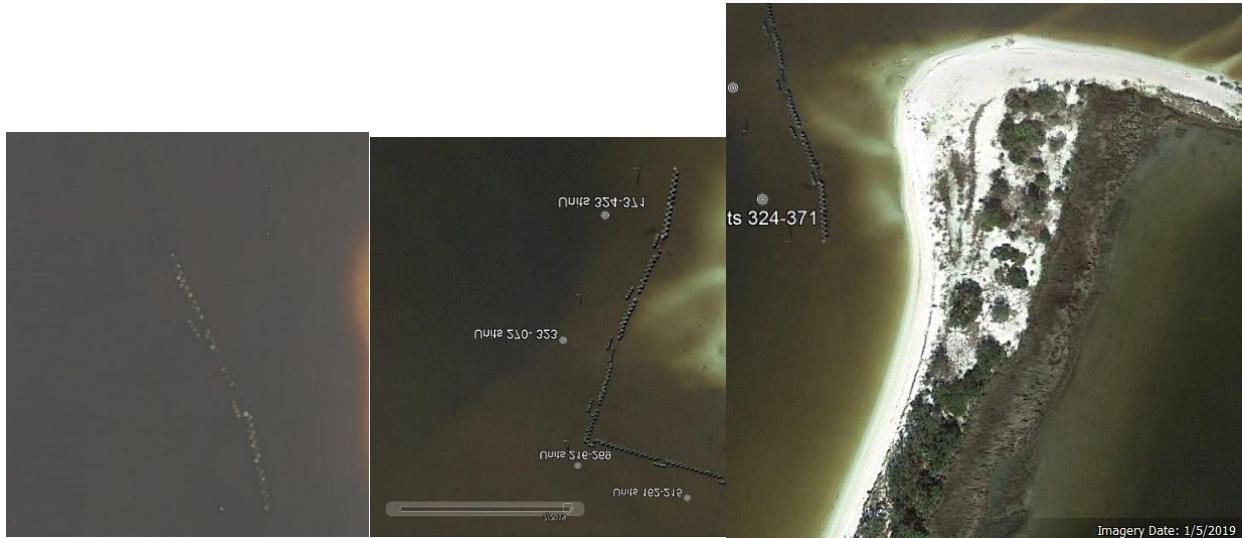
Figure 20: Section C-July 2019 aerial of the eastern breakwaters. The western section of the oyster reef breakwater post Hurricane Sally. Date taken: 09/19/2020

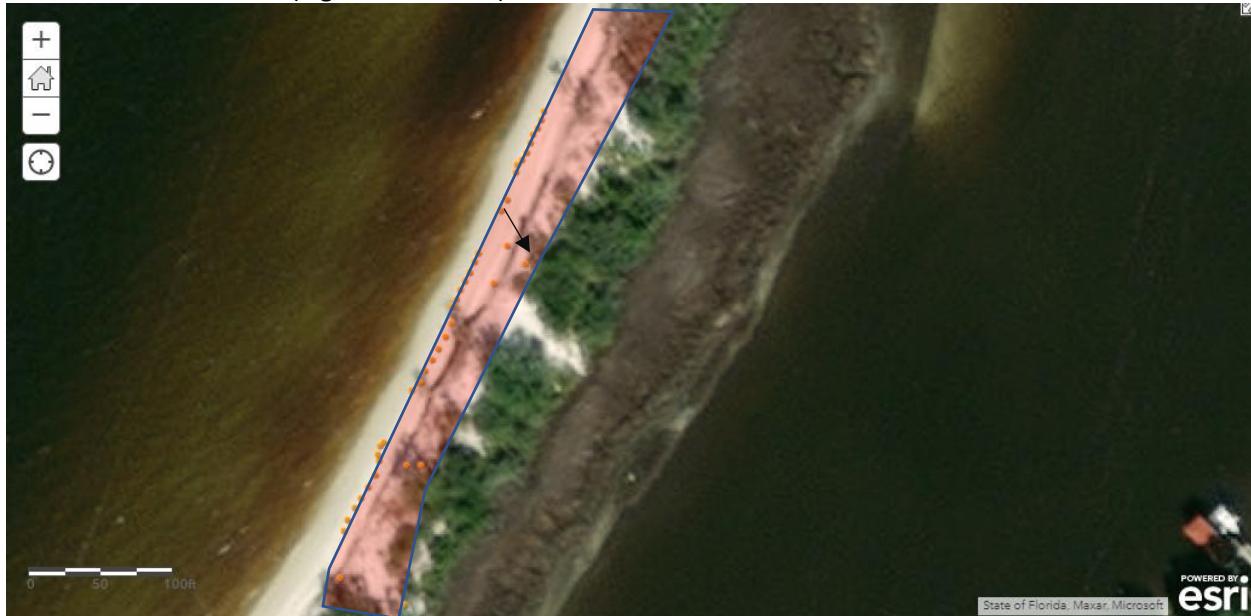
During Hurricane Sally, Deadman's Island dunes sustained considerable damage (Figure 21, 22, 23, 24). Unfortunately, despite all the restoration efforts, the dunes were relatively unprotected. During Hurricane Sally, the dunes suffered a maximum of 45 feet inland loss and a four-foot shear from the top of the dunes. The average amount of scarping and erosion measured from the shoreline was 40 feet (Figure 21).

Figure 21: Section D- Aerials of Section D September 19, 2020 – the Red polygon represent the loss of dunes. The orange dots are the GPS points taken along the shoreline and to the new edge of the dunes.

The recommendation is to rebuild the dune using local dredged material in a tiered system using several vegetation types over five- years. The ECS tiered system would involve using wood posts with a step system for building up the dunes.

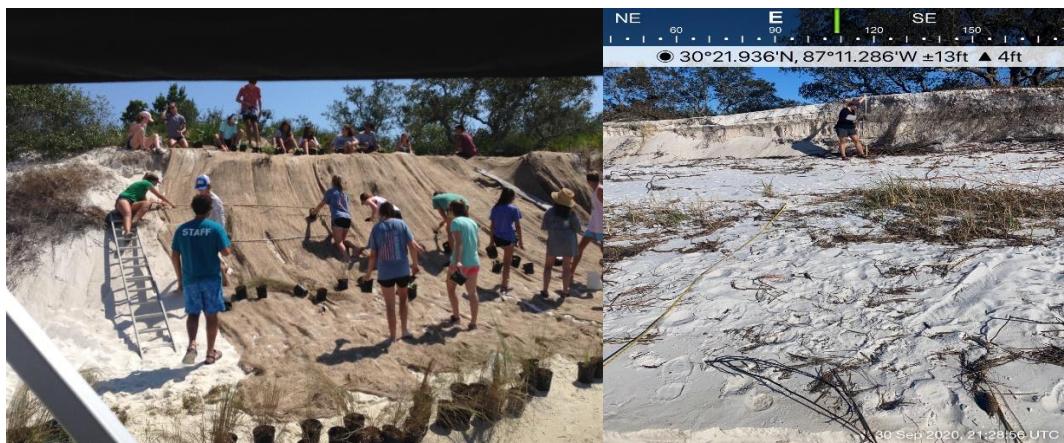
dune was washed away by comparing the current location of the dune to the grass line that used to be at the base of the dune (Figure 21 and 22).

Figure 22: (Left) A section of the dunes being restored before Hurricane Sally, (Right) The same dunes impacted by Sally note where the grass is that was originally at the foot of the dune.

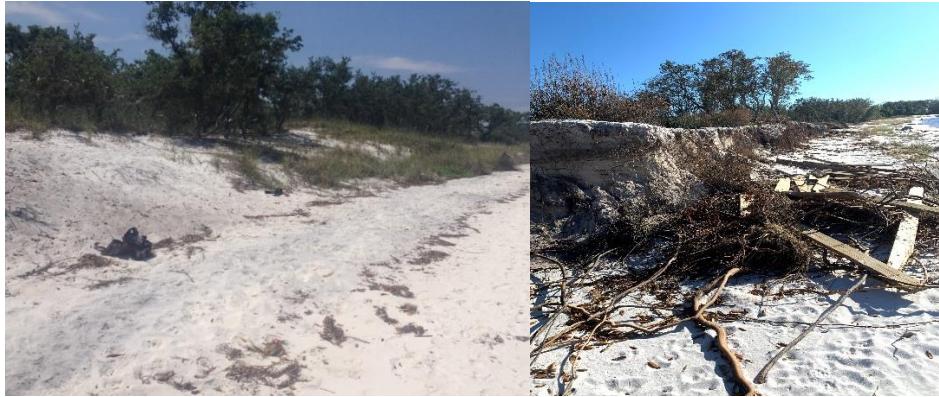
Figure 23: Another section of the dunes before Hurricane Sally that the City maintains. (Right) After Hurricane Sally. Note where the trees are no longer 25 ft behind the dunes.

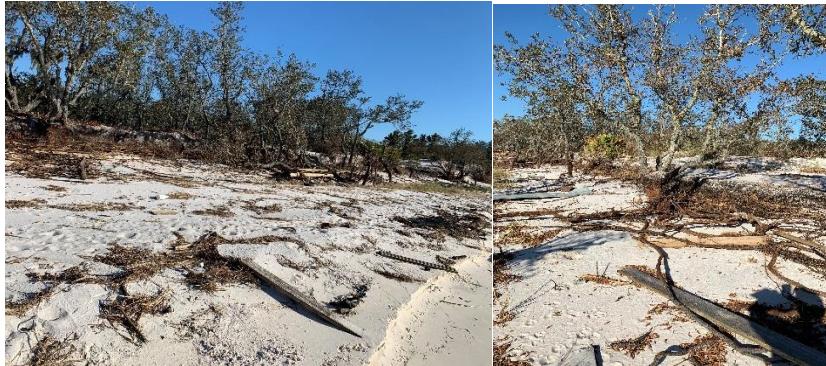
Figure 24: Damage to the dunes and vegetation. Note the shading of the where the tree was once rooted underground.

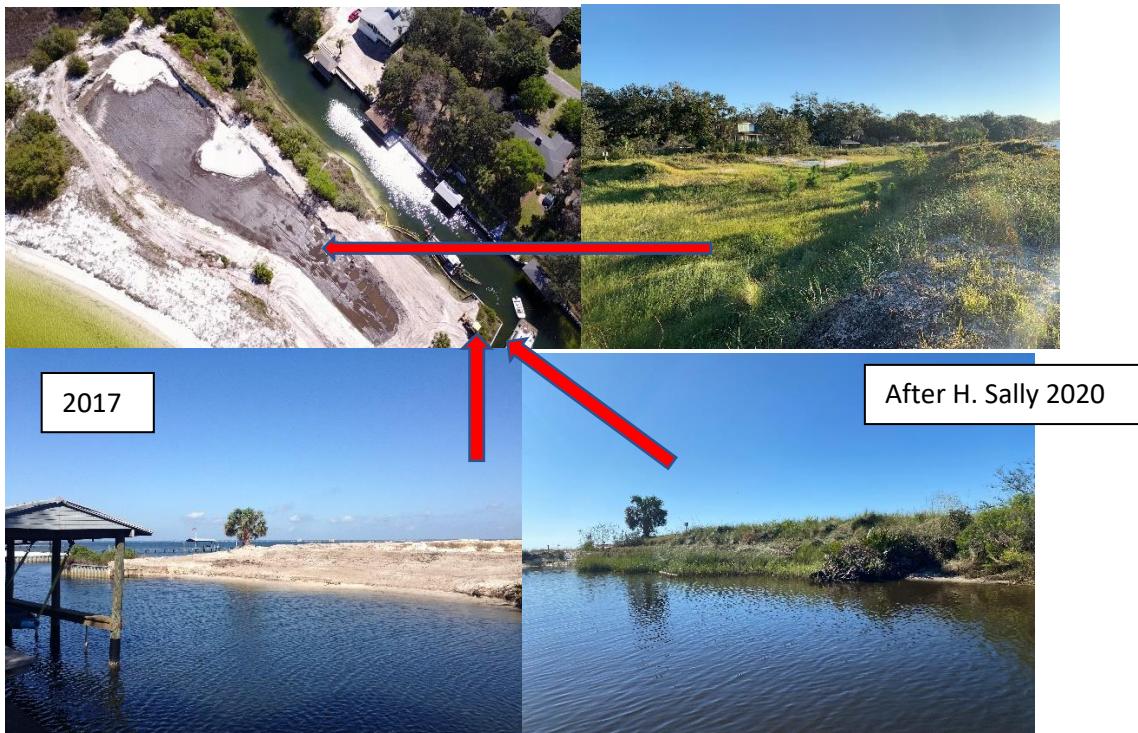
The living shoreline vegetation on the backside of Gilmore Bayou appears to be untouched and stable. The dredged material disposal site is also stabilized with vegetation along with a few pine trees and did not experience any erosion during the last hurricane. Unfortunately, the local canal has filled in with sand. This filling of the canal is most likely due to sand from the adjacent property that has blown and washed out into the bay and canal. The sand is typically placed in the designated dredged material disposal site on Deadman's Island for later use in restoration projects. The dredged material disposal site has the capacity to store more sandy dredged material at this time.

Figure 25: Upper left is the re-shaped dredged material disposal site after the 2017 Beneficial use project. The upper right shows the project after Hurricane Sally. The lower left is the shoreline reshaped from the 2017 Construction. The lower right is the project after H. Sally.

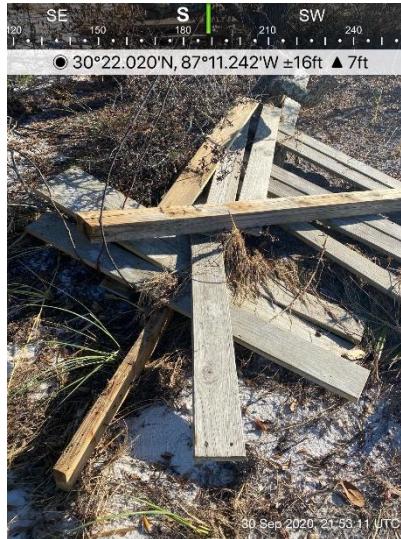
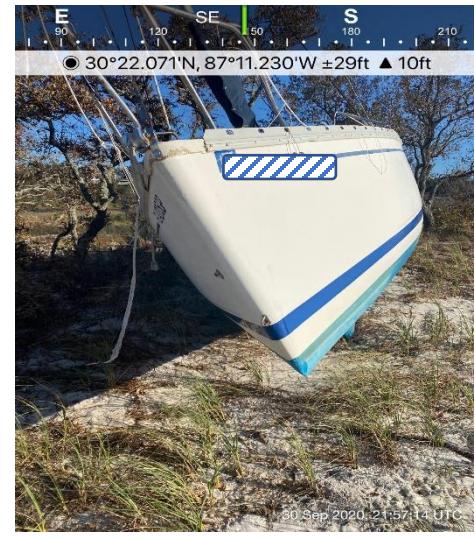
GPS waypoints were taken of each large pile of heavy debris. Large amounts of wood planks, pilings, and even a cleaning station sink washed onshore, along with plastic and other debris. If washed back into the water, this debris can be hazardous to the general public and our navigable waterways.

Remove the debris and haul to landfill. This site is boat access only. Barges will need to be deployed to access the site. Paid labor will be used load the barge. The City can place a trailer or dumpsters at City right of way off of Montrose Dr. The debris will be unloaded from the barge into the trailer or dumpster and the City will haul to the transfer station or nearest permitted landfill. If Hazard materials are within this project, these materials will be disposed of in accordance with local, state and federal laws. Table 1 below has the GPS locations of the debris that requires removal on Deadman's Island.
