2016 FINAL MONITORING REPORT

CITY OF GULF BREEZE DEADMAN'S ISLAND RESTORATION PROJECT PART 1

US Army Corps of Engineers

GULF BREEZE, SANTA ROSA COUNTY, FLORIDA

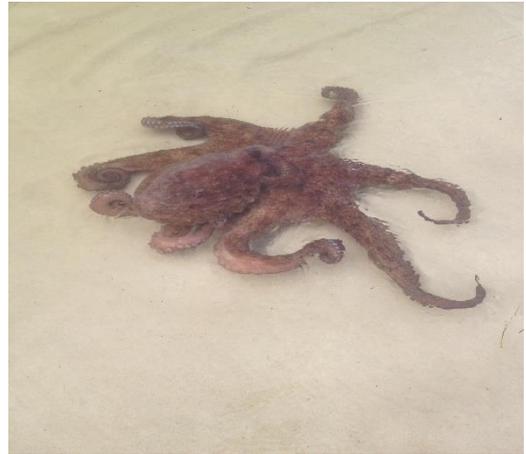
Figure 1: A common octopus found while monitoring on Deadman's Island.

The 2015 monitoring reports discuss the difficulty and ineffectiveness of using a quadrat to quantify species and percent coverage on the Ecosystems. It is difficult to quantify the oysters on a vertical reef by using a quadrat. Since the surface was completely covered, the results would naturally show 100% coverage. However, on top of the 100% coverage oysters are additional organisms competing for space, such as spat, adult oysters, barnacles, egg casings, sponge, and coral. The live and dead oysters/spat were measured as percent coverage on the existing surface of oysters. Unique species not normally found on oyster reefs, such as the octopus, was not included in the statistics (Figure 1).

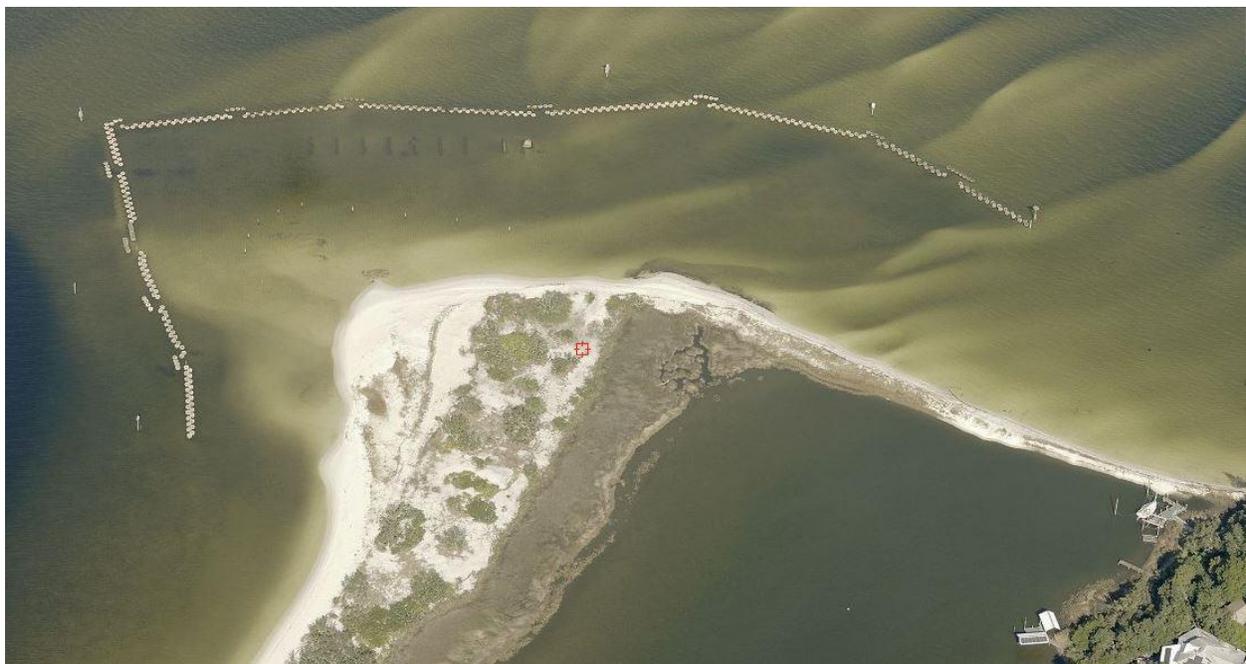
The completion of the 2015 breakwater has been beneficial for monitoring (Figure 2). It is easier to determine the benefit of the Ecosystems by counting the reef as a whole rather than separate sections.

Figure 2: The completed breakwater at Deadman's Island. Pictometry January 2016.

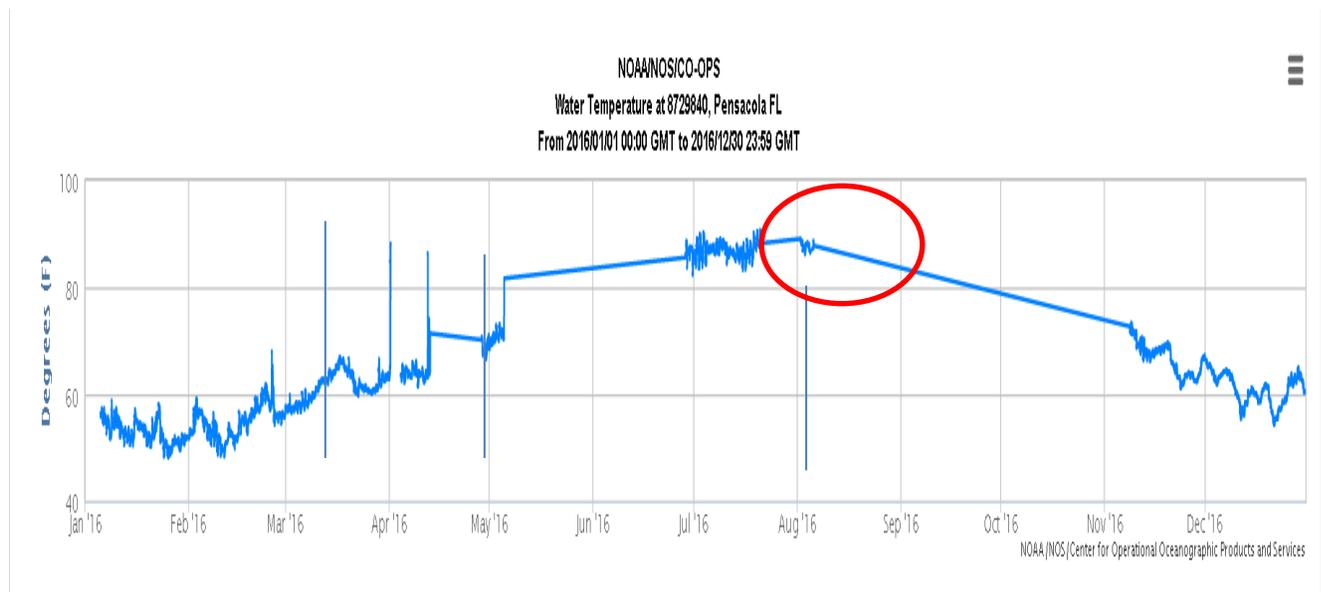
Figure 3: 2106 Water temperature. This chart was used to determine the settlement and age of the new oyster growth on the new breakwaters. The red circle estimates the times of spawning and settlement.

It was discussed in the 2015 report that oysters will spawn when there is a ten degree temperature change. So far, this speculation is observed to be true for the oyster reef. The spat has been observed to have settled within two weeks of placement of the new Ecosystems. Also observed is some spat do not survive over the next month and tend to fall off the reef units.

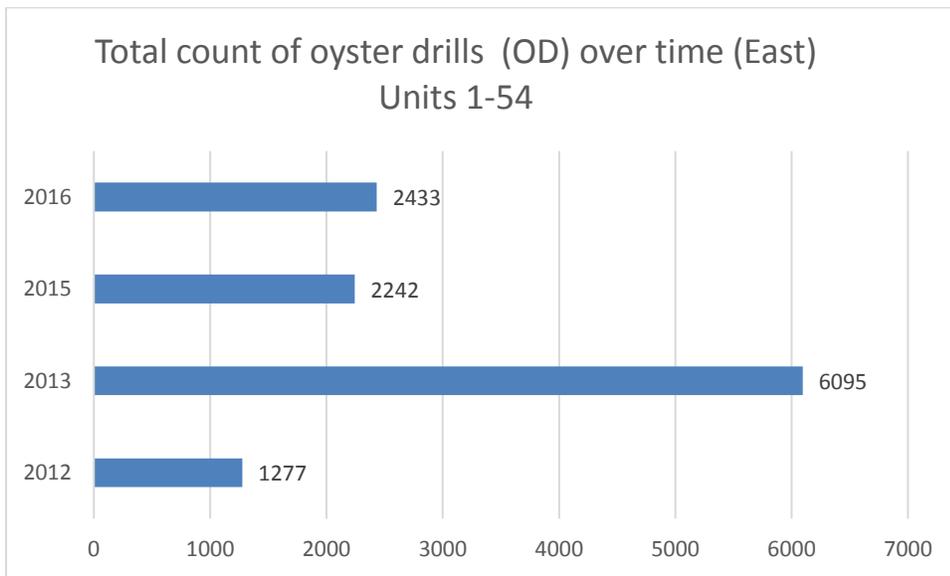
Figure 4: Total count of oyster drills over time 2012 and 2016.

Predators –There are many predators of oysters on the reefs but the most abundant threat to the oysters are oyster drills (*Stramonita haemastoma*). Oyster drills prefer salinity above 15 ppt but can survive in 8 ppt. There was a presence of oysters drills on both reefs, but the population of the oyster drills count was almost equal as 2015. This similar count could be due to an increase in species which prey on oyster drills and possibly the reef is becoming balanced. The stone crab population increased exponentially on both reefs. It was interesting to observe another predator of the oyster drill which was the Sheepshead fish. Sheepshead were found on both reefs. The west reef showed a 3.5% increase in large Sheepsheads.

Last year’s monitoring discussion focused on the increase in Stone crabs, sheepshead and whether or not there was an impact on the oyster drill population. The reasoning behind this speculation is during the 2011 oyster drill boom when there were no “janitors” such as crabs or sheepshead since the oil spill in 2010. During this boom, the fish and crab population had not recovered from such a rapid mortality observed in 2010. Now we are seeing a recovery and determining whether this recovery is a natural cycle or a die off from the oil spill.

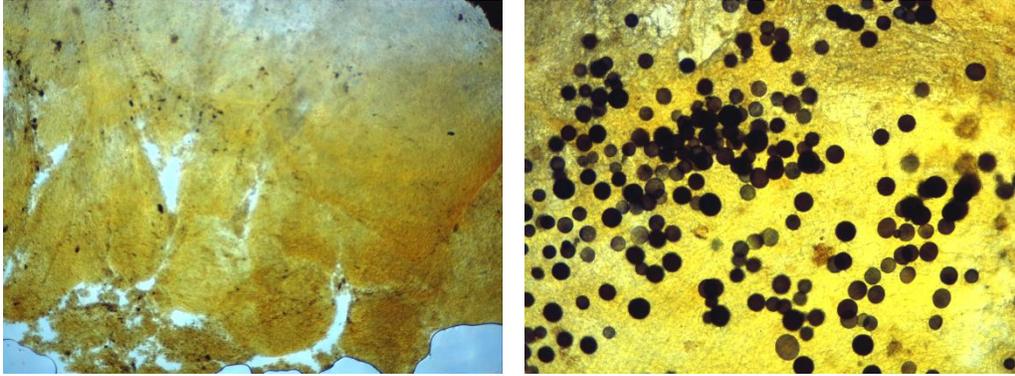
Several samples of juveniles and minimum sized adult oysters were collected and measured from Deadman's Island and tested for Dermo. A comparison was made of a dermo infected oyster tissue and the tissue from Deadman's oysters showed there was no infection in the oysters in 2016 (Figure 5). The Dermo tests showed negative for Deadman's oysters. The Deadman's oysters were randomly selected from various areas and inspected for worms, fungus, indentations, spots, and discolorations. Out of the 60 oysters selected, similar to 2015, there were no signs of diseases or fungus.

Figure 5: Oyster tissue Dermo results. (Left) Clean tissue from Deadman's Island adult oysters (right) an example of a dermo infected tissue in another bay (Photo credit Heather Reed, 2016 (left) , Dermo sample(right) credit by Dr. Bill Walton, Auburn University, 2015)

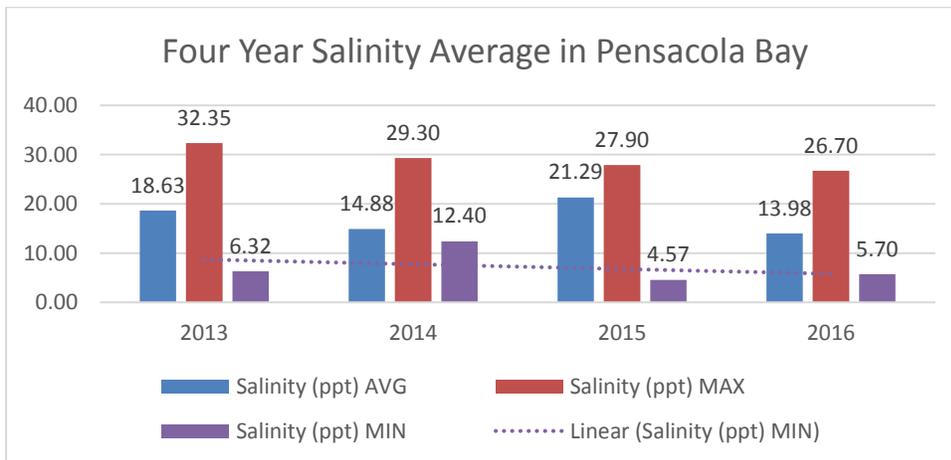
Figure 6: Salinity chart for 2013-2016. The year 2016 shows an average range between 32.35 (ppt) and min and max range 4.57-20.17 (ppt). Data source FDEP STORET.

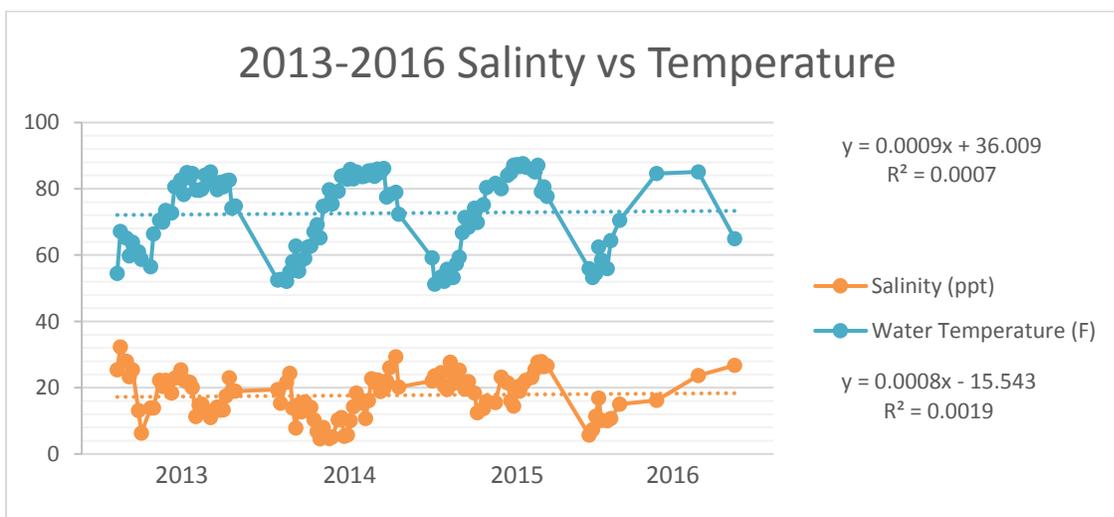
Figure 7: Water Temperature/Salinity trends from Jan 2013 thru Dec 2016 showing a steady trend of temperature vs. salinity.

Salinity changes can be affected by temperature. As the temperature rises the salinity increases in the bay (Figure 7). The exception would be fresh water influx as observed with the floods of 2014. Observations of nearshore shallow water (ten feet from mean high water) found more oysters are susceptible to disease from stress and literally baking in the sun from hotter temperatures when exposed. Shallow water reefs less than four feet deep should not be dependent on oyster growth to create a functional and structural reef due to oyster die off. This die-off leaves a waste of exposed bags of oyster shells. The offshore distance of the breakwater and depth greater than 4 feet is found to keep the temperature and dissolved oxygen ideal for the oysters because of continual underwater exposure. Monitoring shows some oyster growth

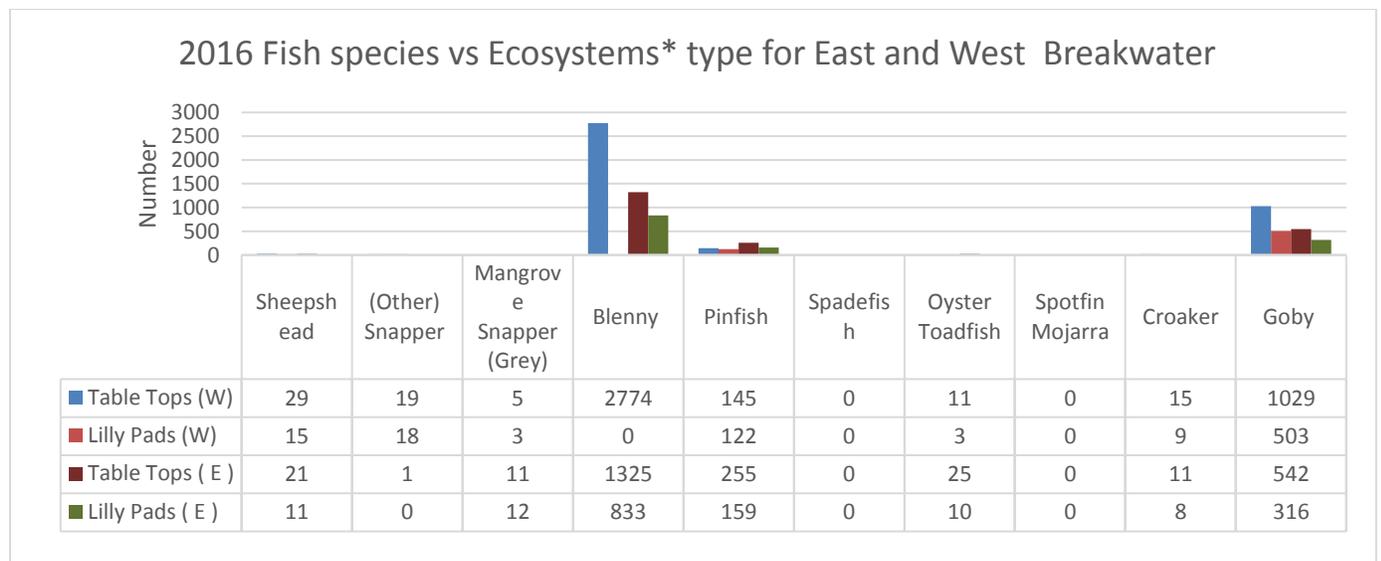
Figure 8: The fish population vs. the various sections of the East and West breakwater reefs.

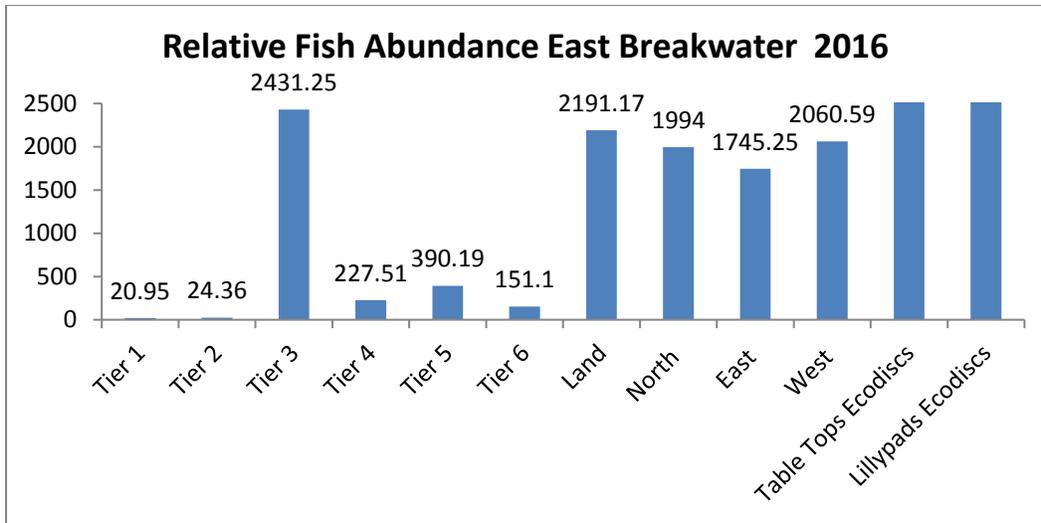
Figure 9: Total abundance of individuals on the East and West breakwater reef in relation to all tiers of each unit, all directions of Land side, north direction, south direction, east direction, west direction and on the two different structure designs of Table Top and Lillypad Ecosystems.

The tiers of the Ecosystems support an interesting ecosystem hierarchy among fish. The stacked units stand in a shallow 4-5 feet depth, with tier 1 being the top unit. As in 2015, Tier 1,2,3 of figure 9, show juvenile fish and the lower tiers show, the larger fish. The deeper in the water column the tiers have, the larger the fish. What is consistent in all years? The third tier seems to show more species (including fish) abundance. The reason could be this area keeps juveniles safe from predators. The other reason could be due to tier three and four are 90% submerged all year, providing protection from surface wave impact and providing a more sustainable habitat.

Tier 6 is usually where the larger fish are found. There is little growth on the last tier. This lack of growth could be a result of two theories; 1) the larger fish control the species population on the sixth tier and 2) the sand builds near these reefs and the wave action causes the moving sand to irritate some of the species. The organisms do not prefer the rough environment of the pelting sand, reducing the ideal habitat for most species.

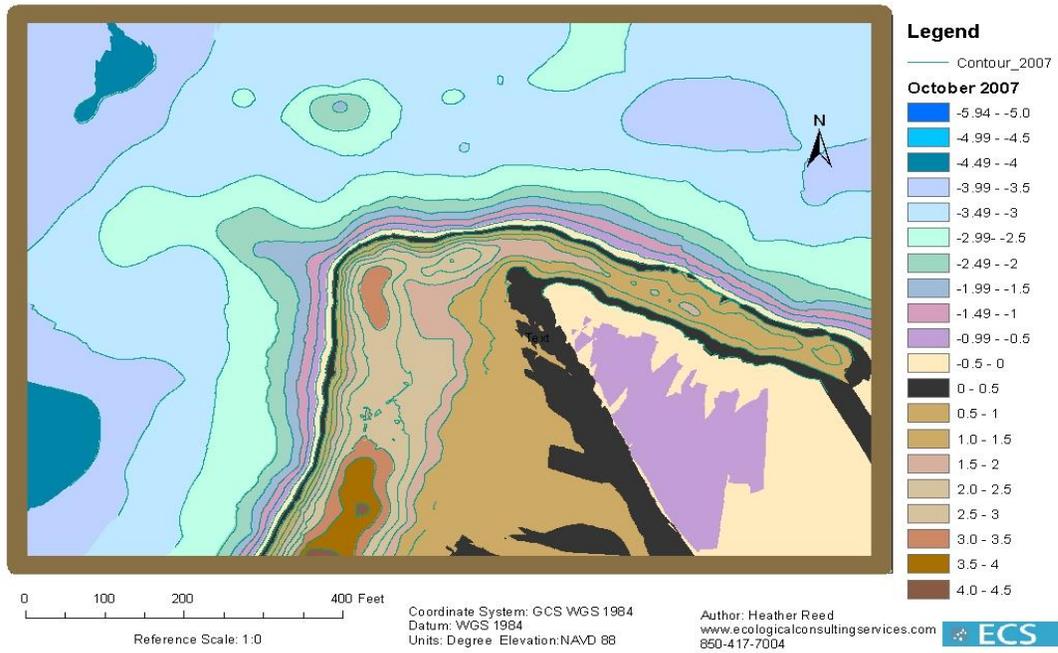
Deadman's Island 2007 Baseline Bathymetric Survey

Figure 11: The 2007 Baseline survey of the bathymetry of Deadman's Island prior to breakwater placement.

When comparing the 2007 and 2016 survey the darker green and blue area (-2.49 and -2) the elevation have been reduced and is increasing in volume throughout the years behind all breakwaters (Figure13). This section remains deep from the lack of breakwater and scouring prior to 2016 on the north-western side. The 2016 bathymetric should provide better insight to how the sand will shift and move with the now complete offshore breakwater. The 2017 survey should determine whether the innovative breakwater and shoreline stabilization project was successful and could be transferable to other site-specific projects needing restoration.

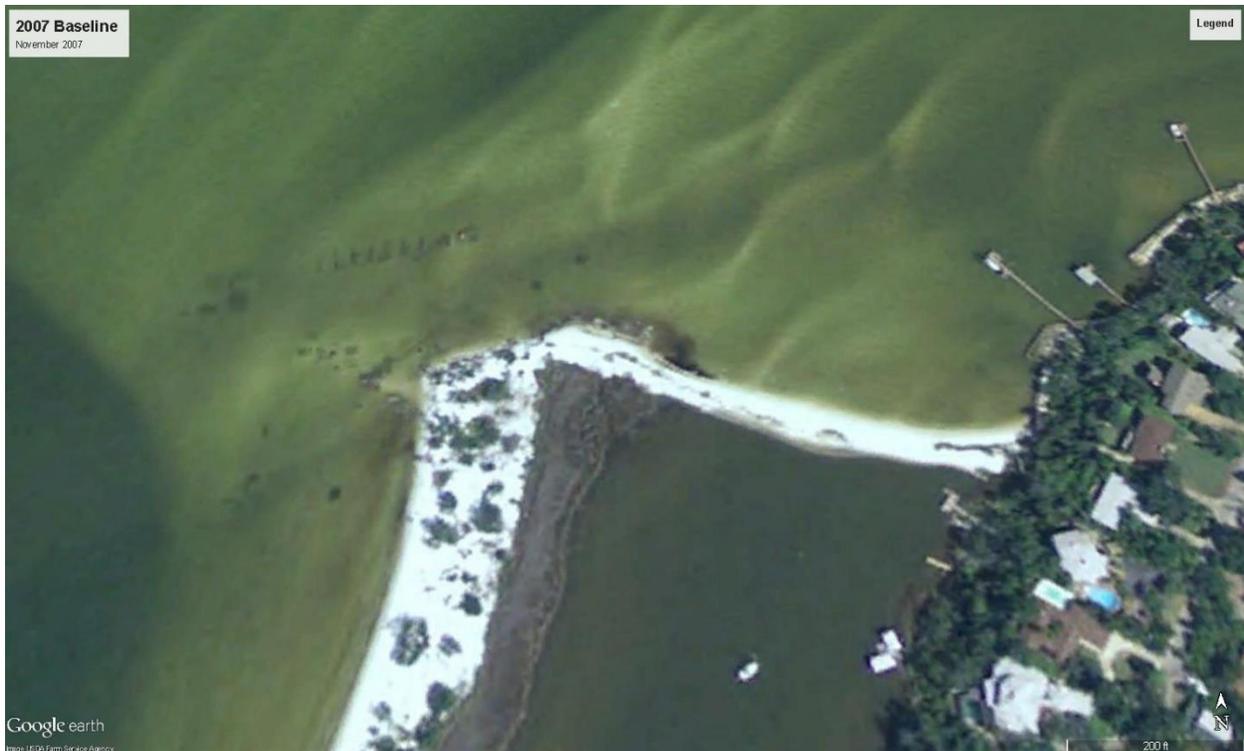
Figure 12: Deadman's Island aerial taken in November 2007 from Google Earth.

monitoring purposes, the baseline of 2007 will be compared with 2016 (Figure 11, 12 and 13)

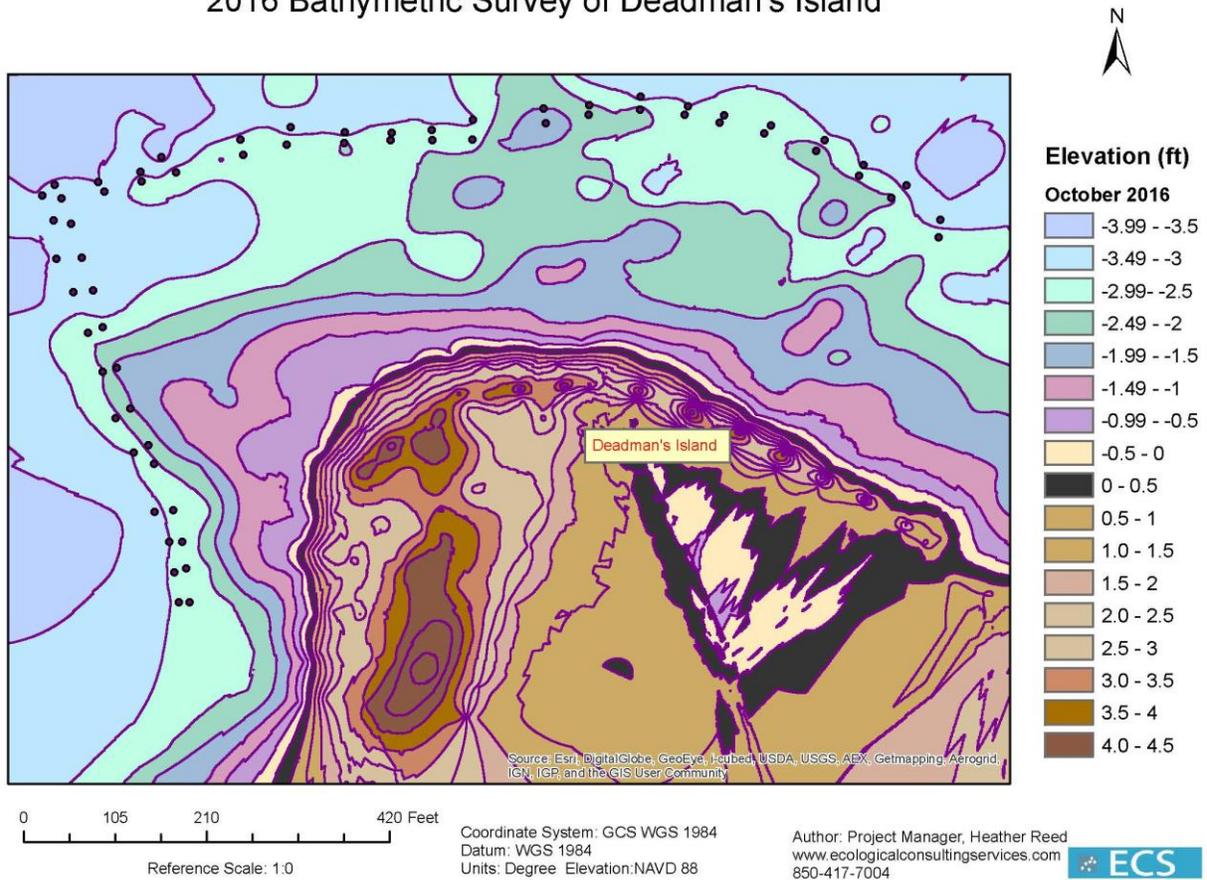
2016 Bathymetric Survey of Deadman's Island

Figure 13: The 2016 bathymetric survey shows the location of the recently placed 2015 Ecosystems breakwater for reference.

With initial bathymetric observation during 2007 and 2016 , it appears sand had accreted behind the breakwater at a rapid rate. There was an evolution of events including sand placement and the shifting and leveling of unprotected areas from wave action. The failing breakwater and northeast open section with no breakwater caused the wave action to push the sand to the east and southeast to spread around the project and accrete behind the existing breakwaters.

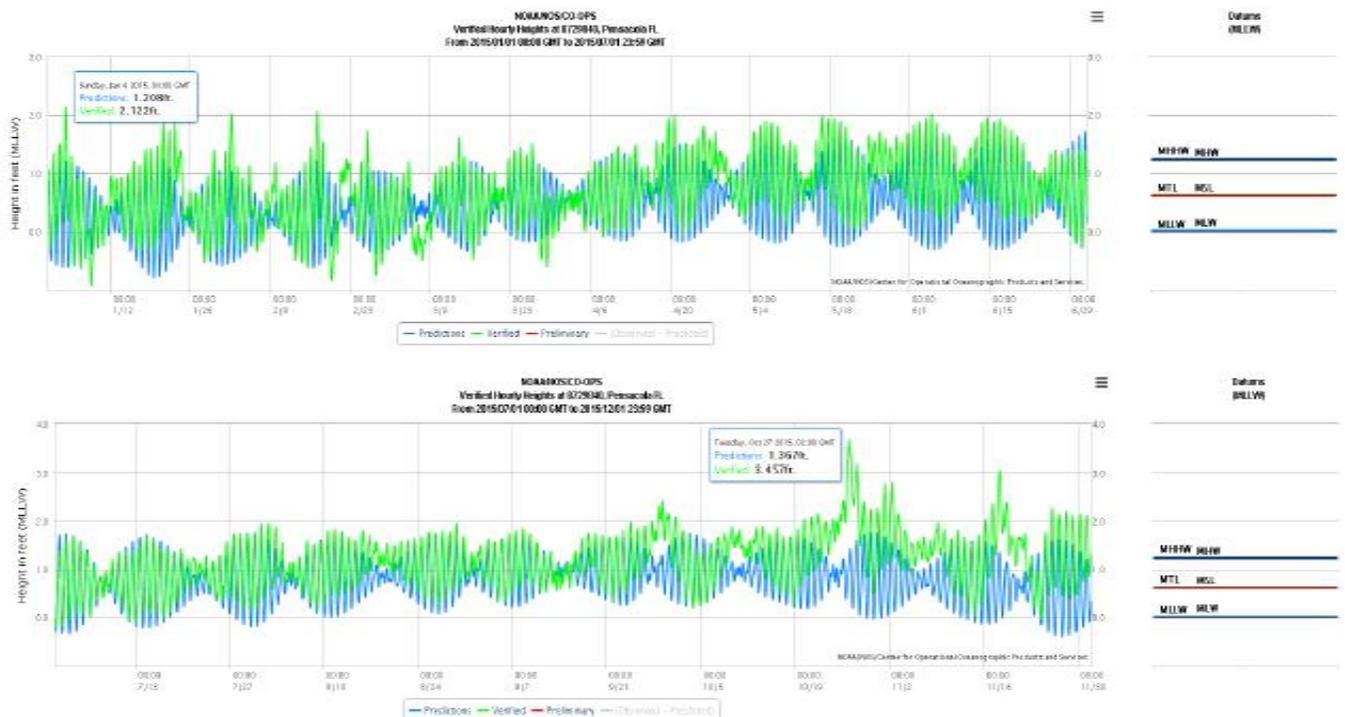
2015 Historic Tide Data- Verified

Figure 15: 2015 Historic Tides data from Station # 8729840. The blue lines are the predicted tides given, and the green lines are the verified tides which were the actual tides. In some cases from January to July, the tides were .69 feet higher than normal tide (Top). From July to December the tides were also approximate .85 feet above normal except a few storms in October and November raising to 2.45 feet above normal (Bottom).

In April, May and June 2015, low tides were also higher than normal and never allowed a normal low tide (Figure 15). In all months of 2015 after July, the verified high tides ranged from 1 to 2 1/2 feet above normal tide. During the months of November and December where there are extremely low tides are expected was more similar to an average summer tide, 1/2 to 1 foot higher than the normal low tide.

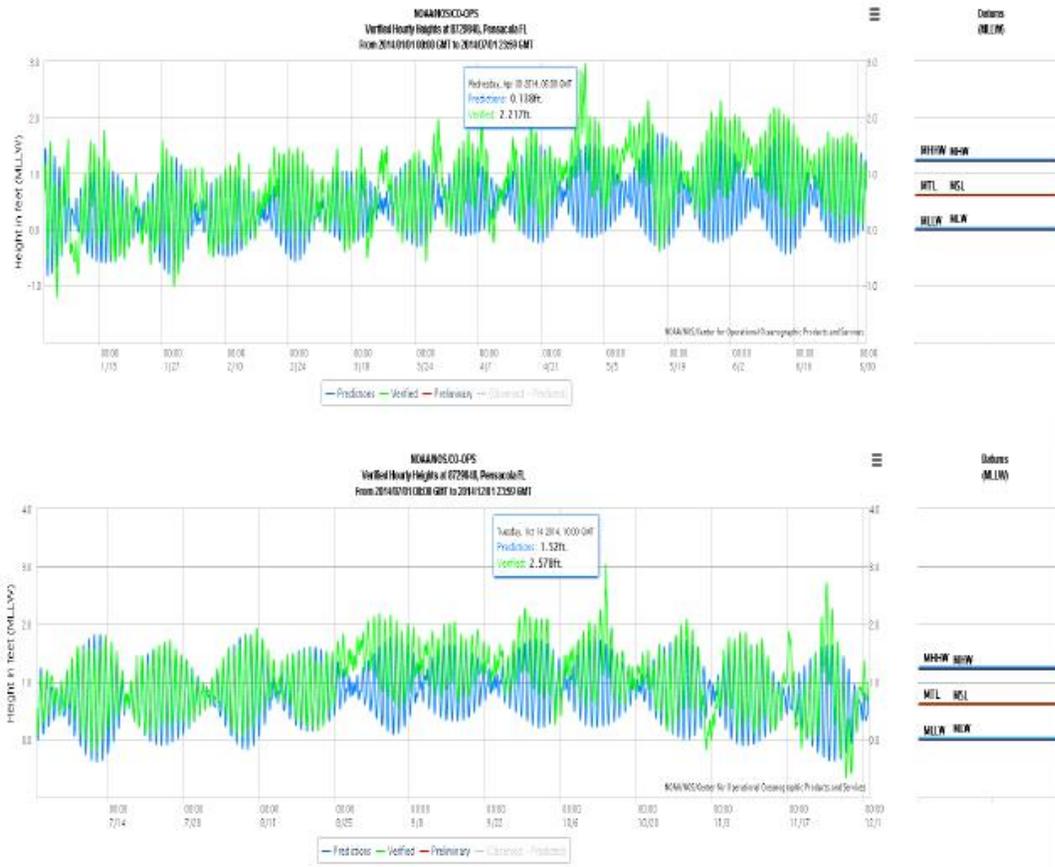
2014 Historic Tide Data- Verified

Figure 16: 2014 Historic Tides data from Station # 8729840. The blue lines are the predicted tides given, and the green lines are the verified tides which were the actual tides. In some cases from January to July, the tides were 2.079 feet higher than normal tide. From July to December the tides were also approximate 1.058 feet above normal.

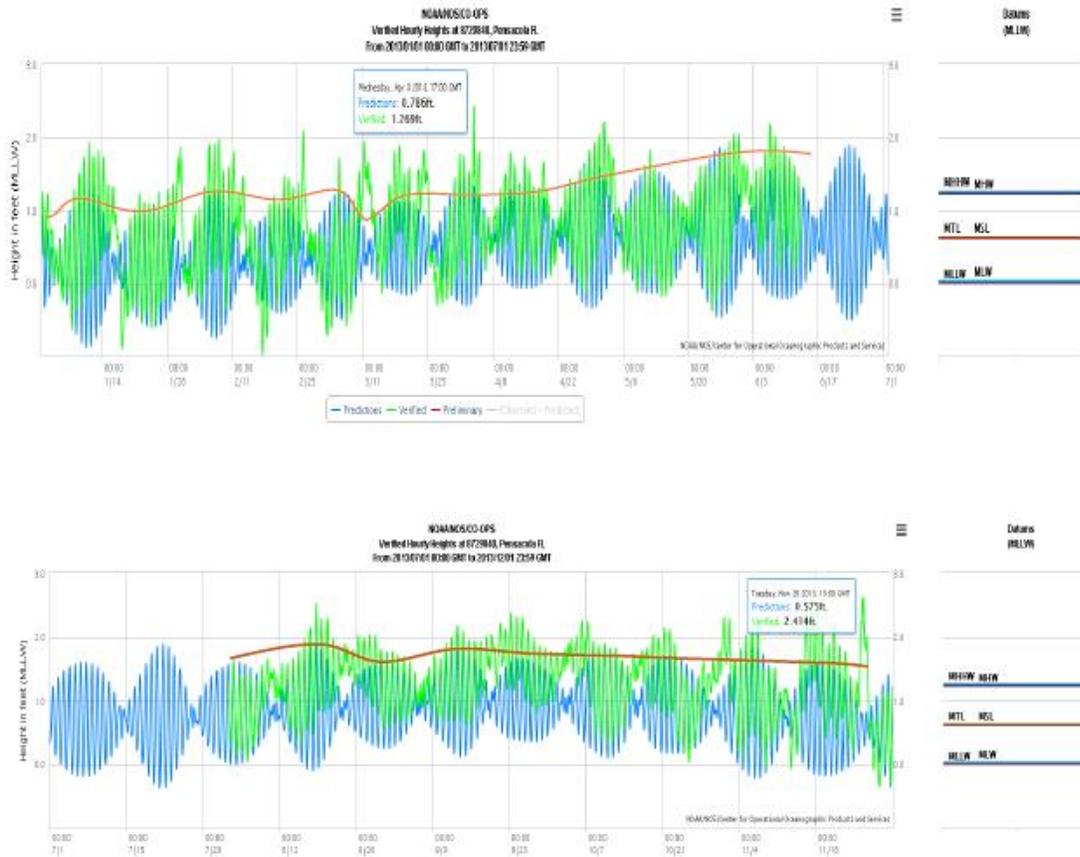
2013 Historic Tide Data- Verified

Figure 17: 2013 Historic Tides data from Station # 8729840. The blue lines are the predicted tides given, and the green lines are the verified tides which were the actual tides. The orange lines show the difference between the verified and the predicted. In some cases from January to July, the tides were 1.19 feet higher than the normal tide. From July to December the tides were also approximate 1.839 feet above normal.

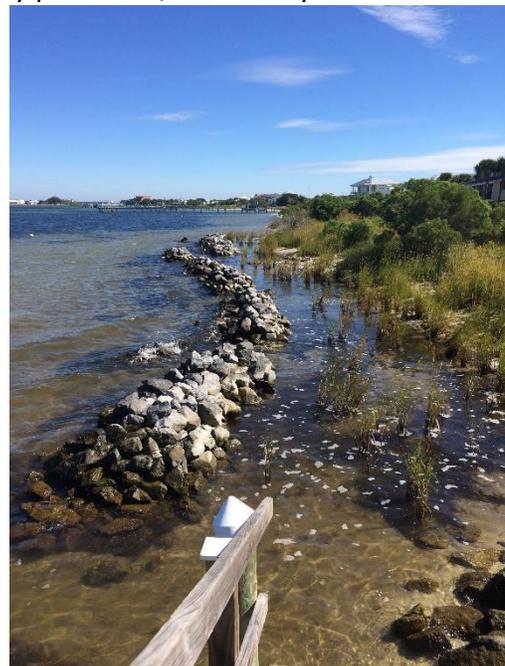
Figure 18: Another ECS restoration project and future example of the proposed isthmus breakwater project at Deadman's Island.

The cause of the erosional threat is from a combination of the lack of sediment for re-nourishment, permitted activities, storms and scouring. This combination caused the breaching of the isthmus and saltmarsh being smothered by sand. This final project will completely restore and protect the remainder of Deadman's Island.
