2015 MONITORING REPORT

CITY OF GULF BREEZE DEADMAN'S ISLAND RESTORATION PROJECT

US Army Corps of Engineers

GULF BREEZE, SANTA ROSA COUNTY, FLORIDA

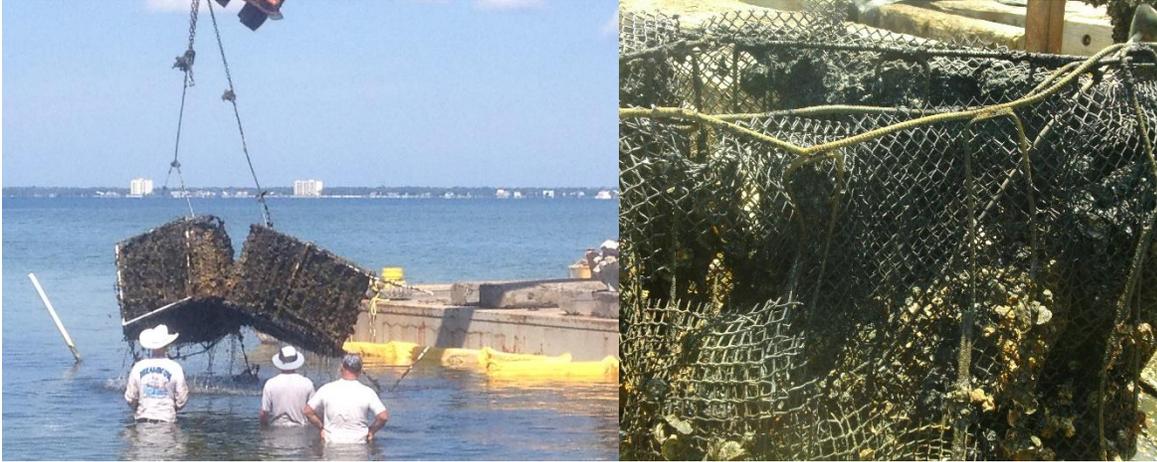
Figure 1: Removal of non-functional breakwater

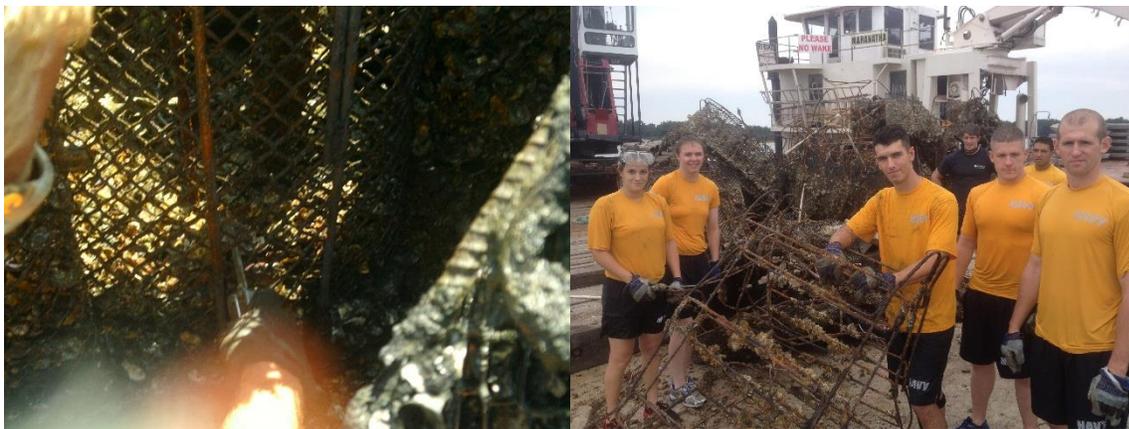
Figure 2- 2013: Phase 1 of the first breakwater placed on Deadman's Island in 2008-2009. The breakwater has lost 67% of its seed shell within the bags. There is no live shell found on the bags. The live shell was found randomly on the inside anchoring system.

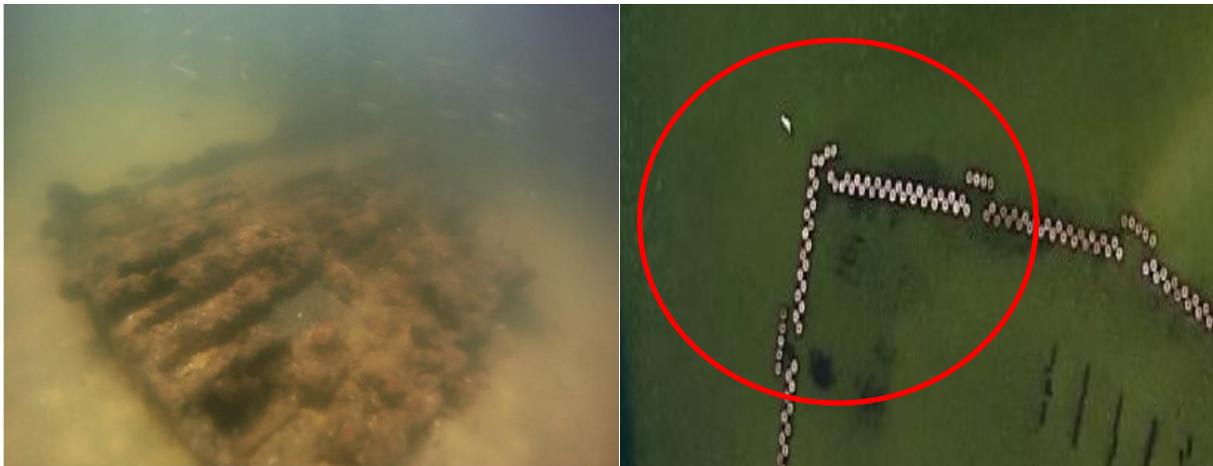
During the removal, some shipwreck remnants were once again exposed and the new breakwater design and placement needed to be modified not to impact the wreck remnants. Any part of the exposed wreck were flagged underwater and avoided. These modifications remained still in the plan and boundaries of the original design and state land lease.

Figure 3: One of the documented exposed historic artifact of shipwrecks (left) The general area (circled in red) of design modification for breakwater placement around exposed historical structures.

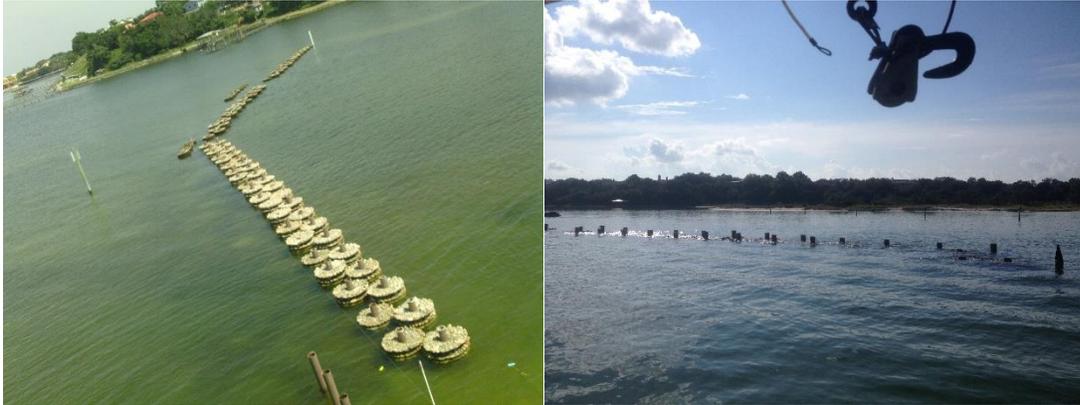
Figure 4: Construction of the breakwaters. The remaining protruding remnants of the pilings were cut flush with the top tier of the breakwater.

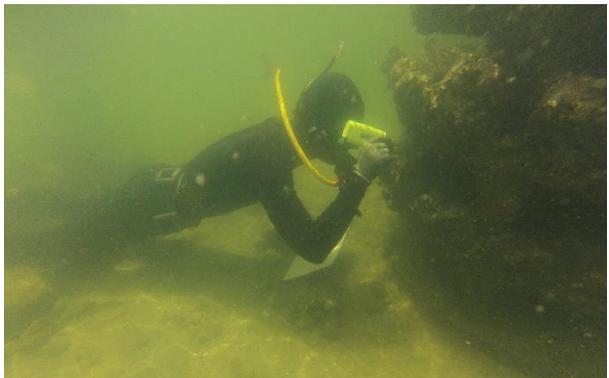
Figure 5: Biological Technician monitoring the Ecosystems reefs.

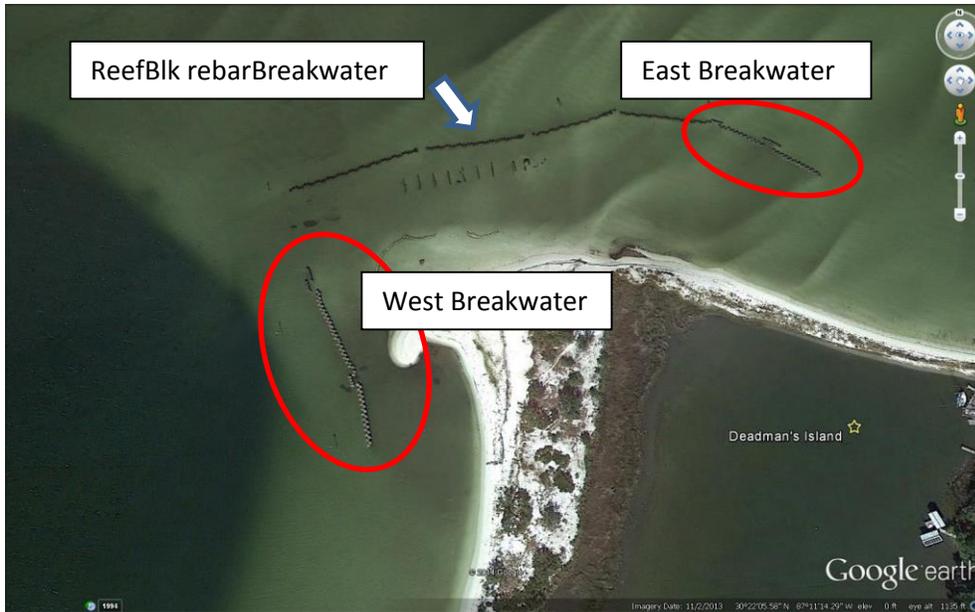
Figure 6: The location of reef monitoring sites at Deadman's Island

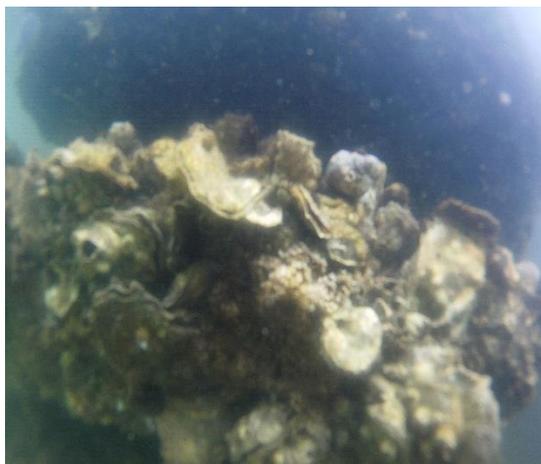
Figure 7: A section of reef showing three dimensional oyster growth and monitoring challenges on one of the Ecosystems units of Deadman's Island.

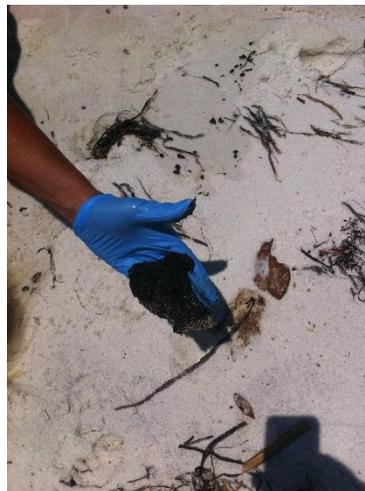
Figure 12: A picture of oil, from the 2010 Deep Water Horizon oil spill event, found at Deadman's Island.

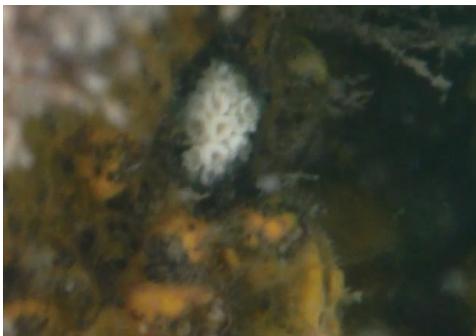
Figure 18: Solitary coral of *Astrangia danae* found on the reefs of Deadman's Island

Other species still found on the reef was coral (*Astrangia danae*) (Fig. 18), sand perch, wrasses, whelks, mudskippers and skilletfish. The smaller fish were found in the upper two tiers, and the larger fish were found on the bottom section of the breakwaters. In 2015, there were other species added to the spreadsheet this year, hooked mussel, *Ischadium recurvum*. Hooked mussels prefer the low salinity ranges. The literature says they are symbionts. However, there is still a competition for space with the oysters. The main predator of hooked mussels is blue crabs. There is a presence of blue crabs on the reef, but not in abundance (0.15%, Table 2) . Species found swimming around the reefs were butterfly fish, sergeant majors, sea robin, black rum, red drum, mullet, menhaden, pompano, white trout.

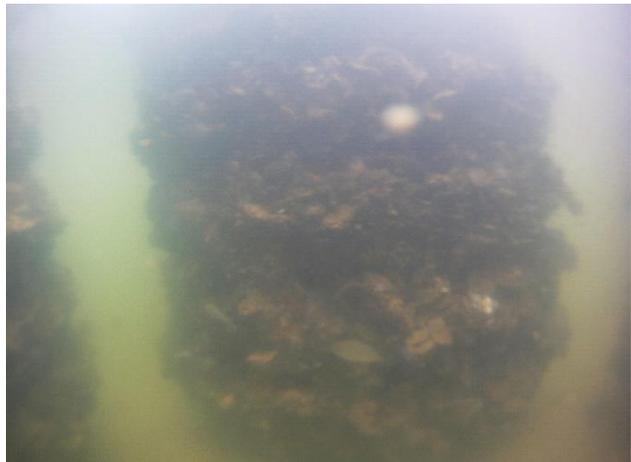
Figure 23: The existing oyster reefs on the north east section of Deadman's Island. The picture shows the entire oyster reef is growing into a dome from the oyster growth on the outside of the reef. The inside of the reef is still open and provides safe habitat for reef species.

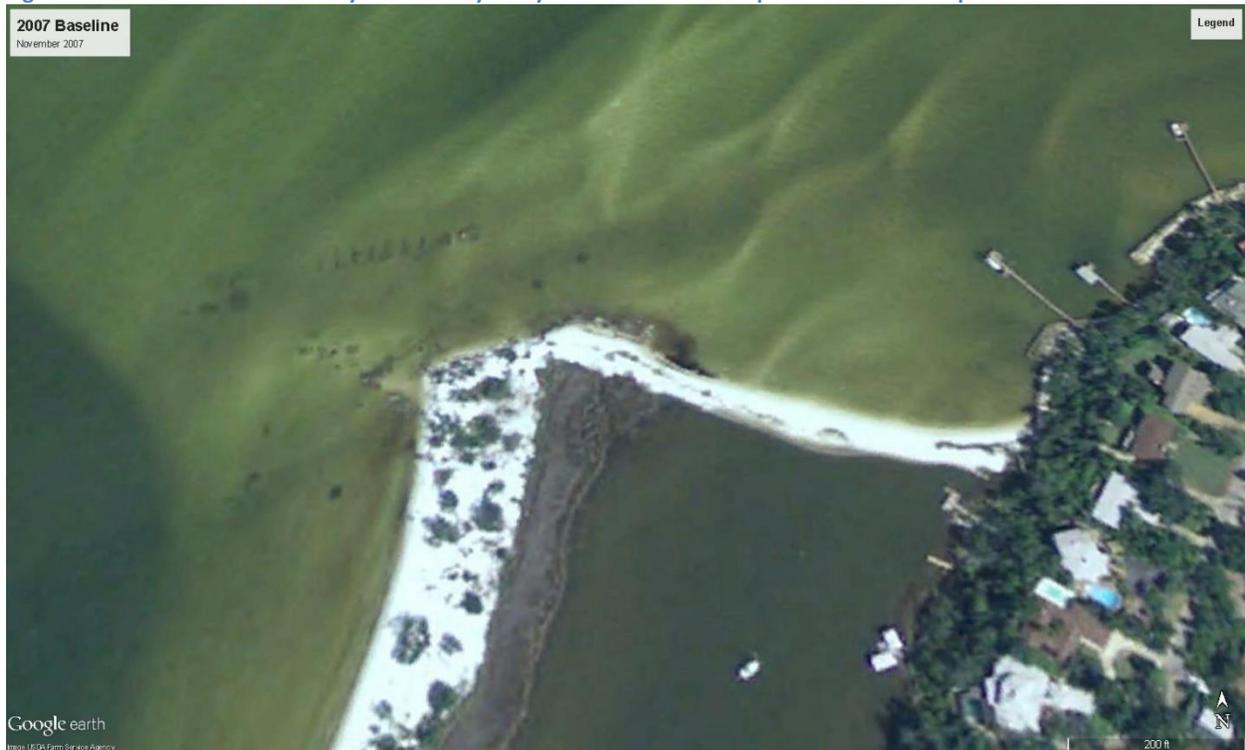
Figure 26: Deadman's Island aerial taken in November 2007

To monitor the sediment movement, erosion, and accretion, a bathymetric survey was taken by a professional surveyor in the month of October. The survey elevation points were then compared to the 2007 bathymetric baseline survey, 2007 funded by US Fish and Wildlife (Fig. 25). The baseline of 2007 was before any breakwater was placed offshore of Deadman's Island (Fig. 26).

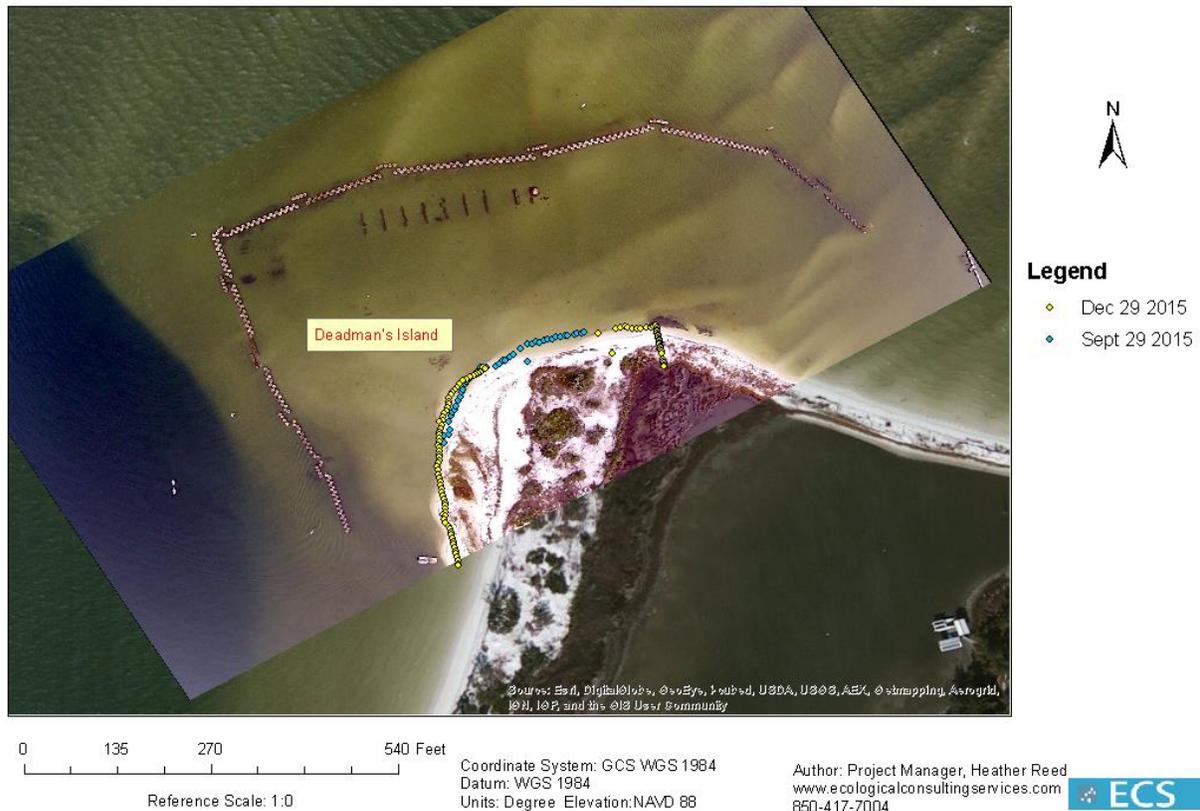
Shoreline survey of North Deadman's Island after the completion of the breakwater footprint

Since the breakwater has been placed, a monthly GIS reading is taken to observe any change in the shoreline (Fig. 32). Although this bathymetric is a baseline for 2015 since the breakwater as been replaced, the depth of the sediment has changed around the breakwaters due to the removal of the old reef and replacement of the new reef. This was due to constrcution activities around around the breakwater and the sediment being disturbed by the equipment. This disturbance does not represent a typical stable condition. The sandy bottom needs to reach equilibrium to determine whether the movement of the sediment is permanent.

Figure 32: A shoreline survey showing GPS point from September and December 2015 along the shoreline of Deadman's Island. There is currently no change in the shoreline and appears to have become stable. Drone overlay supplied by Wes Morgan of Morgan Creative.

The breakwater footprint has been completed and the Ecosystems are now in place, the 16,000 cubic yards of sand and vegetation lost over the years can now be replaced. The dune pilot project shows additional dunes can be built and the seagrass bed located south of the project can also be expanded. This project is anticipated to occur in the summer of 2016 and 2017.
