2018 MONITORING REPORT

CITY OF GULF BREEZE DEADMAN'S ISLAND RESTORATION PROJECT

U.S. Army Corps of Engineers

GULF BREEZE, SANTA ROSA COUNTY, FLORIDA

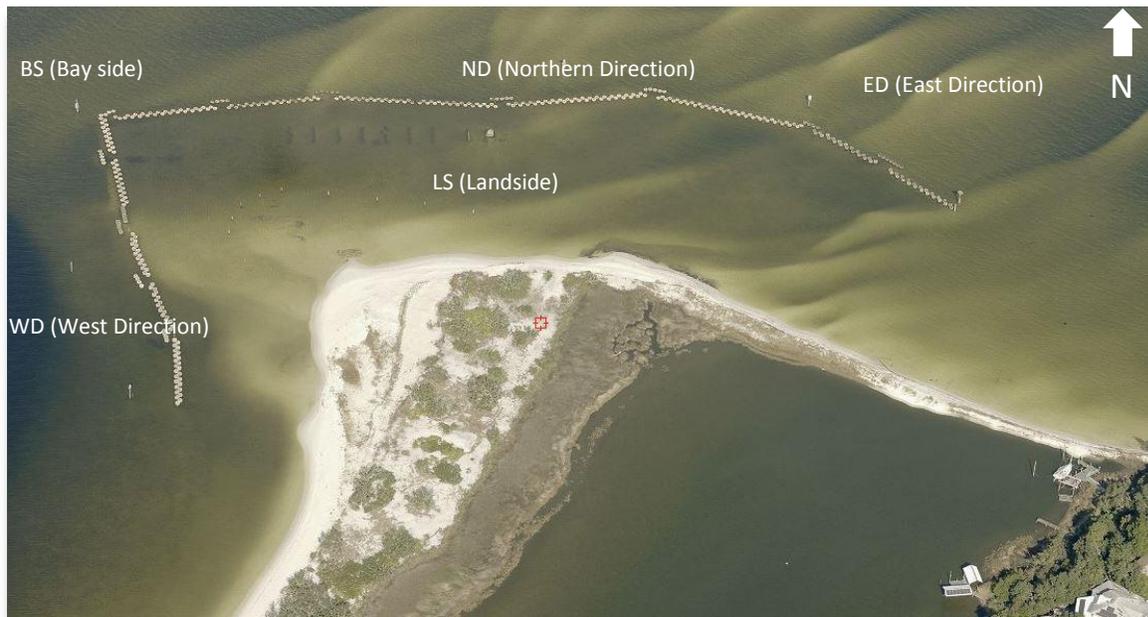
Figure 1: The completed breakwater at Deadman's Island

In the past years, since the breakwater was not complete. The monitoring compared the west section and the east section; however, since the remaining breakwater was completed in 2017, breakwater unit sections are randomly selected equally throughout the entire reef.

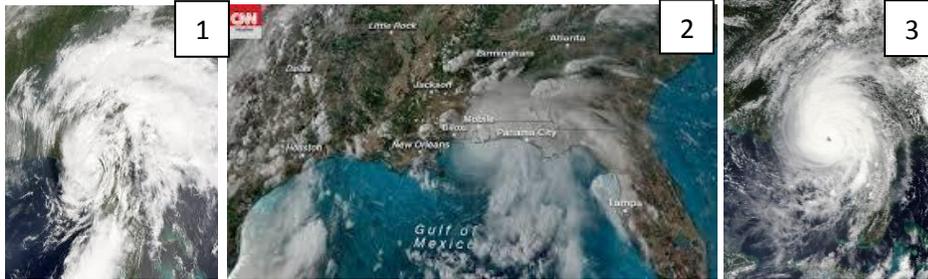
Figure 18: 2017 radar pictures of 1. Tropical Storm Alberto 2. Tropical Storm Gordon and 3. Hurricane Michael

The 2018 storms impacting the project were Alberto, Gordon, and Hurricane Michael (Figure 18). Fortunately, these storms were not direct and were east of the project site, but it did raise sea level, increase precipitation and caused high winds (Figure 19 and 20).

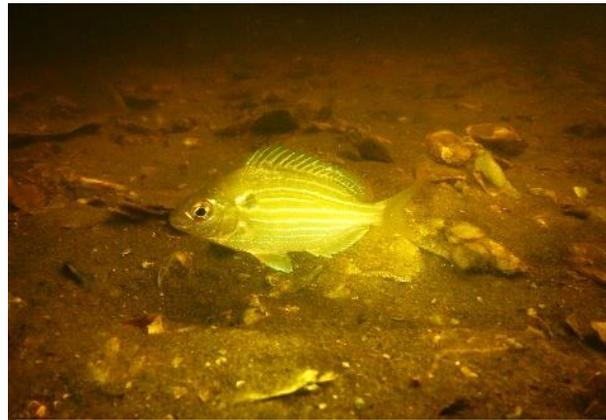
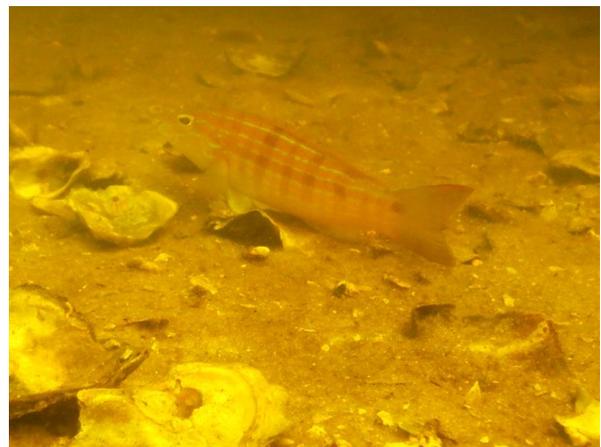
Figure 25 Pinfish, *Lagodon* (above) and Figure 26 (below): Wrasse (*Halichoeres bivittatus*). Photo credit Ashlie Johnson

One observation mentioned several times throughout this, and previous monitoring reports, is the Deadman's Island reefs show diverse communities in various sections of the reef. While pinfish (Figure 25) was plentiful across all reefs, live oyster counts changed a great deal by depth and placement in the bay, for instance after unit 300, on the west side, there wasn't a significant increase in the percentage of live oysters in proportion to 2017 (Table 2).

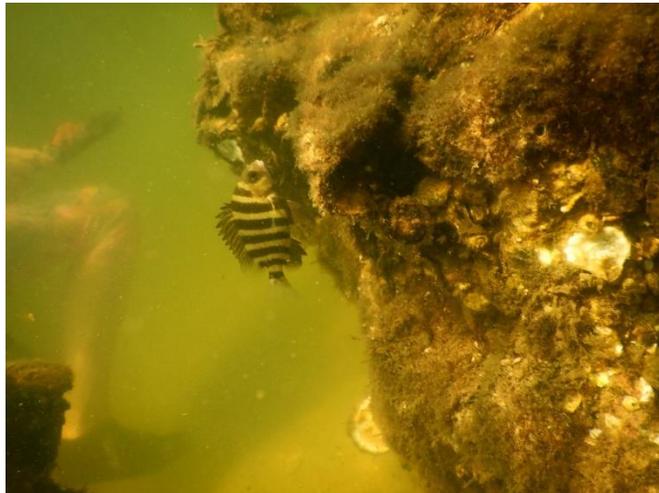
Figure 27: Juvenile sheephead. Photo credit: Caroline Polder

Fish surveys are conducted throughout the monitoring event using the visual census method of the quantitative underwater ecological surveying techniques. Fish swimming in the vicinity of the reef and fish inside the reef were counted such as the juvenile sheephead (Figure 27). After a few transects, the fish are more relaxed with the presence of divers and more accessible to quantify. Certain fish were not counted as part of the reef because there were either baitfish or the fish that preferred the habitat next to the reef such as the ballast rocks.

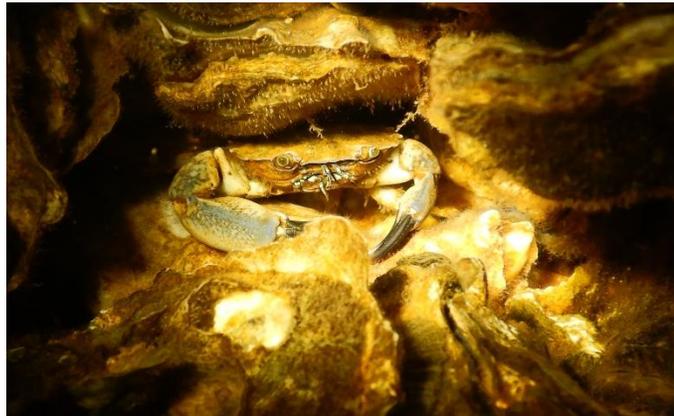
Several observations were made through monitoring the reefs during the summer of 2018. An outstanding number of 2,222 Florida Stone Crabs (*Menippe mercenaria*), were recorded throughout the entire reef (Figure 29). These reefs showed either dead oyster coverage, live oyster coverage or both. It is unsure if the high number of stone crabs were affecting the live coverage and spawning rates of the oysters on the reef.

The stone crabs were mainly noticed on the deepest tiers. Each reef had either four to six tiers, and the stone crabs were on tiers three and lower with the occasional one found on the top two tiers. Most of the stone crabs observed in June through mid-July seemed to be juvenile crabs that were using the dead oysters as coverage from other predators such as Blennies sp., Gobies sp., Blue Crabs (*Callinectes sapidus*) and other organisms. These juvenile crabs seemed to be just seeking structure rather than eating the live oysters. Occasionally, it would be noticed that the juveniles would pick at algae growing on the reefs trying to find some nutrients to grow and survive.

Figure 29: Juvenile stone crab on the reefs of Deadman's Island. Photo credit by Ashlie Johnson

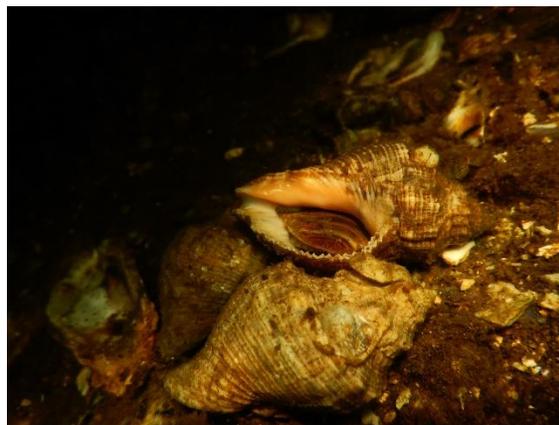
Figure 30: Oyster drill located on the reefs of Deadman's Island. Photo credit: Ashlie Johnson

The fluctuation in the abundance of oyster drills (Figure 30) has been the most interesting. It was hypothesized that the stone crab population could compensate for a large oyster drill population thus allowing for a balanced and healthy ecosystem.

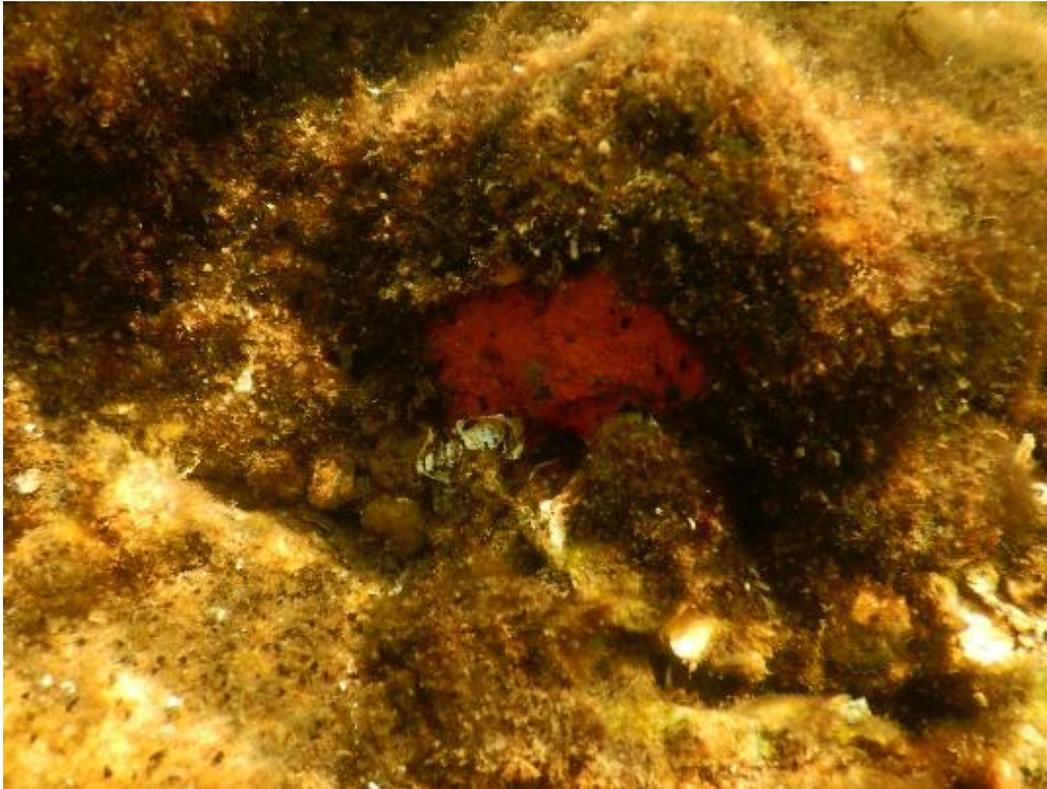
Although in the 0.001% range, Corals and sponges (Figure 33) have appeared throughout the years at Deadman’s Island reefs but only to disappear the following year. It is unknown why at this point. At this point, the presence is documented but because the presence is low, it was not added to the reef species table in 2018.

Figure 33: Sponges are becoming a common species on the reefs of Deadman's Island

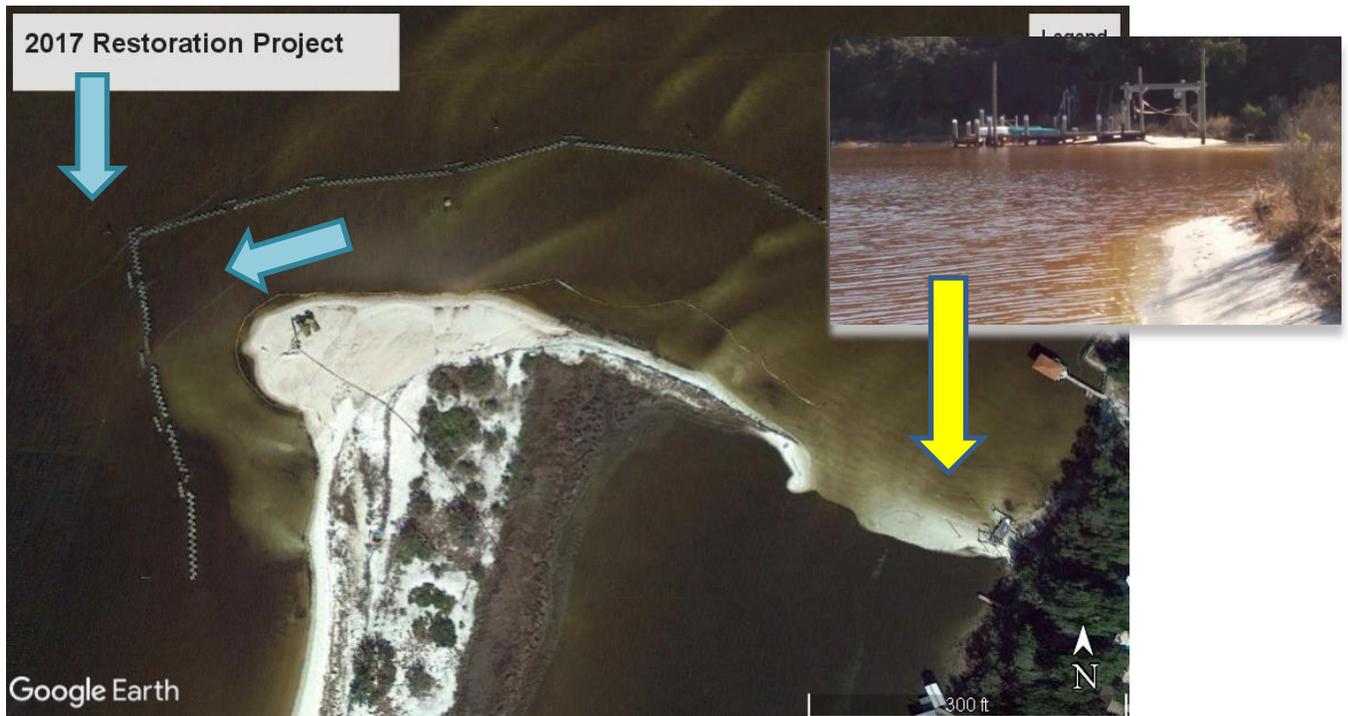
As mentioned in the 2017 report, the 2017 aeriels show whitecaps on the landward side of the reef (Figure 36). Further studies of tide datum showed the date of the aerial was during a supermoon and high tide (NOAA.gov 2018). When the water rose above the reefs, the shoreline would be impacted. With the higher than normal tides, a majority of the reefs were rarely observed out of the water. The 2018 study of measuring any gaps between the bottom of the unit and subtidal floor found that although the reefs as being submerged and not effectively attenuating the waves to protect the shoreline, the current underneath the reef may also have contributed to the erosion (Figure 35).

Figure 36: 2017 Aerial of Deadman's Island. Blue arrows show the whitecaps of the current from the northeast.

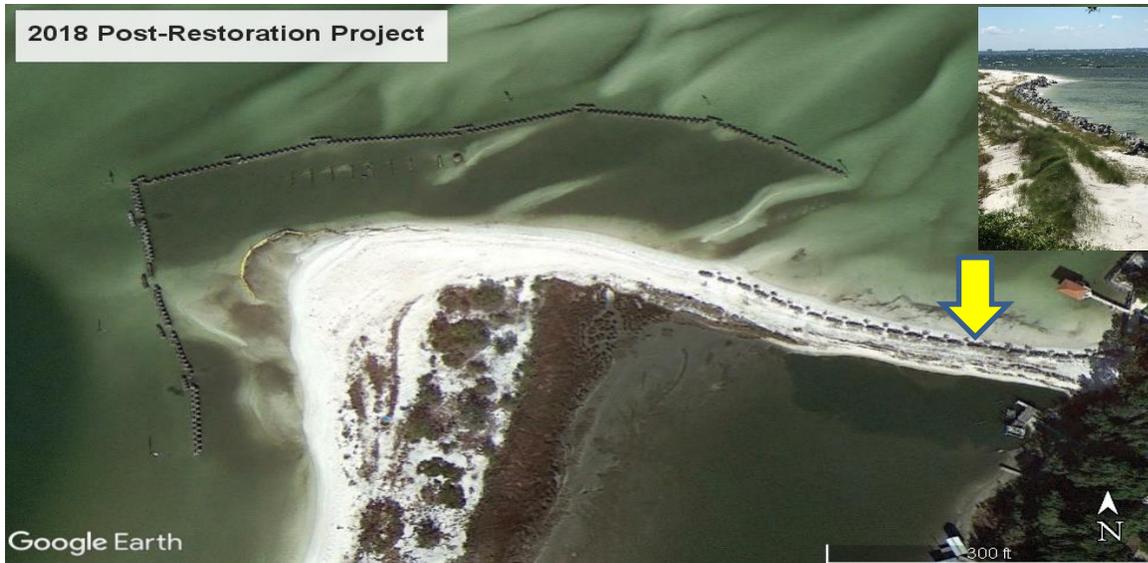
Figure 37: 2018 Post-restoration of the sand transport and placement and also the isthmus repair.

This has also been shown a successful project, primarily through storm evaluation. The storms did knock over large riprap, but overall the vegetated berm that was placed behind the rock held up well with only a few intense water blowouts of the established root systems.

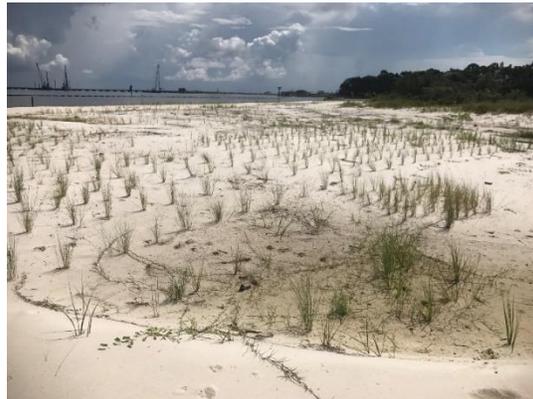
Figure 38: vegetation planting success of wetland bogs and upland

As monitoring continues and lessons are learned such as the wetland bogs in Figure 38, these projects can easily be transferred to other areas to determine best practices for restoration projects along the Gulf Coast and U.S.
