2017 MONITORING REPORT

CITY OF GULF BREEZE DEADMAN'S ISLAND RESTORATION PROJECT

U.S. Army Corps of Engineers

Ecological Consulting Services, Inc.

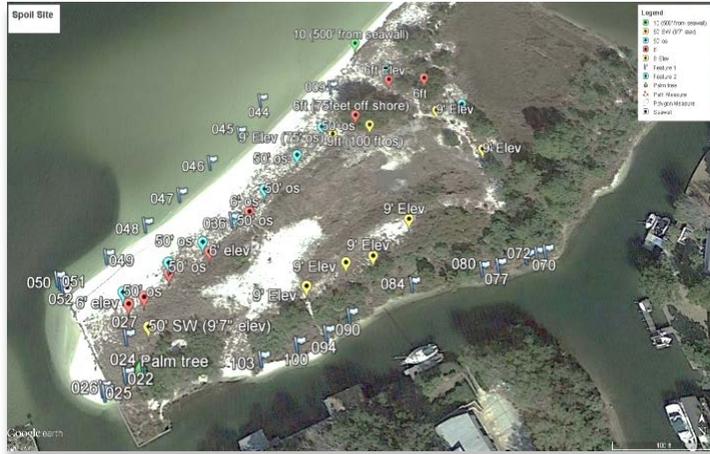
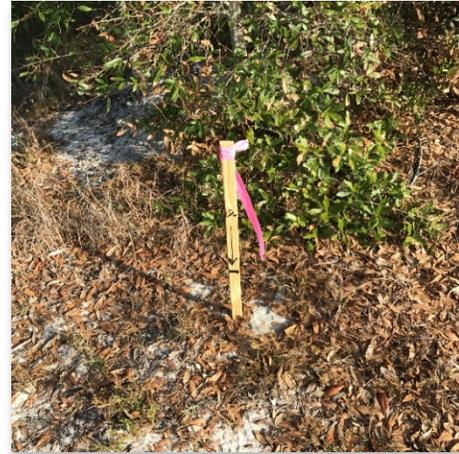
Figure 2: Evaluating the amount of sand to be transported to the north end of Deadman's Island. The disposal site was surveyed, marked and flagged according to elevation (left). Stakes were surveyed and marked according to elevation (right)

Sixteen thousand cubic yards of sand from the disposal site located on Deadman's Island, called the Donor site, was removed by an excavator and pumped using a hydraulic dredge. The sand was piped to the northern point of Deadman's Island, called the Receiver site (Figure 3). The Donor and Receiver sites are located sixteen hundred feet from each other. The dredging portion of the project lasted from December 6, 2016 to February 26, 2017 (Figure 4). Planting of the site was completed on September 30, 2017 (Figure 6).

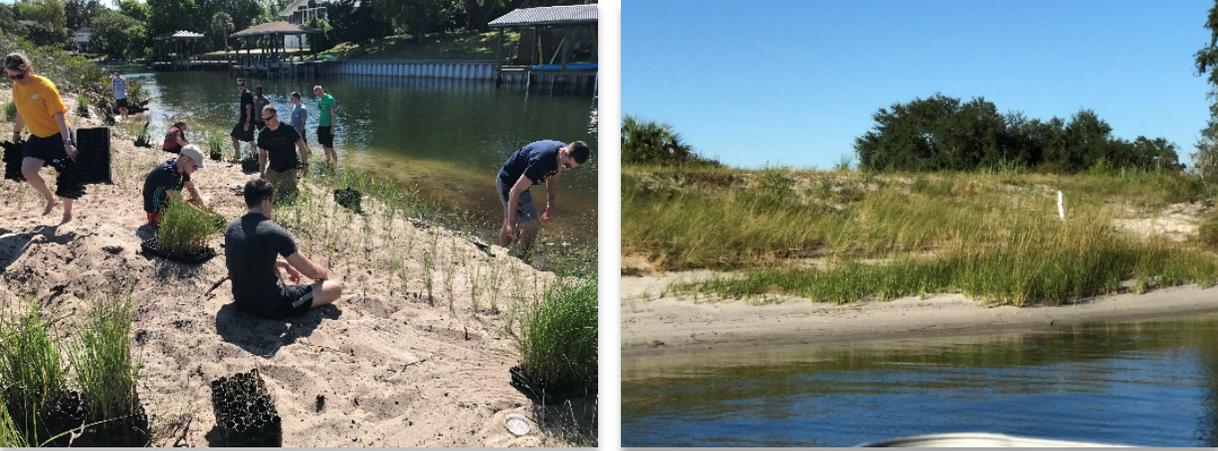
Figure 6: Repairing the disposal site after excavation (March 2017) and dredging (left) and a few months later in October 2017 (right).

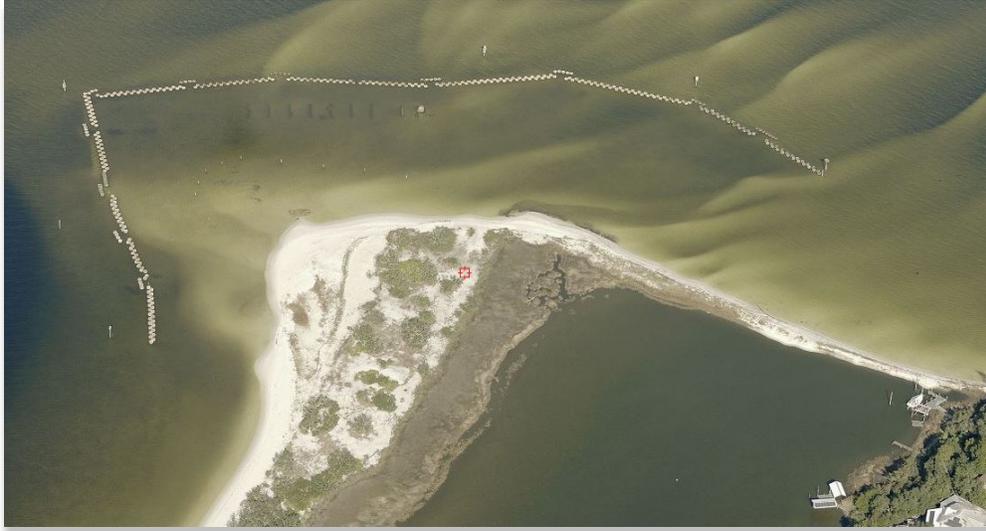
Figure 9: The completed breakwater at Deadman's Island

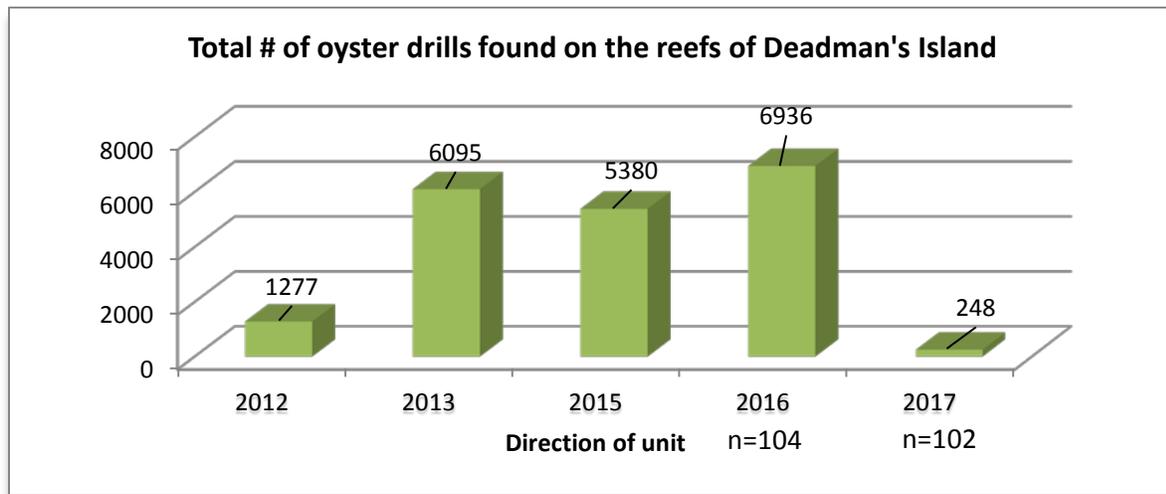
Figure 10: Total count of oyster drills over time.

Predators –There are many predators of oysters on the reefs but the most abundant threat to the oysters, are oyster drills, *Stramonita haemastoma*. Oyster drills prefer salinity above 15ppt but can survive in 8ppt. The salinity dominated the reefs at 5 ppt until around late September where is raised to 14 ppt. Oyster drills were almost non-existent. Out of the 102 reefs units surveyed, there were only 26 drills found on the entire reef during the monitoring period of July to October.

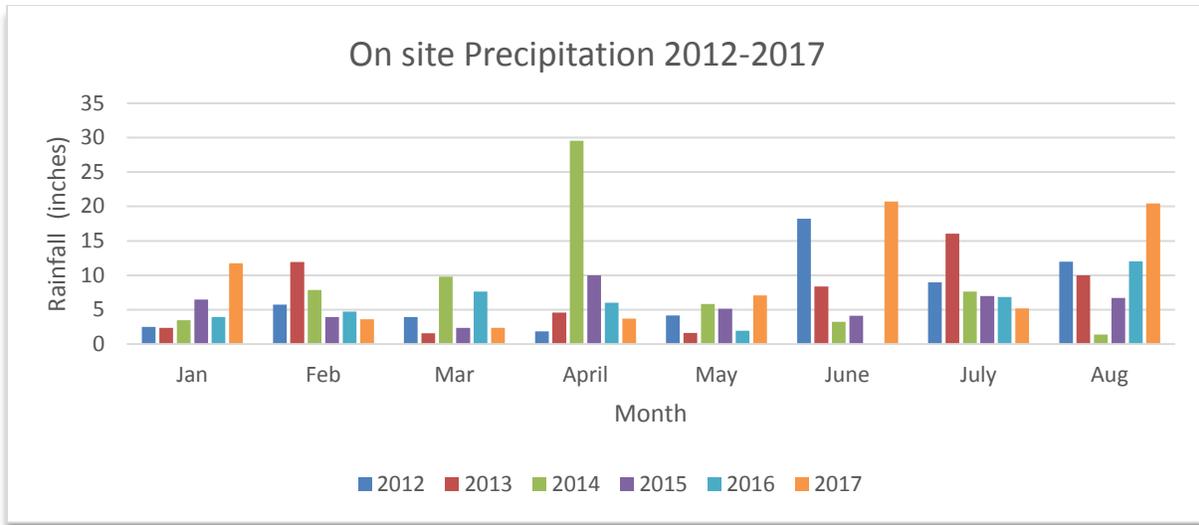
Figure 12: Precipitation near Deadman's Island. Rainfall from June and August 2017 increased in the summer months causing low salinity and turbid waters. In 2014, a massive flooding event in April also caused turbid waters and somewhat low salinity.

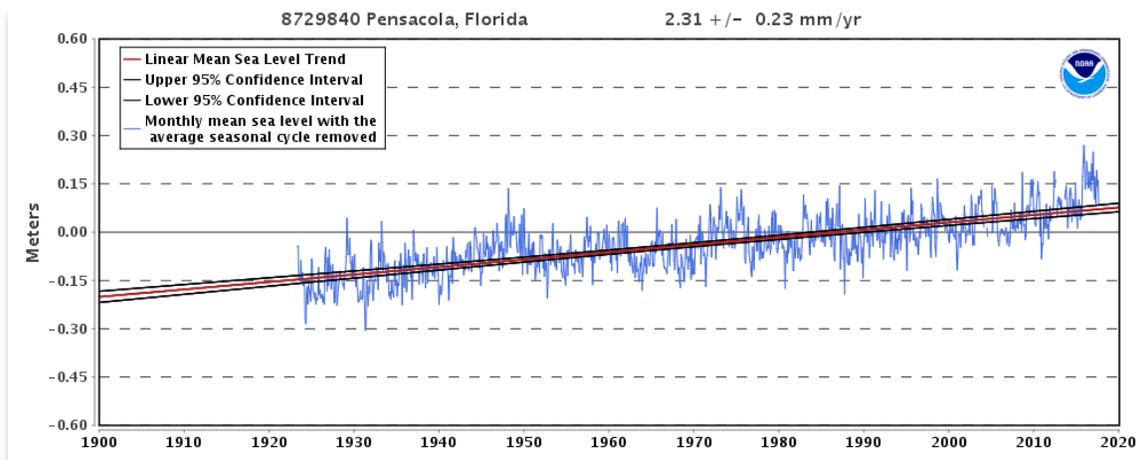
Figure 14: One Hundred year average trend of sea level rise of Pensacola, Florida.

The predicted tides are from models based on the last 100 years (Figure 14). In most cases, not only was the high tide greater than normal but the low tide, from some months, represented more of a high tide and remained above one foot above normal. In other words, the verified data in the charts, which is green, shows the low tide were absent at a time when salt tolerant plants needed to recover from the lengthy duration of high tides.

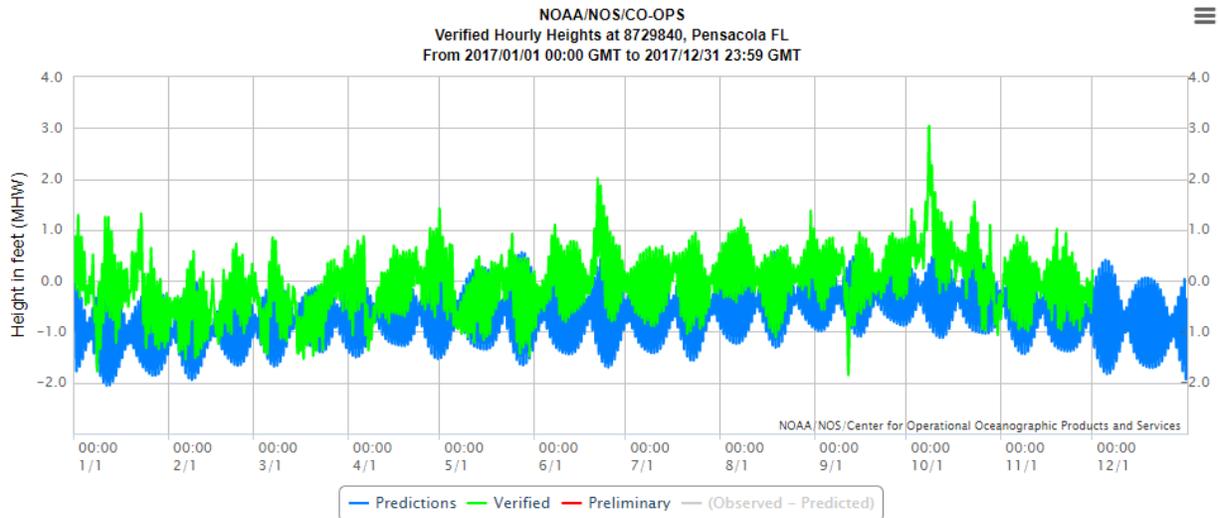
Figure 15: The actual and predicted tides levels of 2017. The blue lines are the predicted tides given, and the green lines are the verified tides which were the actual tides.

As shown in the graphs of 2014-2017 (see figures 15-17), the actual tides continue to rise above the predicted level initially given by NOAA. This fluctuation makes it difficult to plan for tide dependent projects. Although tropical storms and hurricanes were affecting the Gulf region, the trend of sea level rise continues throughout the months where there were no storms.

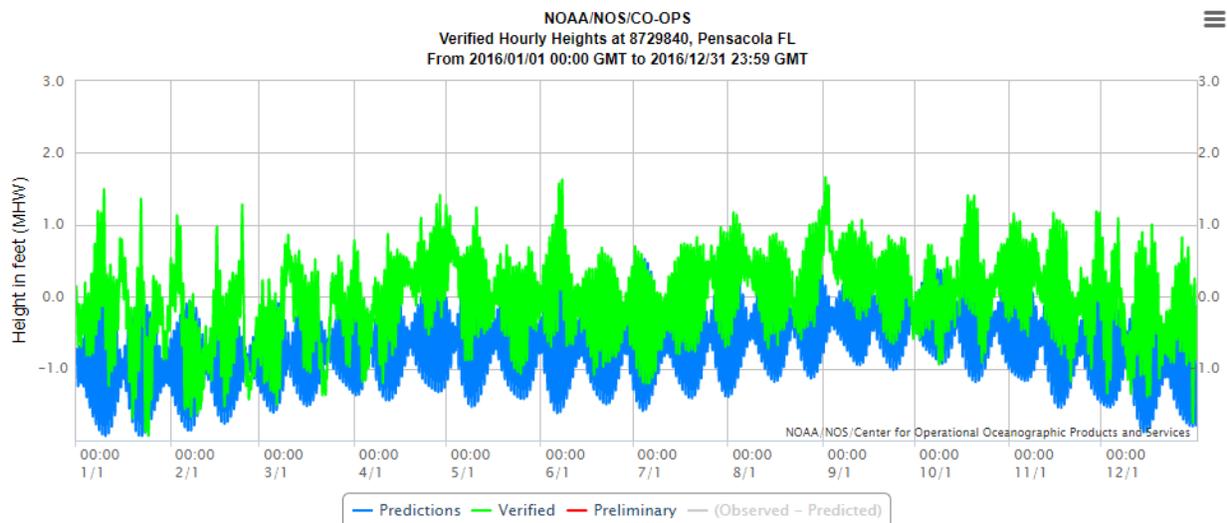
Figure 16. 2016 Historic Tides data from Station # 8729840. The blue lines are the predicted tides given, and the green lines are the verified tides which were the actual tides. In some cases, from January to July, the tides were .69 feet higher than normal tide. From July to December the tides were also approximate .85 feet above normal except a few storms in October and November raising to 2.45 feet above normal.

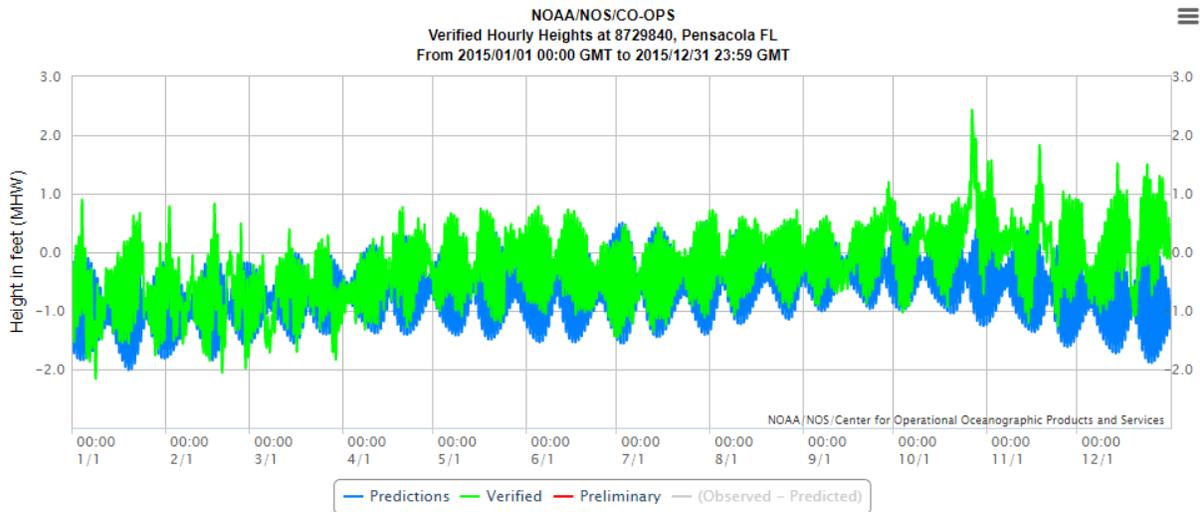
Figure 17: 2015 Historic Tides data from Station # 8729840. The blue lines are the predicted tides given, and the green lines are the verified tides which were the actual tides. In some cases, from January to July, the tides were 2.079 feet higher than normal. From July to December the tides were also approximate 1.058 feet above normal.

In April, May and June 2015, low tides were also higher than normal and never actually allowed a normal low tide. In all months of 2015 after July, the verified high tides ranged from 1 to 2 1/2 feet above normal tide. In the months of November and December, were supposed to have extreme low tides. This particular low tide was compared an average summer tide, which was 1/2 to 1 foot higher than the normal low tide.

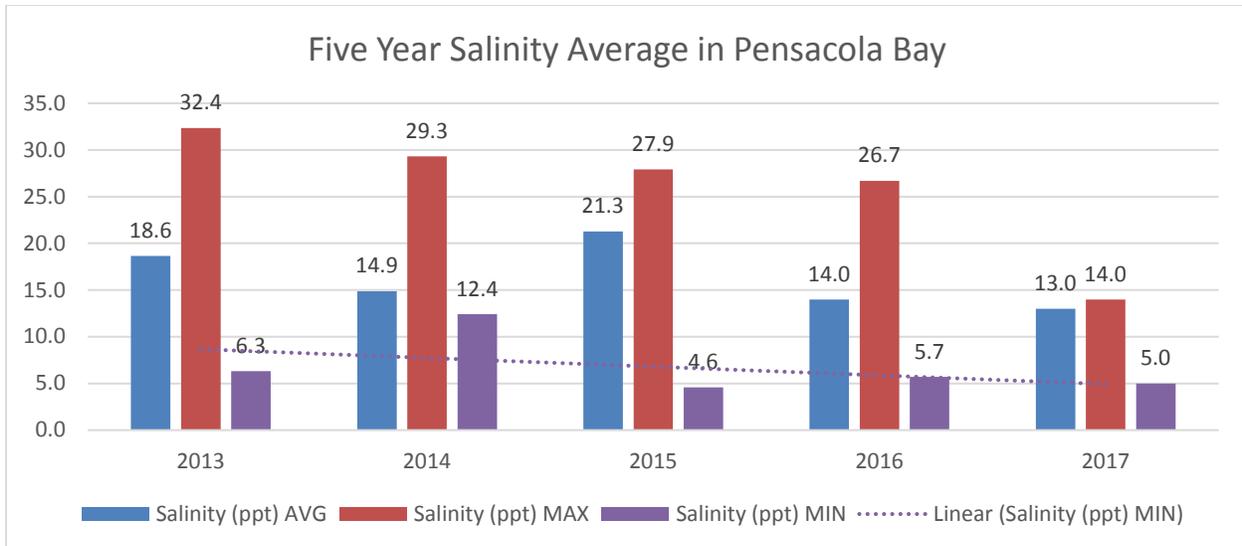
Figure 18: Salinity chart for 2013-2017. Salinity levels represent March, June, July, August, and September of 2017. The year 2017 shows an average range of 13 (ppt) and min and max range 5-14 (ppt) during spring and summer months. Data source FDEP STORET and Deadman’s Island project monitoring data.

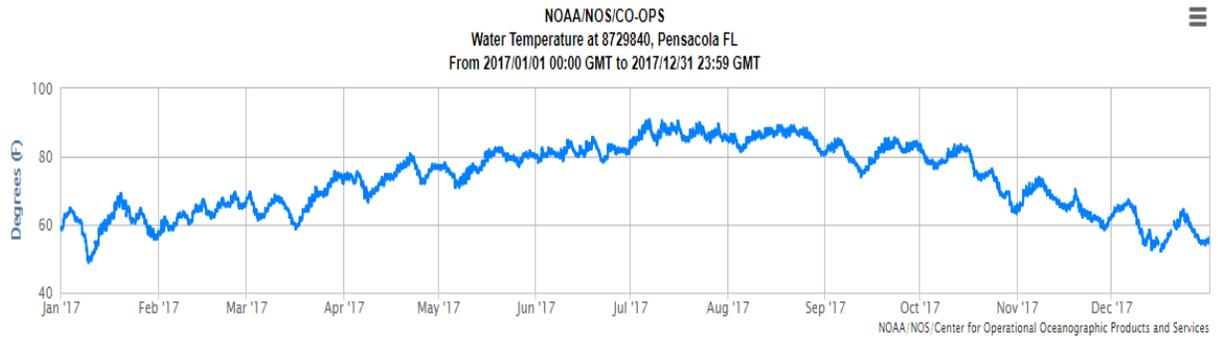
Figure 19: 2017 Water temperature. This chart was used to determine possible random spawning by determining temperature fluctuations. NOAA Air Temperature, Pensacola FL. January to November 2017

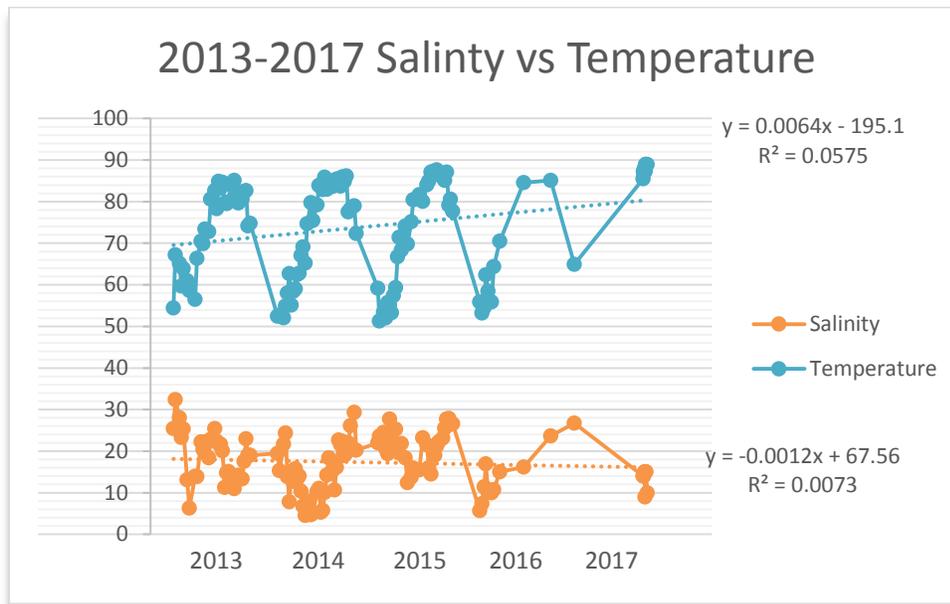
Figure 20: Water Temperature/Salinity trends from Jan 2013 through November 2017. Temperature trends through NOAA.gov are from January to November 2017.

Salinity can be affected by water temperature. As the temperature rises, the salinity increases in the bay (Figure 20). The exception would be fresh water influx as observed with the floods of 2014 (Figure 20) and multiple heavy precipitation events in 2017. The salinity was much lower in the bay despite the temperature. Observations of nearshore shallow water oysters are more susceptible to disease from stress and baking in the sun from hotter temperatures when exposed. The offshore distance of the breakwater keeps the temperature and dissolved oxygen ideal for the oysters because of continual underwater exposure. Monitoring shows some oyster growth out of the water, but this exposure is normally tidal influenced.

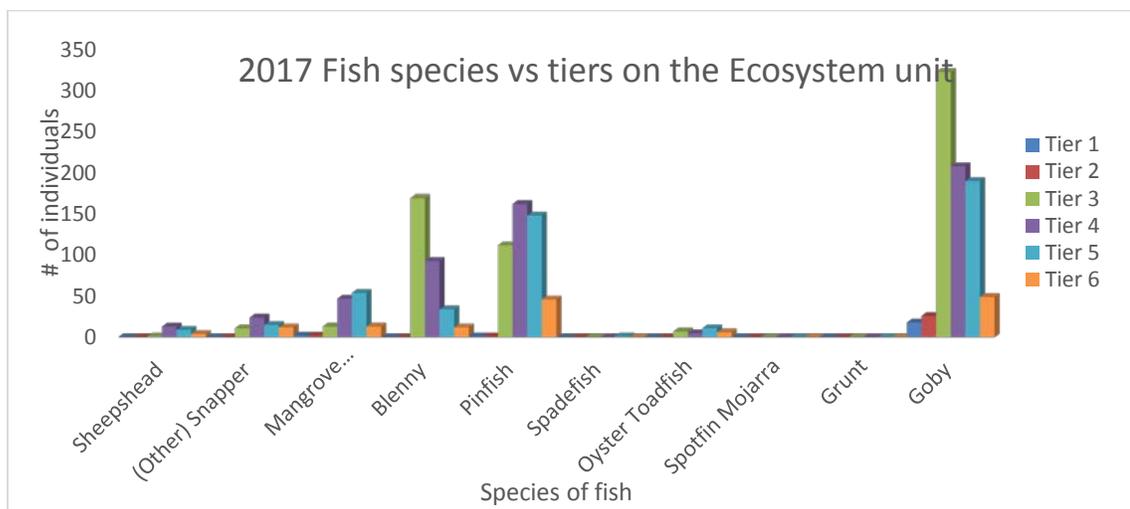
Figure 22: The fish population vs. the various sections and units of the East and West breakwater reefs.

Fish surveys are conducted throughout the monitoring event as the fish are seen on each unit- using the visual census method of the quantitative underwater ecological surveying techniques. Fish swimming in the vicinity of the reef and fish inside the reef are counted. After a few transects, the fish are more relaxed with the presence of divers and easier to quantify. After placement of the 2015 wave attenuators, the fish and crabs showed up on the new reefs within 24 hours.

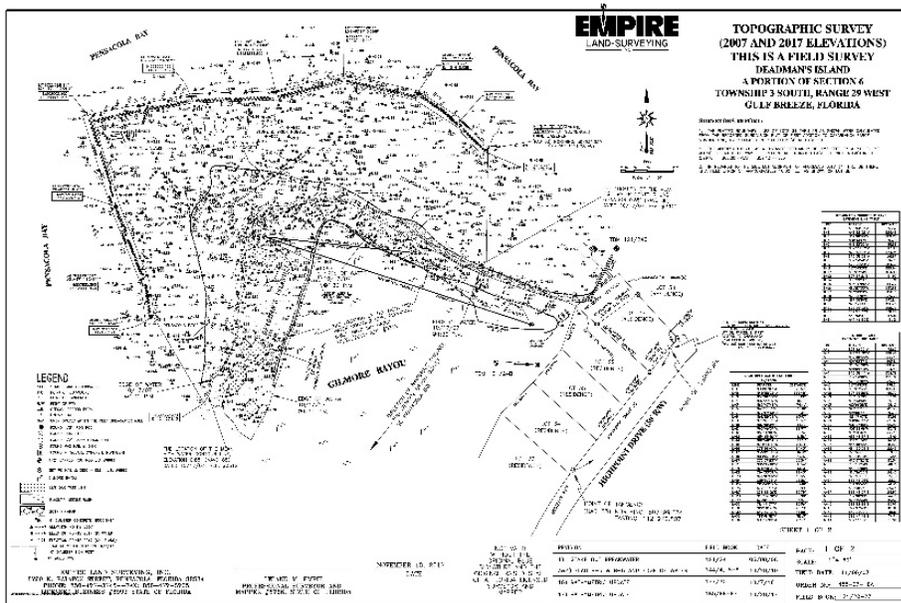
Figure 23: 2017 bathymetric survey and mean high water survey

interpreting thousands of elevation readings (Figure 23) .

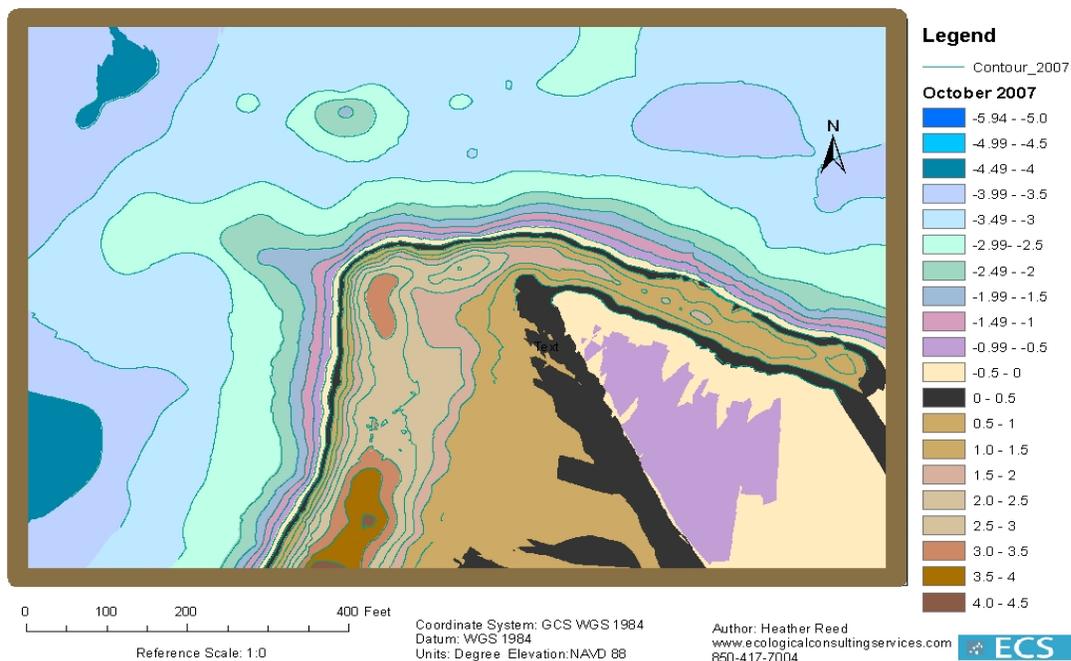
Deadman's Island 2007 Baseline Bathymetric Survey

Figure 24: The 2007 Baseline survey of the bathymetry of Deadman's Island prior to breakwater placement.

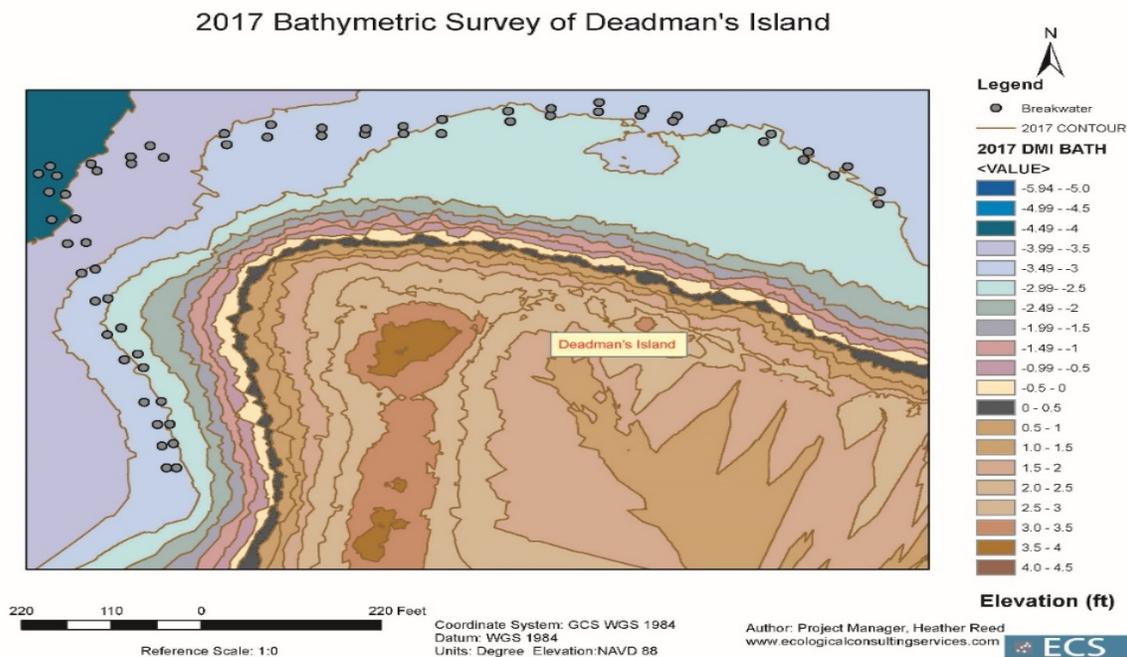
Figure 26: 2017 Bathymetric of the substrate behind the breakwater showing the fill and equilibrium of depth on the subtidal floor along Deadman's Island

The 2007 baseline shows increased depth throughout the project. In some areas (Figure 26), there was no gradual profile. This steep profile is what was causing trees and vegetation to uproot and fall into the water. The roots systems were undermined and destroyed. This depth along with the harsh current from the 12-mile fetch was the main factor the historic resources were being unearthed, and the saltmarsh was in danger of being smothered and impacted by high salinity or saltwater intrusion. The 2017 also shows a gradual slope and also a deeper depth at the corner of breakwaters, similar to 2007 bathymetric (Figure 26).

The 2017 bathymetric shows the sand movement prior to the breakwaters and sand was placed. Naturally, the elevation changed, but what is important to note, a gradual beach profile was created by the temporary barrier system, to allow the sand to settle on a slope causing the water to roll onto shore rather than scour and undermine the shoreline. The previous rebar breakwater and north east open section with no breakwater caused the wave action to push the sand to the east and south-east to spread around the project and accrete behind the existing breakwaters.

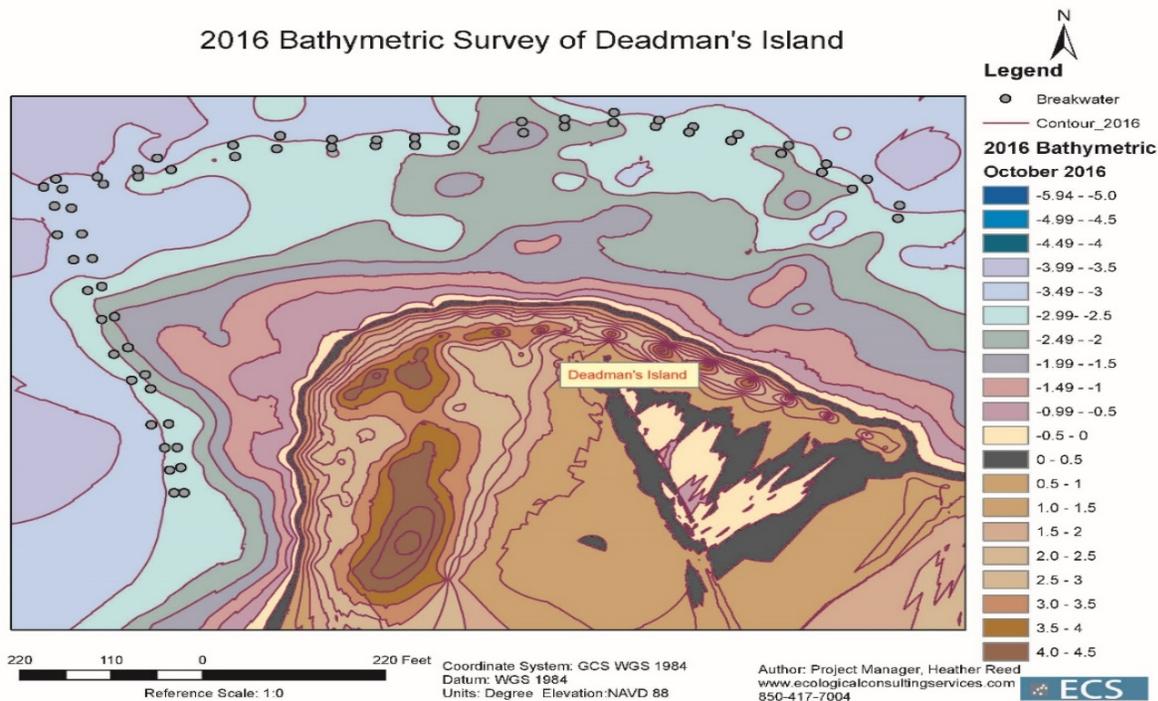
2016 Bathymetric Survey of Deadman's Island

Figure 27: 2016 bathymetric of Deadman's Island

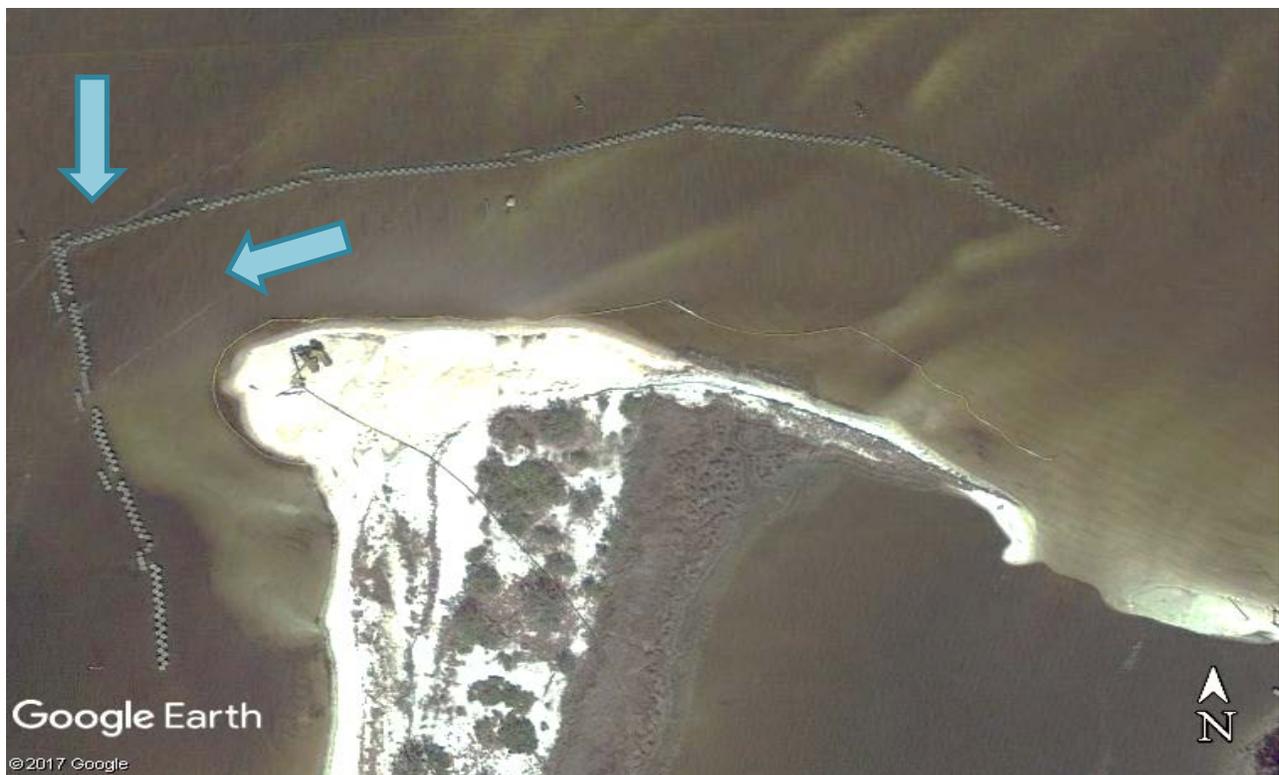
The 2017 aerial also shows the white caps of the current in the mid-section of the northern reef and the west. These two areas intersect where the lower western reefs are located (Figure 28). In 2017, the lower reefs were re-set to a height even with the rest of the reef in September. Resetting reef height so all tops are even with each other, should stop the strong current when the water level is below or even with the breakwaters. The time to observe and measure the impact along the shoreline is when the water level is higher than the breakwaters. Hopefully, these events won't be frequent and the shoreline vegetation can recover fairly quickly.

Figure 28: 2017 Aerial of Deadman's Island. Blue arrows show the whitecaps of the current from the northeast

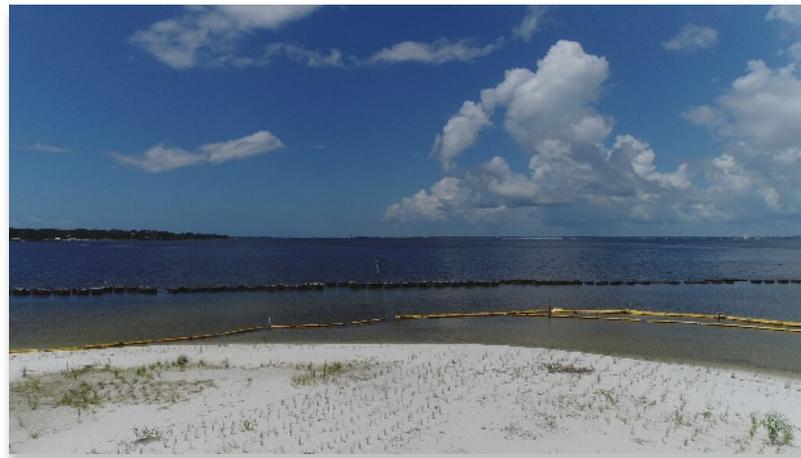
Figure 29: Vegetation stabilized the fill recently placed on the north point of Deadman's Island

Community volunteers and paid labor planted vegetation to stabilize the newly placed sand throughout the spring and summer (Figure 29). The upland plants showed successful growth, a few of the low lying wetland bogs were smothered by displaced sand from storms but survived. The shoreline plants were also smothered by the recent hurricane Nate. The high tides caused erosion to countless attempts of shoreline planting on the north-west point.

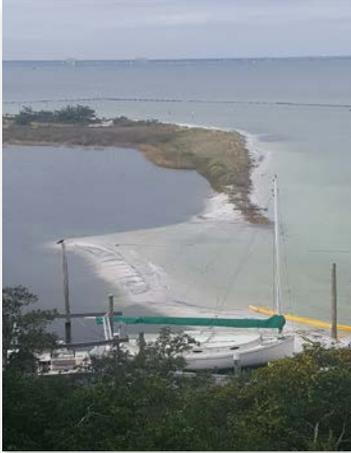
Figure 31: Facing west. The breach of the isthmus in 2017

In 2016, the moving isthmus finally eroded back to the last standing seawall (Figure 32). Once the erosion reached the adjacent property which contains no seawall, the water scoured the land almost to the edge of the bluff. The water pushed the sand further and filled underneath a dock and boat lift (Figure 30) and buried half of the bow of a sailboat (Figure 31).

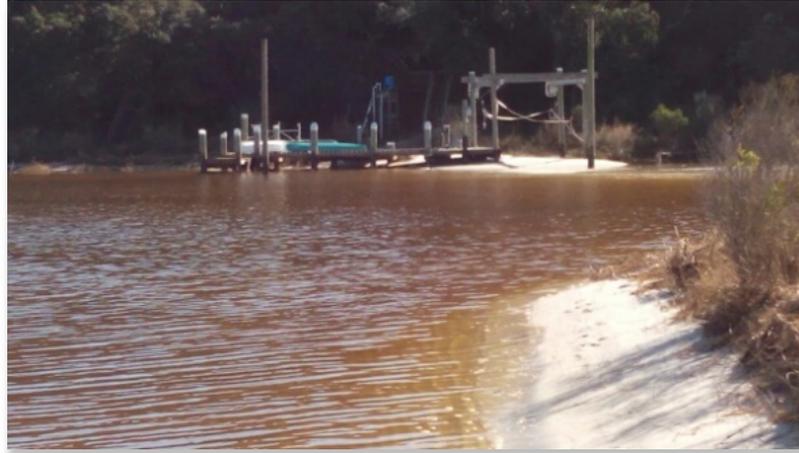
Figure 30: Facing east. The breach of isthmus showing the strong movement and placement of sand over living shorelines and under the dock and boat lift of resident.

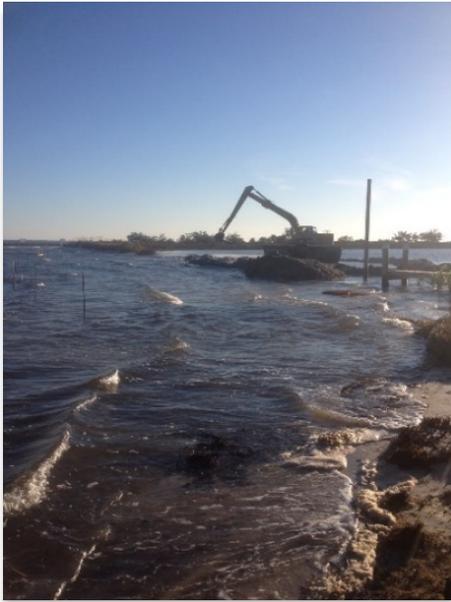
Figure 32: Amphibious excavator working in rough water conditions.

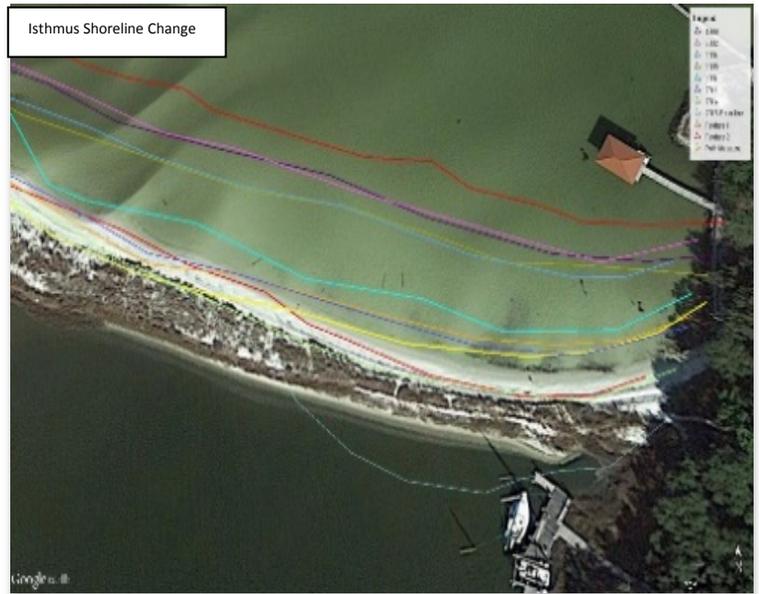
Figure 33: 1994-2016 Shoreline Change along the isthmus at the North East portion of Deadman's Island.

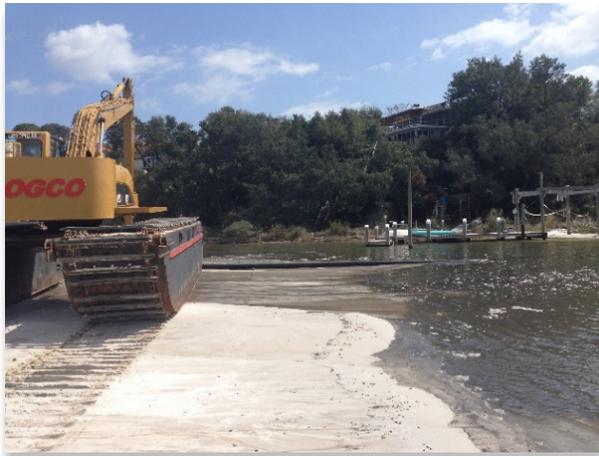
Figure 34: Repairing the isthmus breach. Laying the pipe to pump the sand from the spoil site.

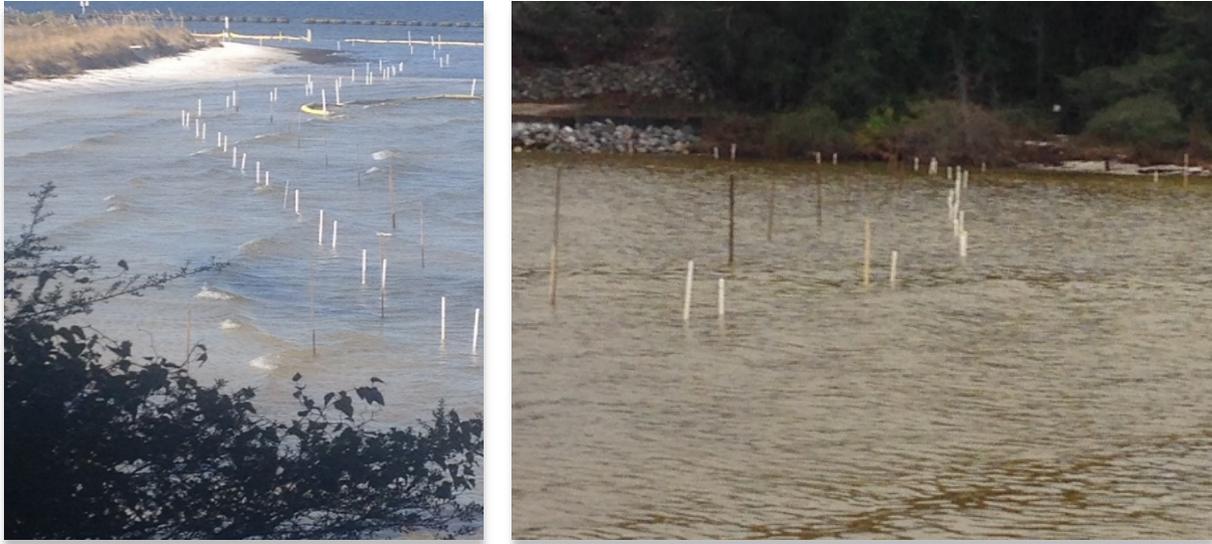
Figure 35: Facing west, survey stakes marking the 2010 shoreline in preparation to repair the isthmus.

The sand was placed 10 feet from the shoreline to allow for the breakwater. Rough weather caused the barrier to break and sand settled on our outside barrier along the staked profile of the 2010 shoreline (Figure 35).

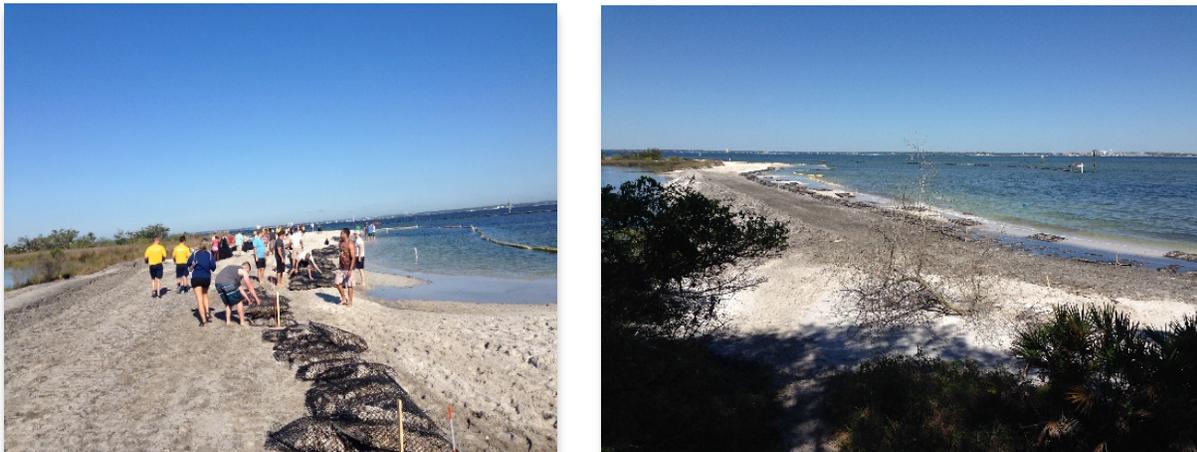
Figure 36: Volunteer filling bags with oyster shell and placement on geo fabric (left). The first phase of setting the foundation for the coastal protection barrier units.

ECS created five methods of defense. To stay within the permitted guideline of using a hybrid of oyster shell and rock, we placed bagged recycled oyster shell on fabric underlayment to cradle the riprap in one place and make it easier to stack in a pyramid form (Figure 36).

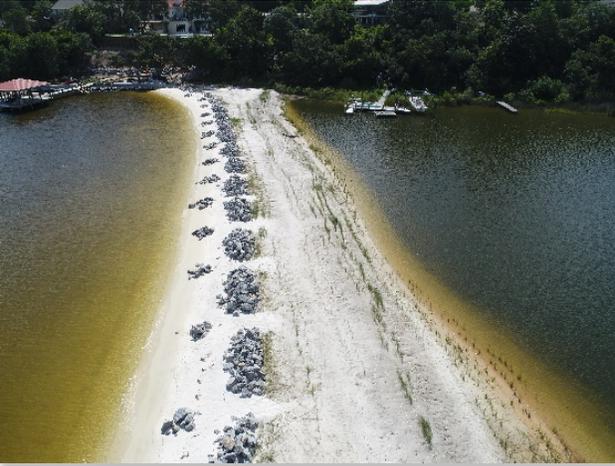
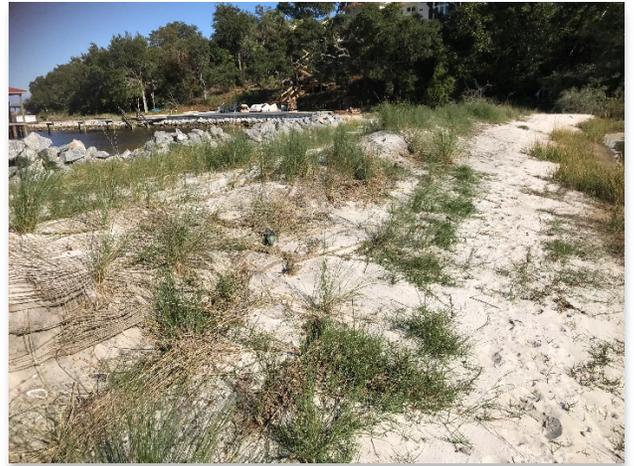
Figure 37: Drone photo of the finished breach repair (left) with newly planted vegetation (right).

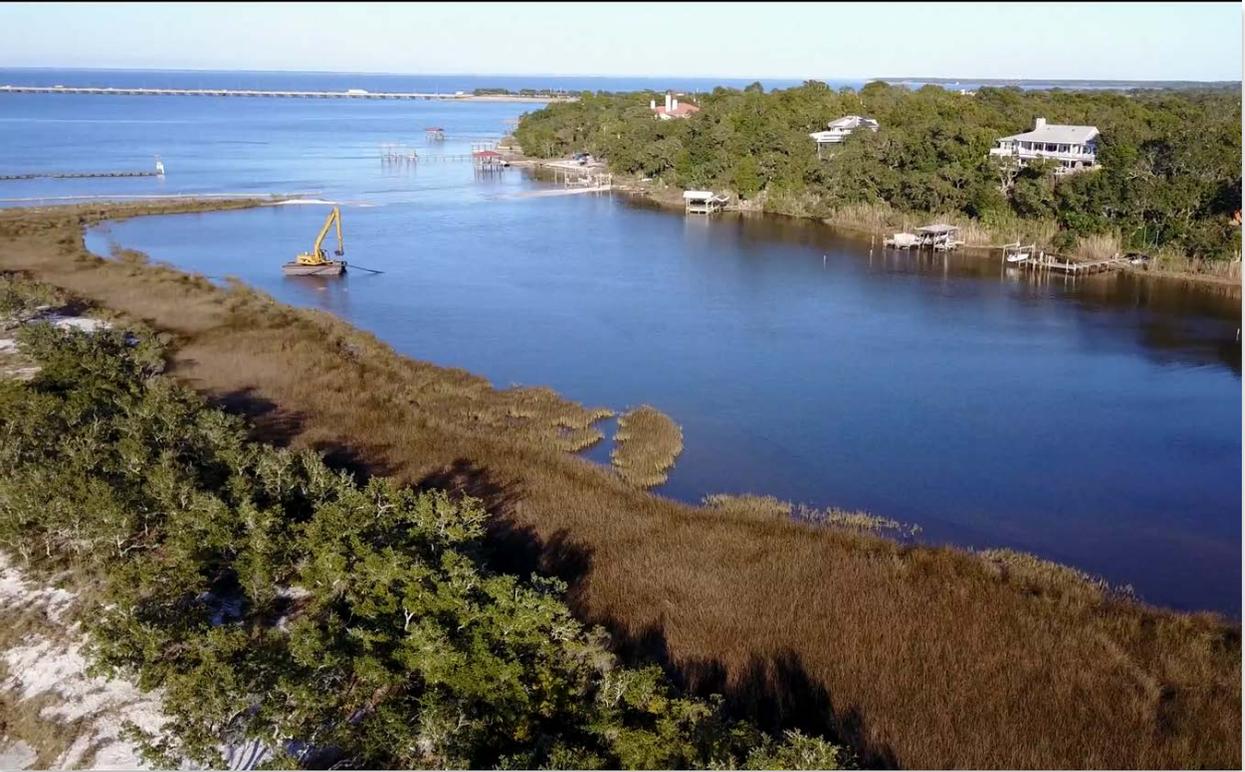
Figure 38: Before picture showing the isthmus blowout 2017

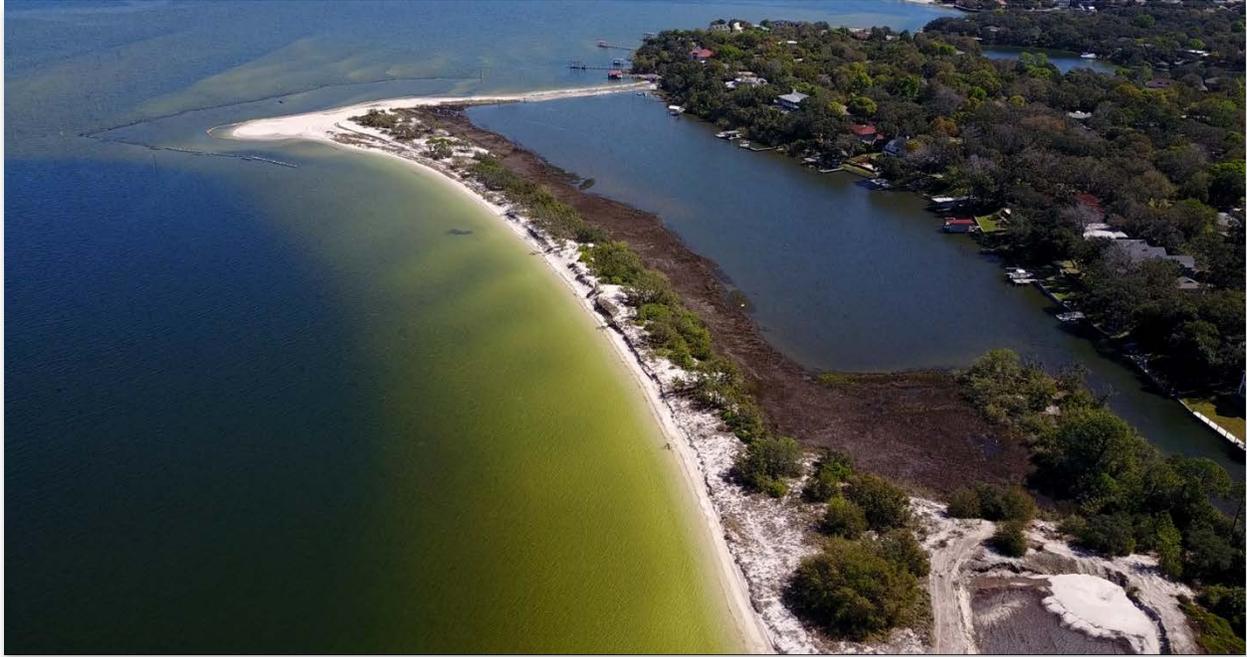
Figure 39: An after picture of the sand transport to the point and the isthmus repair

To date, the project has stabilized (Figure 39). The project seems to be working as designed. An incidental benefit of this project came from our strong north winds and Hurricane Nate. A large amount of sand was pushed between the gaps of the breakwater. This additional sand protected the wetland plants behind the breakwater. This sand movement helped create a barrier to keep the sand wet and sustain the growth of the wetland vegetation. Also, the water tables under the isthmus will help keep the plants moist in the hot, dry season. As the tides rise, the water under Deadman's also rises sustaining the "wetland bogs."
