2014 MONITORING REPORT

CITY OF GULF BREEZE DEADMAN'S ISLAND RESTORATION PROJECT

ESTUARY HABITAT RESTORATION PROGRAM

GULF BREEZE, SANTA ROSA COUNTY, FLORIDA

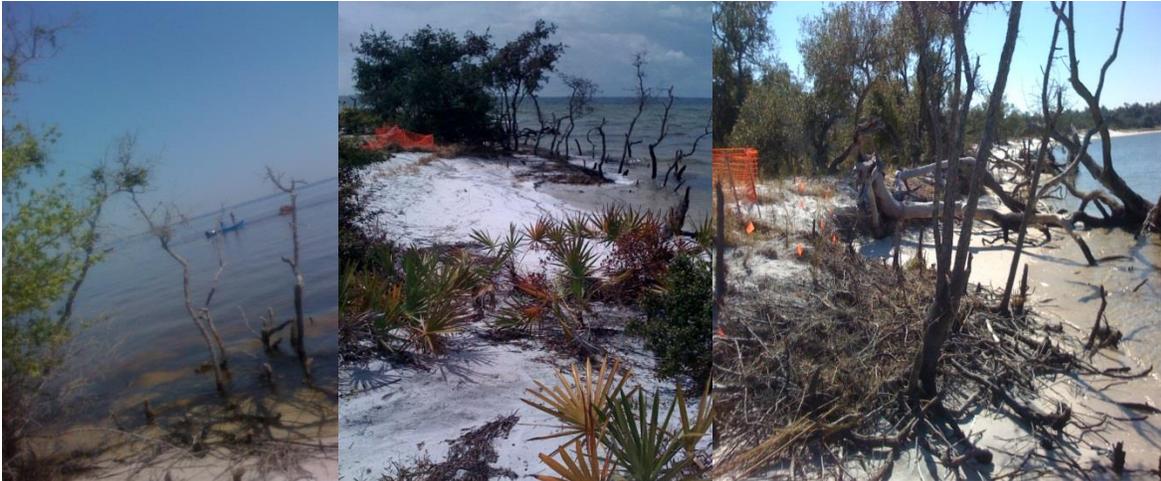
Figure 1: History: Distressed Shoreline of 2007

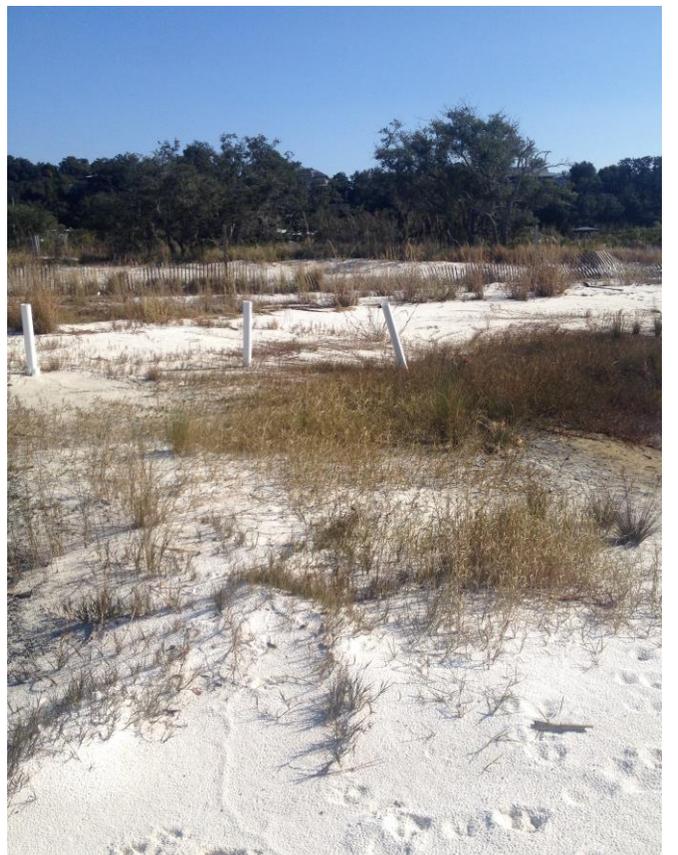
Figure 2: Remnants of the wetland creation before shifting of the sand caused by the failed oyster reef breakwater.

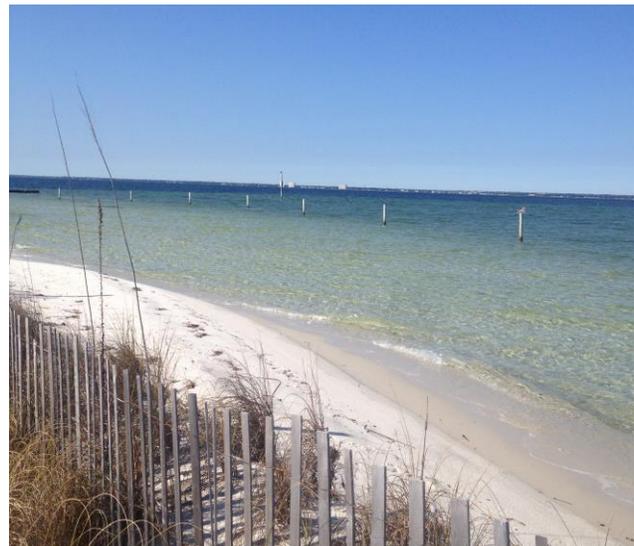
Figure 3: Barrier System and maintenance. The submerged and floating barrier was removed in 2014, leaving only the reference poles showing where the sand was placed in the previous years. Notice the light shallow sand in front of the barrier and the deeper water behind the barrier.

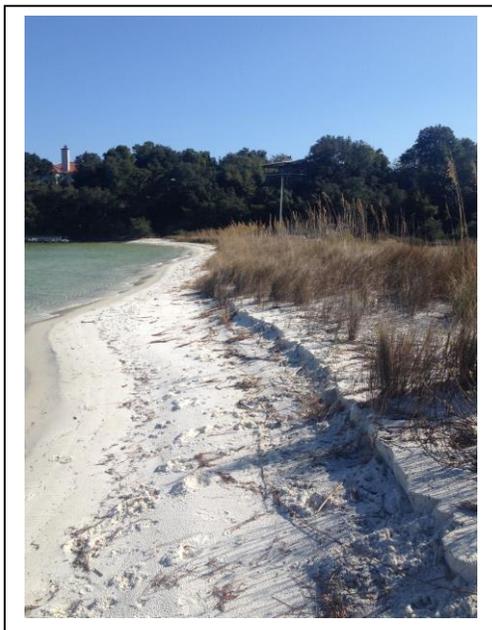
Figure 4: 2014 Shoreline along the isthmus

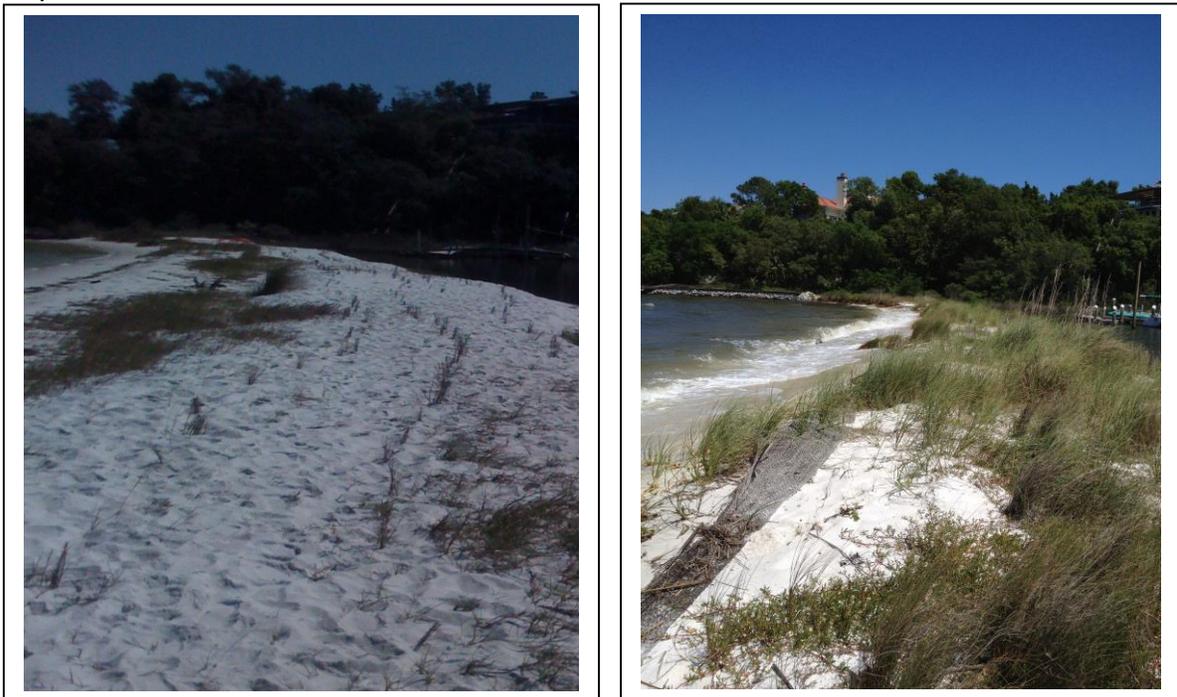
Figure 5: 2008 Isthmus planting on the north end of Deadman's Island (left) and same site in 2013

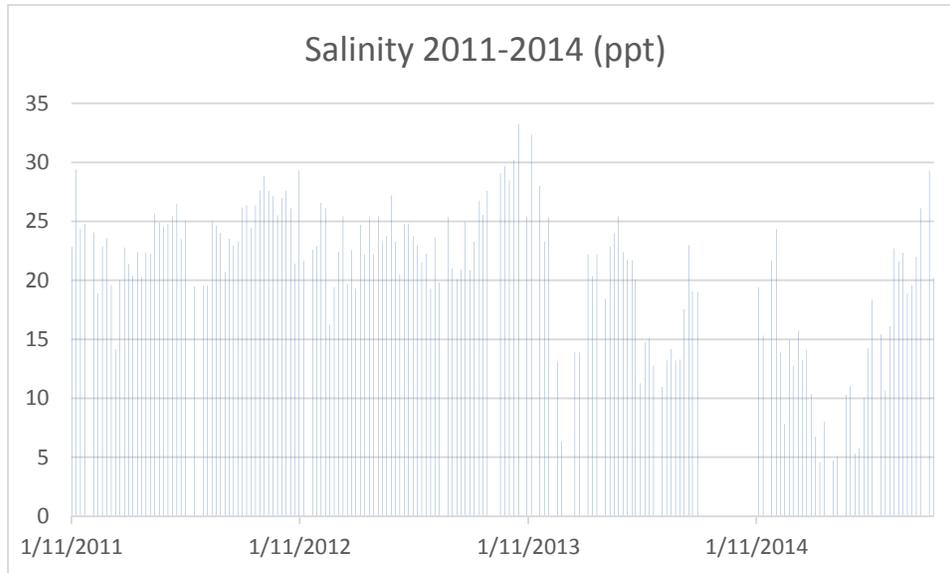
Figure 6: Salinity chart for 2011 thru 2014. 2014 shows an average of 20.83 ppt and a range of 4.57-33.26 ppt

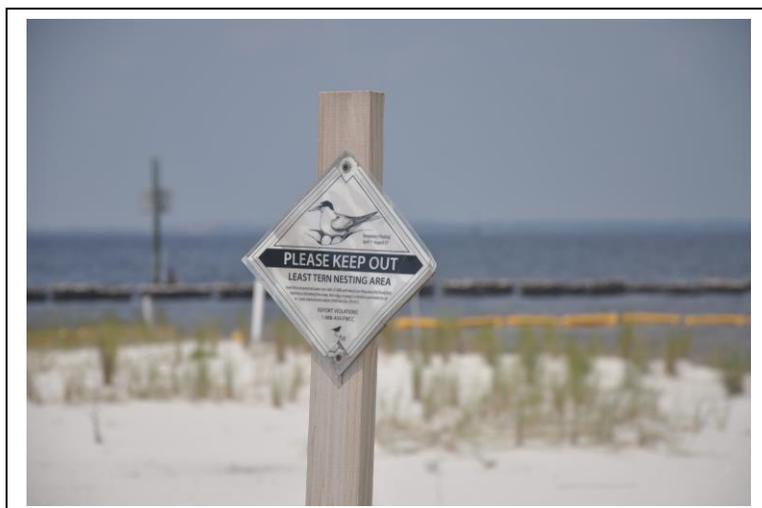
Figure 7: Least Tern signage to help protect the nesting of the least terns

Upon completion of the 16,000 yd.³ of sand being transported in the wetland created, people seem to think a new section of the beach was placed for their recreational purposes. The major damage was from a lack of breakwater and constant erosion. In 2014, fences were removed, and residents still allowed pets to frequent the area. There were not has many birds nesting this year, more likely due to the anthropogenic stressors.

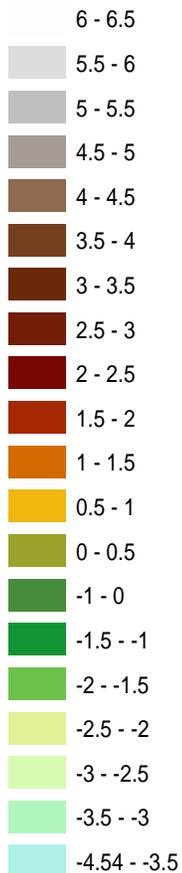
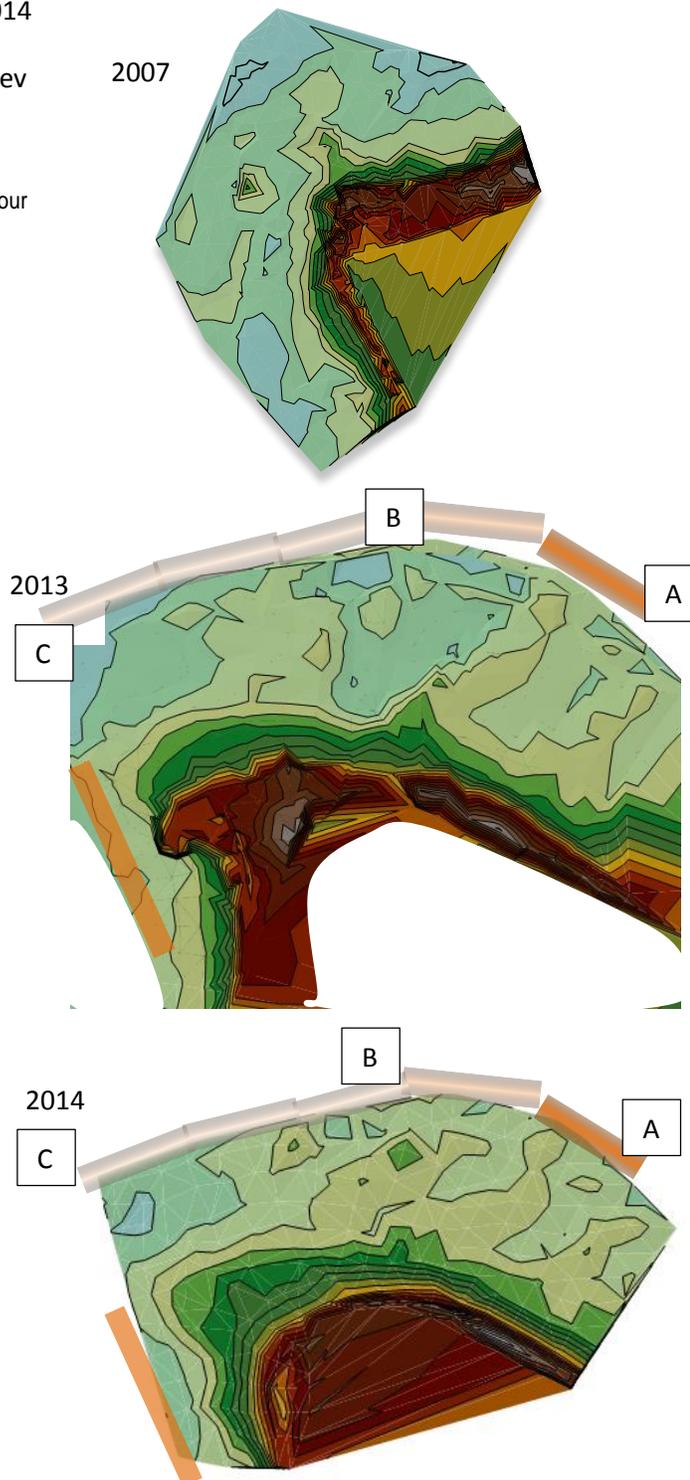
2007, 2013, 2014

The baseline of 2007 funded by US Fish and Wildlife (left) was before the breakwater was placed around Deadman's Island. The areas was subjected to an underwater current until the breakwater was placed. Once the breakwater was placed the bathymetric survey boundary were expanded to get a better idea of the bigger picture of the sediment transport. The survey from 2009-2011 showed an increase in accretion directly behind the breakwater. It wasn't until 2013 aerials, the rebar breakwater was observed as breaking down and not being able attenuate the 12 mile fetch from the North East. The phase 1 oyster reef breakwater did not recover from the 2010/2011 die-off. At this time, the sand was already placed due to funding deadlines.

The 2011 (A) east side breakwaters were a pilot design to not accrete sand and maintain the constant depth. If you notice in 2013, on the (A) sections there are deeper pockets of the blue shading, indicating a deeper elevation of 3.5 to 4.0 feet. The 2014 (A) section does not show as many blue or deeper elevations. These results were not expected for Section A. Section B and C are accreting more sand and the elevation and depth.

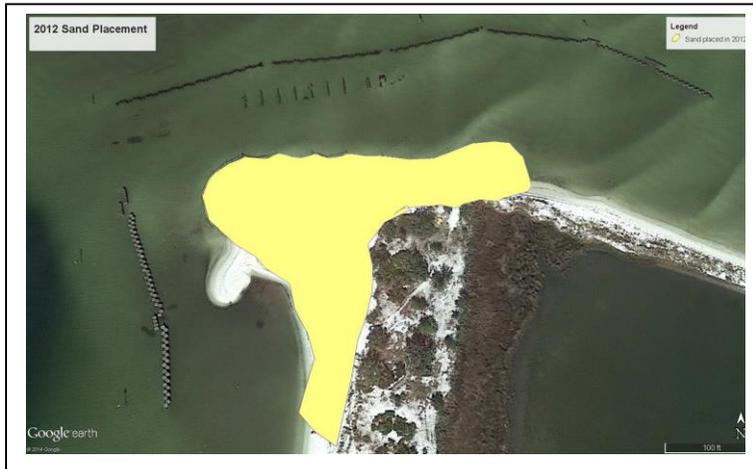
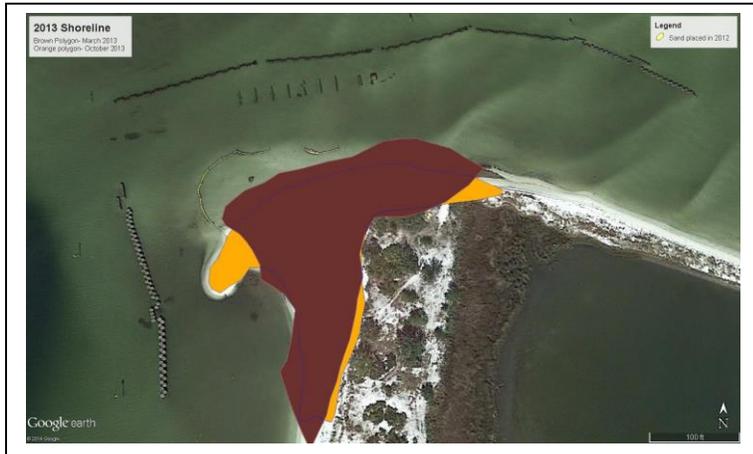
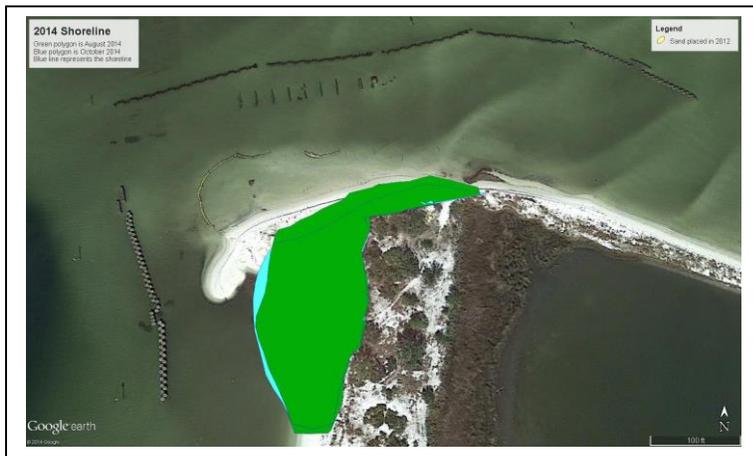
The yellow polygon is the outline of 2012 the 16,000 cubic yards and spans (1.62 acres) of sand placement. Currently the barrier is removed and the poles remain for erosion GIS reference. The northern oyster breakwater reef did not recover as anticipated from the oyster die-off beginning during the oil spill event of 2010 to 2011.

2013 received 30-102 feet of shoreline erosion/shifting in one year. Judging by the direction of the current, most of the erosion occurred from the northern breakwater failing. The small "peninsula tail" being extend to the south west is most likely due to barren area with no breakwater and the water "pushing and shifting the sand south, when the winds came from the north west. The Ecosystems breakwater provided protection from the westerly winds and the shoreline began to accrete and become stabilized. The year of 2013 is when the barrier was starting to give way despite the efforts of maintaining the barrier as a wave attenuator until the vegetation became established. Once the barriers were completely removed in 2014, erosion accelerated and a 39% from the previous year left only 0.7 acres. The 2013 acreage was 1.14 acres and suffered a loss of 30%.

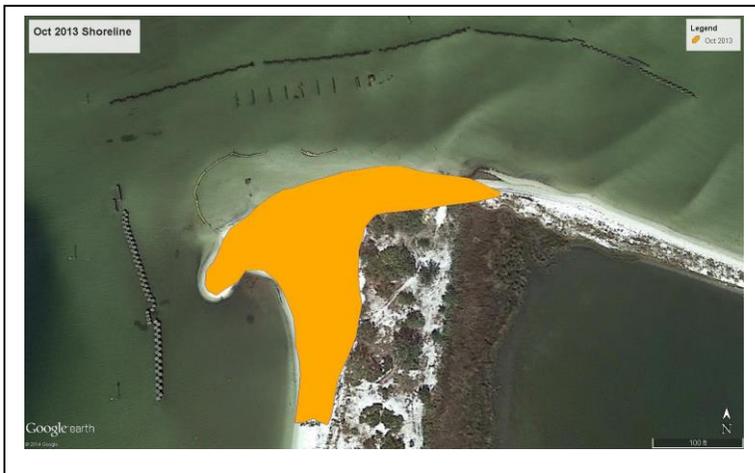
The 2013 shift changes, orange polygon, appears to have allowed the sediment to settle in the barrier footprint but moved a majority of the sand south and eventually south west. The vegetation and plantings organized from volunteer events could not develop an established root system and stabilize the evolving shoreline. The wetland bogs created to establish wetland vegetation and deeper root system before the wave reached them 15 feet away was not able to establish the root system fast enough.

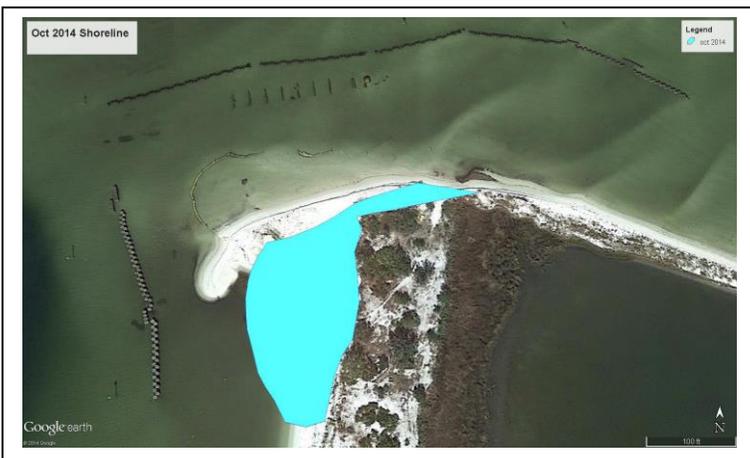
The 2014 shifting, light blue polygon, caused the peninsula to wash out and merge with the southwestern section and become protected behind the Ecosystem reef. The northwestern section which has not washed out is in the vicinity of the coffin areas. The concern is one more year of erosion, may wash out and expose the coffins again.

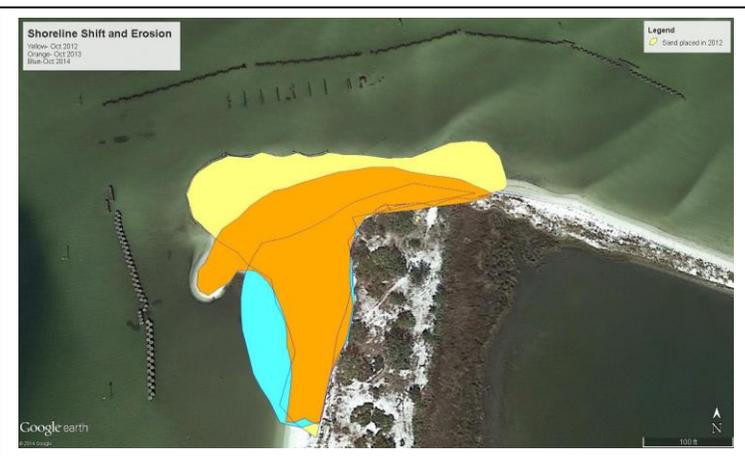
The comparison of the 2012, 2013, and 2014 shows the importance of complete breakwater protection. The northern breakwater was the first priority when determining where partial funding could be used the most. This failure and these results show the dire emergency to obtain funds to complete the breakwater. If the project is funded completely as designed with no interruption in funding, the project would not evolve and constantly need permit modifications and the project would be sustainable.

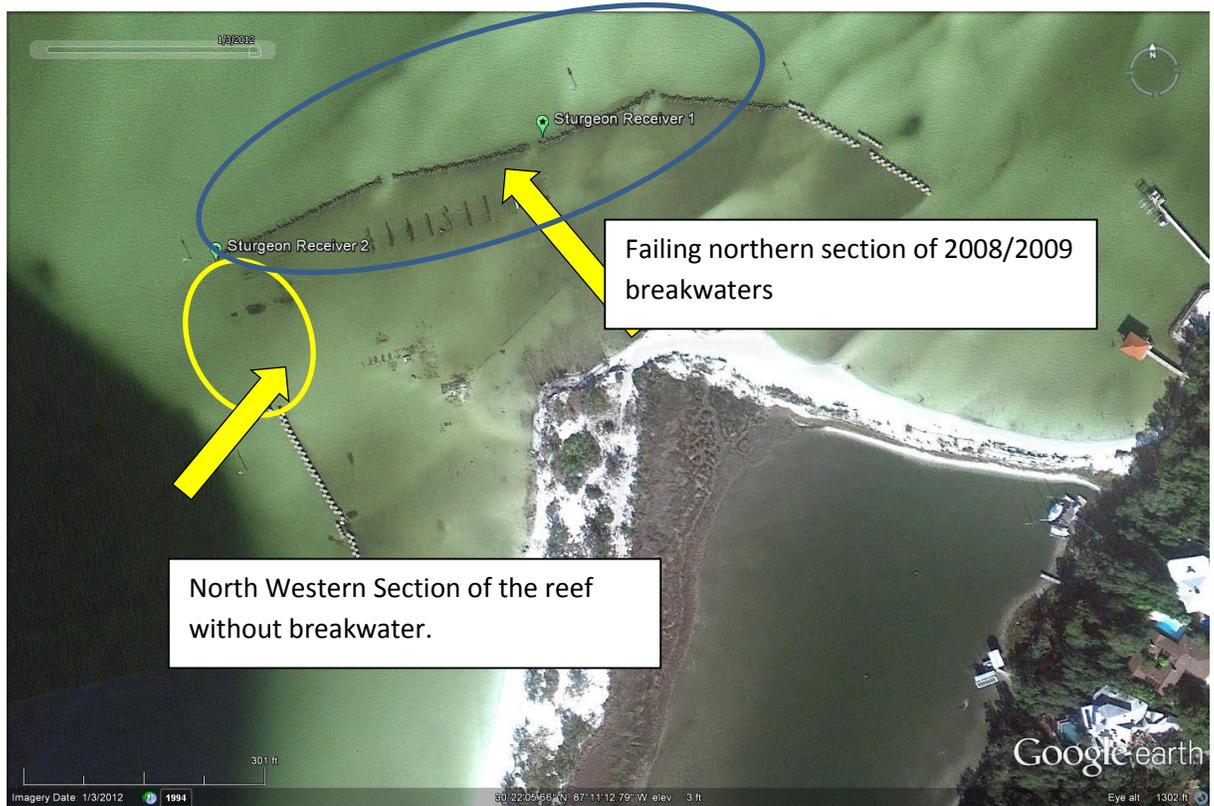
Figure 17-Project future needs, removal and replacement of northern breakwaters (blue circle) and barren western area (yellow circles) with Ecosystem.

The completion of the entire breakwater footprint is needed to complete the project. The barren 200 feet of the breakwater and the replacement of the no maintenance, oyster reef, fish habitat wave attenuators. It is more cost effective as far as maintenance, for the replacement of the pre-oil spill timeframe, rebar units than repair what is already present. Once the entire footprint is complete, a few more plantings of the shoreline will be needed and then the project will be self-sustaining, will require no more maintenance and will be finished.

1.2 million dollars is needed to replace the failed rebar breakwater and the absent breakwater with the above mean high water ecosystems, remove PVC barrier posts, and replace the sand lost from this incident. If funding can be awarded all at once, then the project will not have time to evolve into other problems and the project will be low maintenance and successful restoration project.
