**Monitoring and Detection of Gulf Sturgeon During a Bridge
Deconstruction Project in Pensacola Bay, Gulf Breeze Florida**

Ecological Consulting Services Inc.
for
Tetra Tech Inc. and the City of Gulf Breeze

July 2011

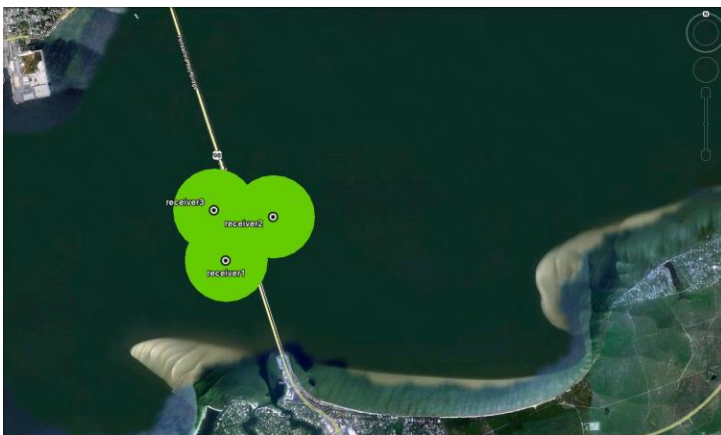
Fig 2. Receiver stations surrounding the deconstruction site

Three buoy receiver stations were positioned to surround the deconstruction site at all times to set up a triangulation pattern and positioned to overlap detection ranges. As the deconstruction barge and equipment moved north or south alongside the bridge, the buoys would be relocated to maintain a triangulation around the deconstruction site. The buoy system contained a weighted, lighted buoy, a trawl float, receiver anchor, and buoy anchor. The buoy anchor secured the entire setup. The large trawling buoys were daytime, visual navigational aids. The solar powered flashing lighted buoy provided navigational visual aids at night. Instead of pulling the entire anchor systems, the receiver was attached to a separate line to allow easy access and retrieval. The receiver line is pulled onto the boat and wrapped around one of the side cleats of the vessel, and the receiver is activated for data retrieval onto a laptop. The entire anchor system was pulled out of the water only for relocation.

Receivers to detect the transmitters were placed, in a triangular shaped pattern, to surround the deconstruction area and

equipment. Range tests were performed to determine the appropriate spacing distance to allow an overlap in the triangular pattern of the receiver locations. The design had 100-meter radius overlap of all three buoys to assure the detection of the presence of the sturgeon within the deconstruction area. Periodically, the receivers were retrieved to download the data to the computer, mapped, and analyzed. The receivers were attached to solar powered lighted buoys which were maintained as needed. The receiver sensors were also maintained and cleaned periodically to prevent fouling and cause transmitters interference.

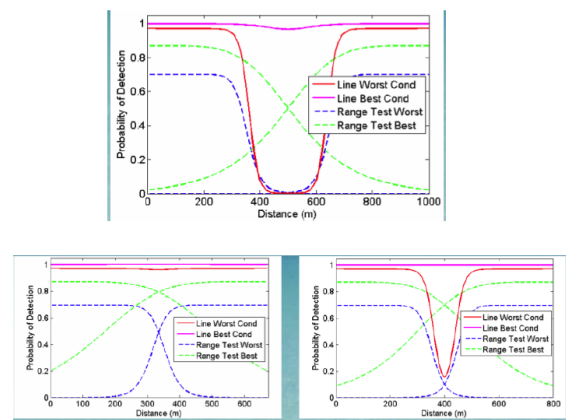
Fig 3. Range test comparison. Vemco receivers

The receivers used were the VEMCO VR2W, with a memory available of 8 MB 69 kHz, capable of detecting over 1,000,000 detections, real-time clock, Bluetooth compatible communication, and battery life of fifteen months. Three receivers were used for this assessment. The receiver was set at a distance of ¾ of the current depth between the surface and bottom. The VR2W records the code from the transmitter’s tag number, the date/time of valid detections, and sensor data. The information is stored in memory until downloaded from the receiver using Bluetooth wireless communication and a laptop PC running the VUE software provided by VEMCO (VEMCO 2011). A range test was conducted using an untagged transmitter on a tow line. Once the distance range was determined, the overlapping range was then tested for the best location with the triangulation pattern.

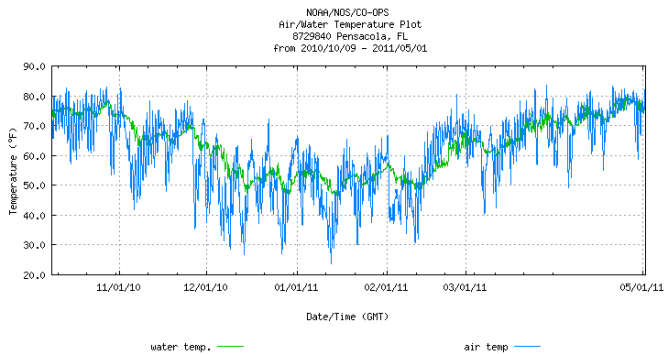
Fig 4. Air and water temperature from October 2010 to May 1, 2011

Stations at the area varied in depth from 10ft- 22ft. Station 1 was the northwest buoy and range from 23ft- 19ft. Station 2 was the southwest buoy and ranged from 22ft to 10ft. Station 3 was the west buoy and ranged from 22ft-10ft over the seven months. The salinity and temperature were relatively constant among stations but varied throughout the months ranging from 28.3-13.2 ‰ and water temperature 75 F to 45F respectively.

Sturgeon migration patterns are triggered according to temperature (Heise et al. 2005). The temperature of the entire season ranged from 32 F to 79 F. The period from December 31st, 2010 to January 4, 2011, showed no transmitters were detected. During the Holidays, the barge was present

in the water. The air temperature, during this study, was 47 F, and the water temperature was 55 F.
