# Santa Rosa Dunes Condominium

Shoreline Stabilization Project

For the Santa Rosa Dunes Homeowners Association

By Heather Reed, Ecological Consulting Services

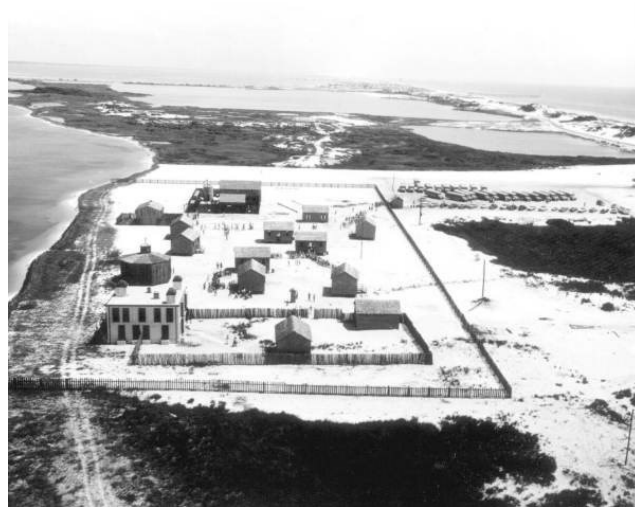
**FIGURE 1:1959 PHOTO OF THE SOUND SIDE OF PENSACOLA BEACH AND THE CURRENT LOCATION OF THE SANTA ROSA DUNES HOMEOWNERS ASSOCIATION (PHOTO CREDIT: DEPARTMENT OF COMMERCE COLLECTION: FLORIDA STATE HISTORIC PRESERVATION OFFICE)**

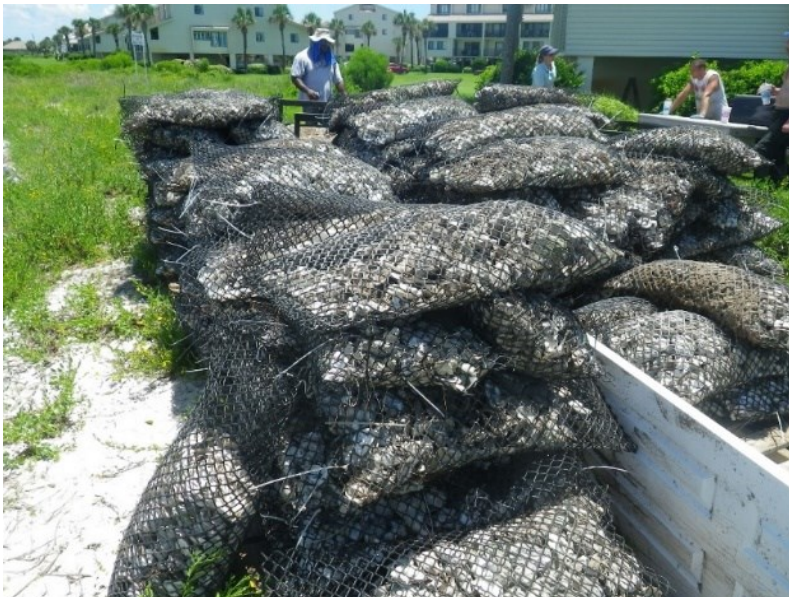
FIGURE 4: PHASE 1 PURCHASED OYSTER SHELL LOADED INTO MESH BAGS

Preparing a project is essential for the health of the environment and ecosystem about to be created. Figure 4 shows oyster shells in the mesh bag. These shells will make micro reefs in the water. All shells are thoroughly washed and dried out in the sun before placement in the water. All rock are washed before placement in the water. This method will reduce sedimentation which can initially kill fish and smother seagrass.

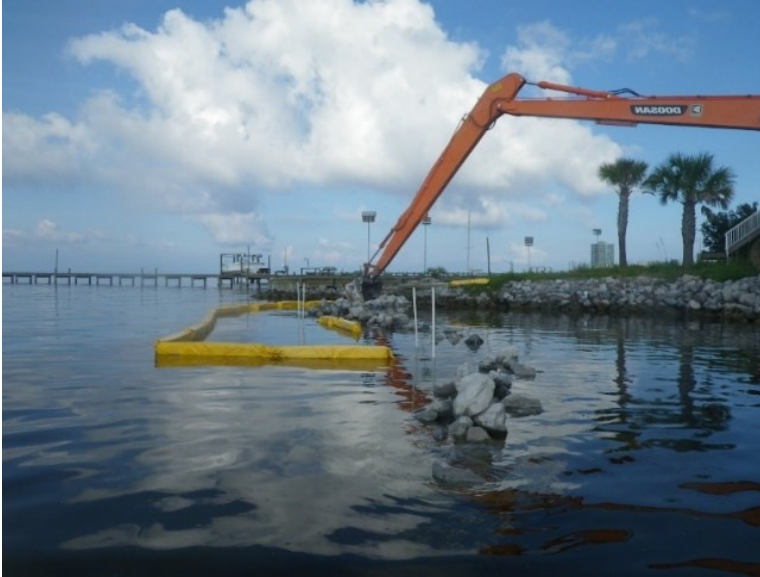
FIGURE 5: PHASE 1 CONSTRUCTION OF THE BREAKWATER

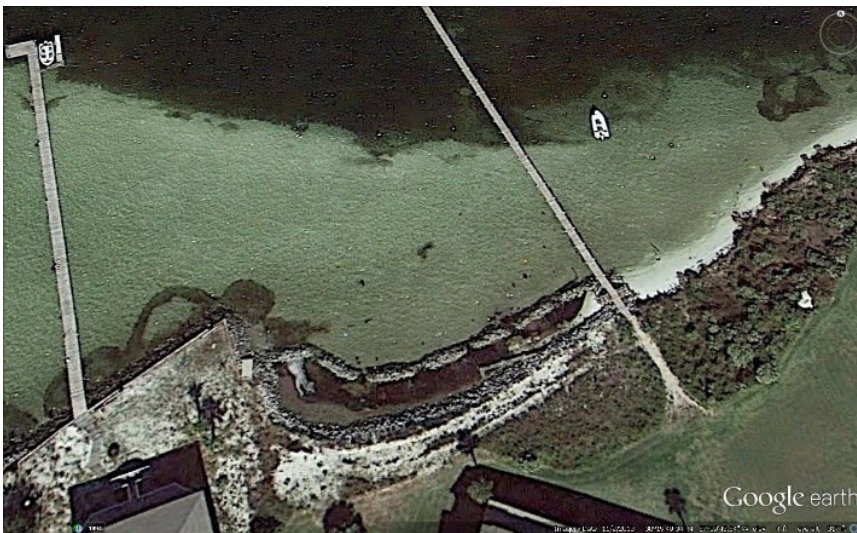
FIGURE 7: AERIAL OF COMPLETION OF PHASE 1

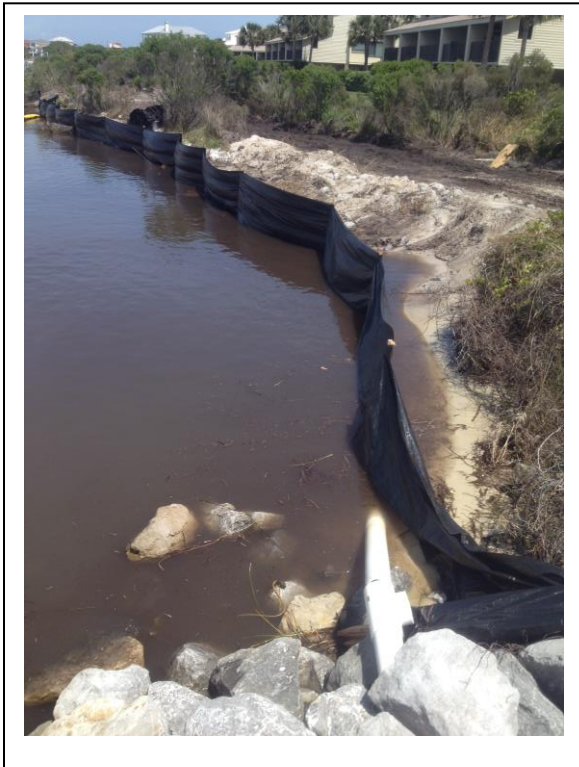
Fig. 15 -Berming of the side to create a slope to protect the property

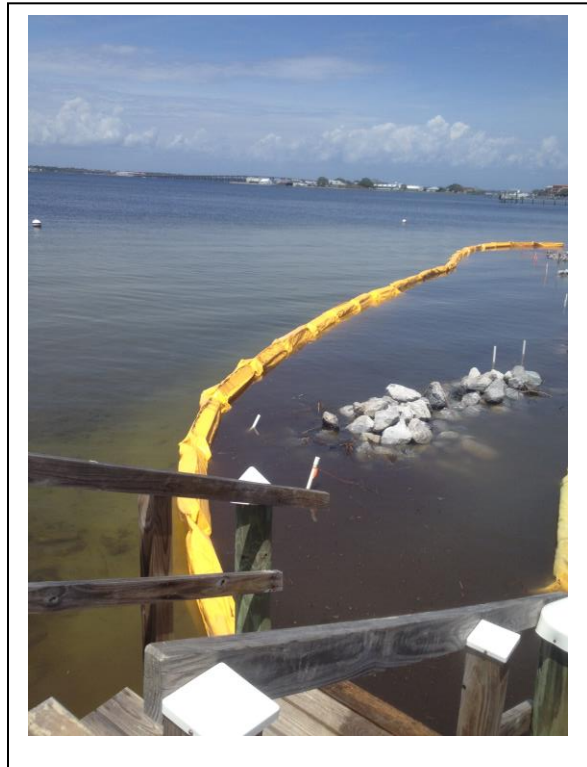
Fig. 16- The turbidity curtain containing the silt and sediment

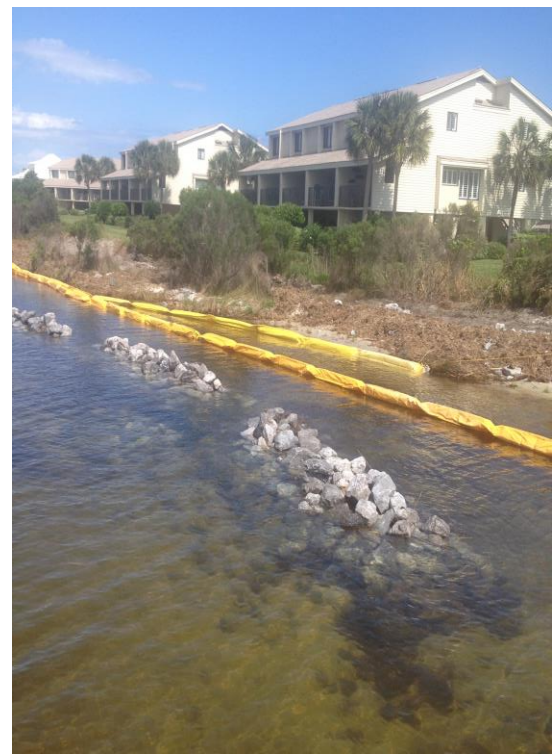
Fig. 26- Riprap placement over the oyster reef foundation

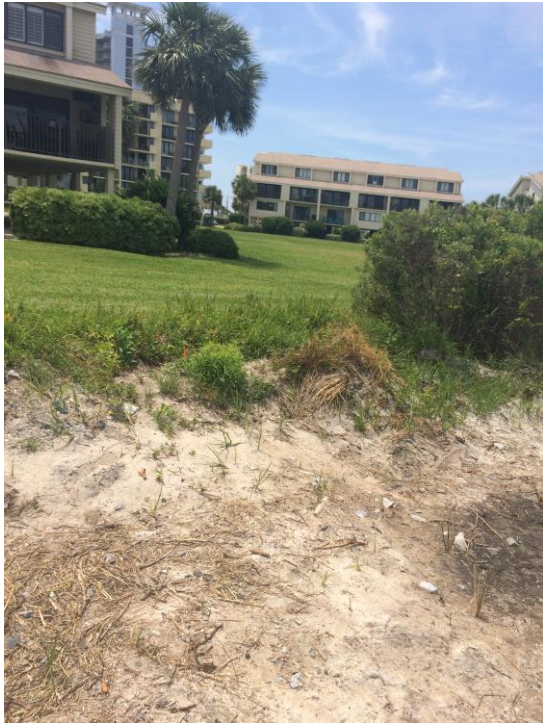
Fig. 29 -Spreading out sand to determine the elevation for the appropriate plants

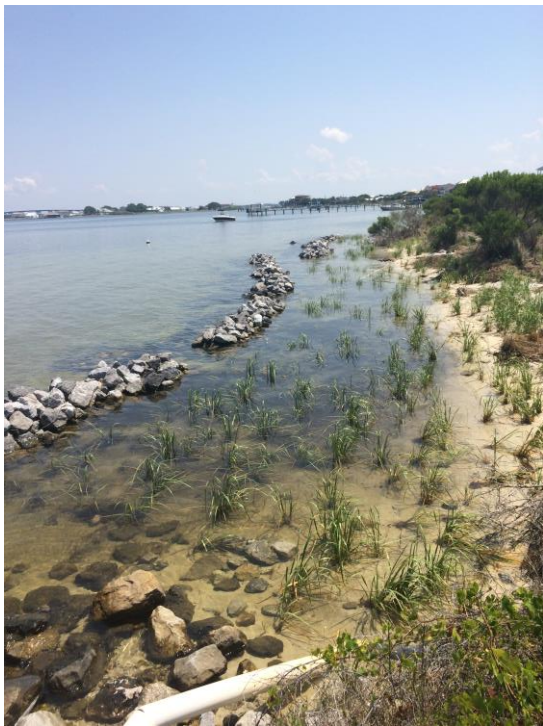
Fig. 35-Finished project left to establish

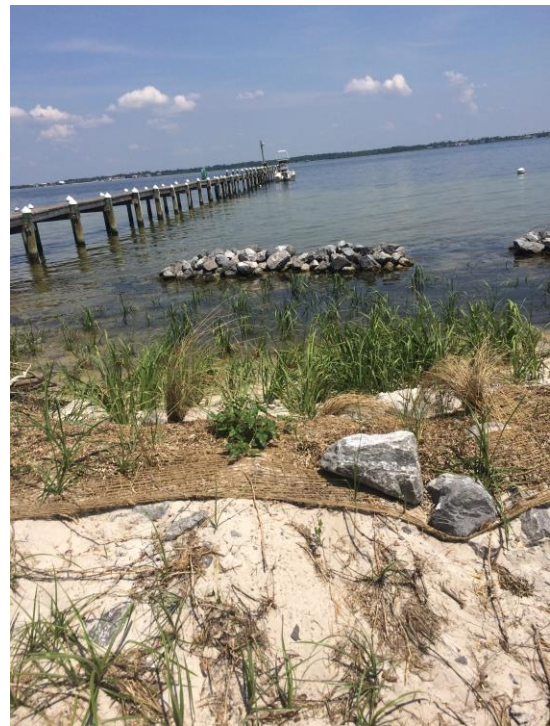
Fig. 36- Meshed mat used to provide additional stabilization to the shoreline
