2020 Damage Assessment for Hurricane Sally and Monitoring Report

CITY OF GULF BREEZE DEADMAN'S ISLAND RESTORATION PROJECT

GULF BREEZE, SANTA ROSA COUNTY, FLORIDA

Ecological Consulting Services, Inc.

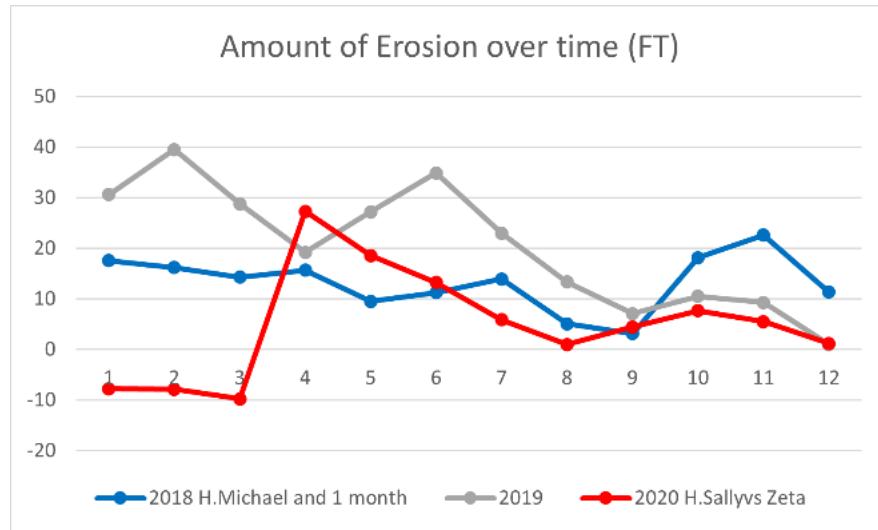
Figure 13: Erosion Comparison 1 month after a Hurricane

A GPS shoreline survey was taken one month after each storm. The rate of erosion was compared to Hurricane Michael and Sally (Figure 10 & 13). Waypoints were also taken one month after each Hurricane (Figure 14). The average rate of erosion of Hurricane Michael and one month after in 2018 was 13.23 ft. The range of erosion measured was from 3.13 feet to 26.16 feet. The erosion rate between Hurricane Sally and Hurricane Zeta in 2020 was 4.95 feet. The range of erosion measured was from 1.2 feet to 27.29 feet. This erosion was measured and compared to hurricanes that previously impacted the site (Figure 12). This observation leaves a question about a large amount of erosion in 2019 when no significant hurricanes impacted the project site. In the 2019 monitoring report, lunar changes and tidal influence may be responsible since there were many higher than normal tide changes caused by super full moons (Reed 2019). These super moons affect the sea level and the earth's distance before the lunar perigee. The closest new moon of the year will cause larger than usual

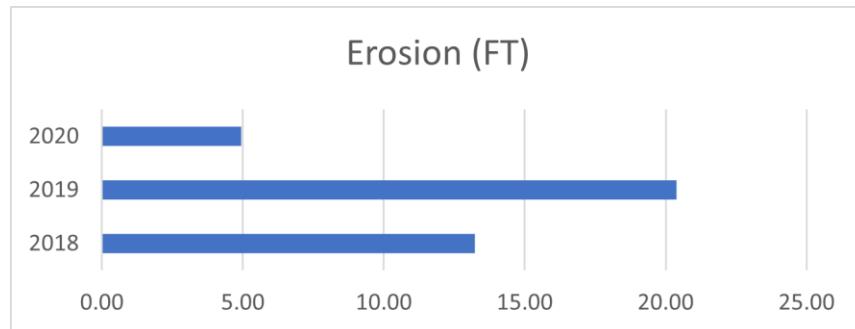
Figure 14: Amount of erosion one month after a hurricane and one month after storm surge.

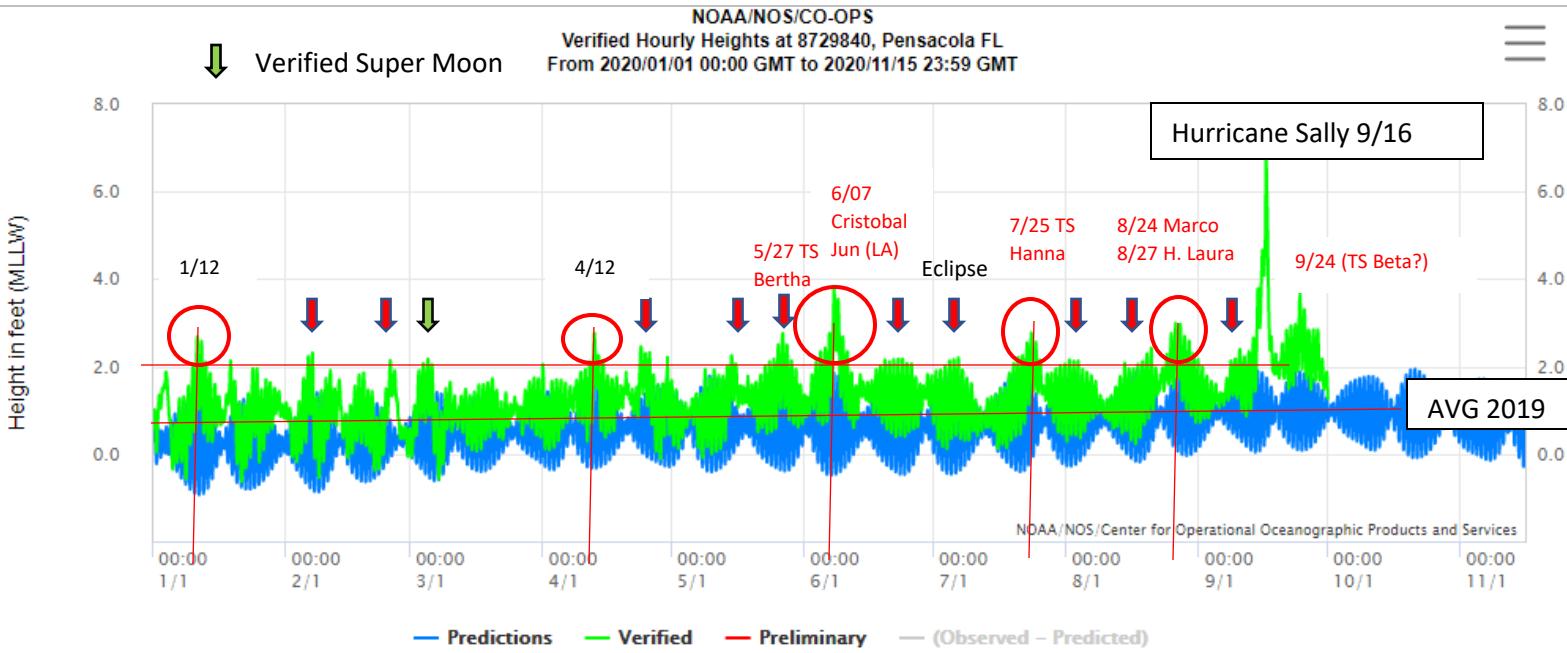
Figure 16 shows the predicted vs. actual tide where the actual tide was once again higher than predicted but shows the tide level's rise and fall during full moon events and various hurricane events.

Figure 16: 2020 Tide, lunar and hurricane events

In 2020, it was difficult to correlate any increase in water level rise to the lunar cycles as in 2019 (Figure 15). The issue may be due to the incredible hurricane season this year. Observing the graph of the 2020 tides and lunar events vs Hurricanes (Figure 16), it appears there is no correlation to the moon and high tides as were similar last year. However, after reviewing the water level, a trend and correlation to increasing tides due to tropical storms and hurricanes may have been more apparent than initially thought. The surprising fact is that the water level did not rise with just local hurricanes but hurricanes elsewhere that did not impact the area.

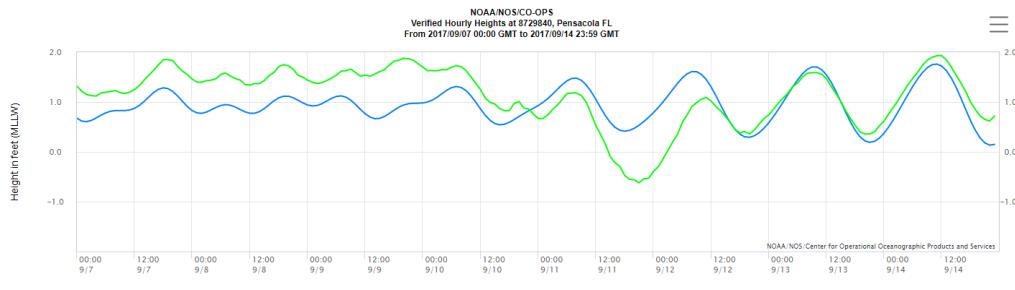
Hurricanes and tropical storms tend to rise and lower tides as well create surges and erosions (Figure 13, 14, 16). Studies of previous projects do correlate with hurricanes impacting coastal restoration projects (Reed 2019). One observation of the most drastic impacts of water level change that was surprising was Hurricane Irma in September 2017. Hurricane Irma impacted Florida over 500 miles away from Pensacola and Deadman's Island. Although the hurricane was 500 miles away, the water in Pensacola Bay receded drastically, exposing shallow water seagrass under docks. When looking at the water level chart for Hurricane Irma during the timeframe, they were -0.62 inches in Pensacola Bay (Figure 15). The water level receded very quickly in Pensacola Bay and correlated to the tide data and timeframe when Hurricane Irma impacted South Florida (NOAA 2017). The water level quickly receded and gave an eerie impression of a tsunami characteristics, but without a preceding earthquake. The water was pulled from the shallow tidal flats exposing seagrass and fish. It was expected the water would surge and return the water levels quickly causing higher tidal action and impacting at least 15 feet upland. Instead, it took a day for the water levels to slowly return to normal. It was incredible how a powerful storm 500 miles away could remove such a quantity of water from Pensacola Bay.

Figure 17: Hurricane Irma impacted south Florida on September 10, 2017. The Hurricane was over 500 miles away and caused a drastic drop(-.062)in the water levels of Pensacola Bay.

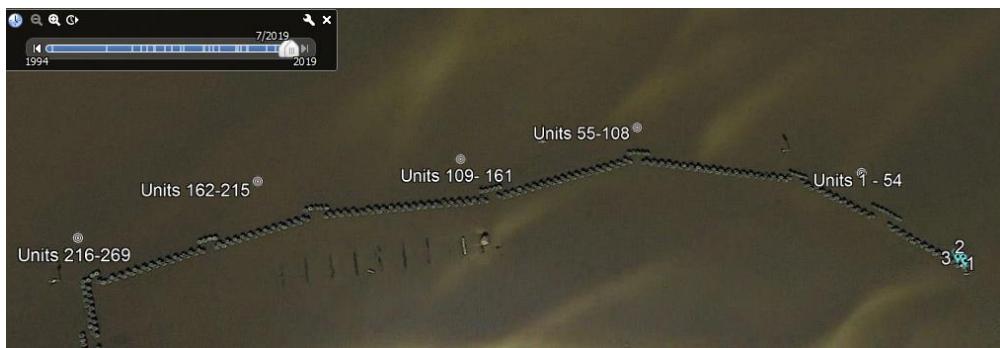
These reefs are boat access only. An underwater inspection of the reefs showed 35 units out of the 371 were impacted (Figure 18, 19, 20). The 35 units were located mostly on the north end and each have at

Figure 19 : Section C-July 2019 aerial of the northern breakwaters.
