# Santa Rosa Dunes Condominium

Shoreline Stabilization Project

For the Santa Rosa Dunes Homeowners Association

By Heather Reed, Ecological Consulting Services

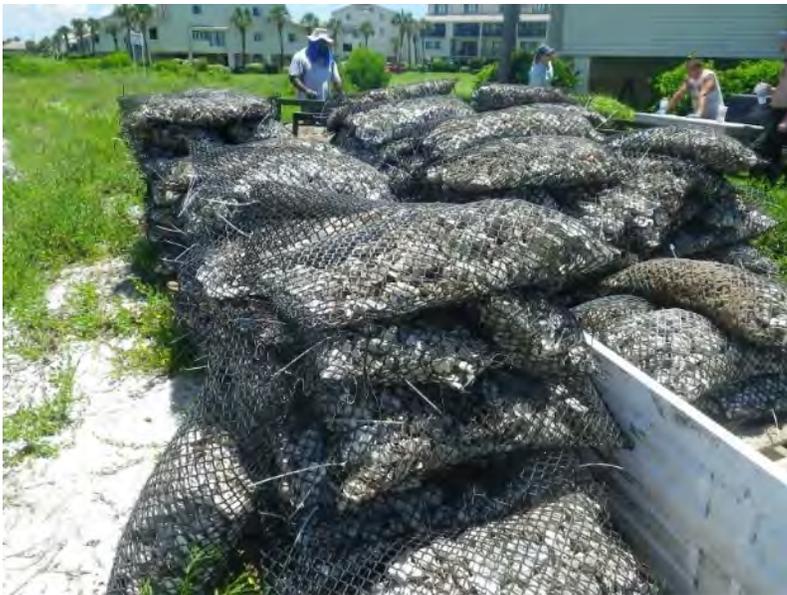
FIGURE 4: PHASE 1 PURCHASED OYSTER SHELL LOADED INTO MESH BAGS

Preparing a project is essential for the health of the environment and ecosystem about to be created. Figure 4 shows oyster shells in the mesh bag. These shells will make micro reefs in the water. All shells are thoroughly washed and dried out in the sun before placement in the water. All rock are washed before placement in the water. This method will reduce sedimentation which can initially kill fish and smother seagrass.

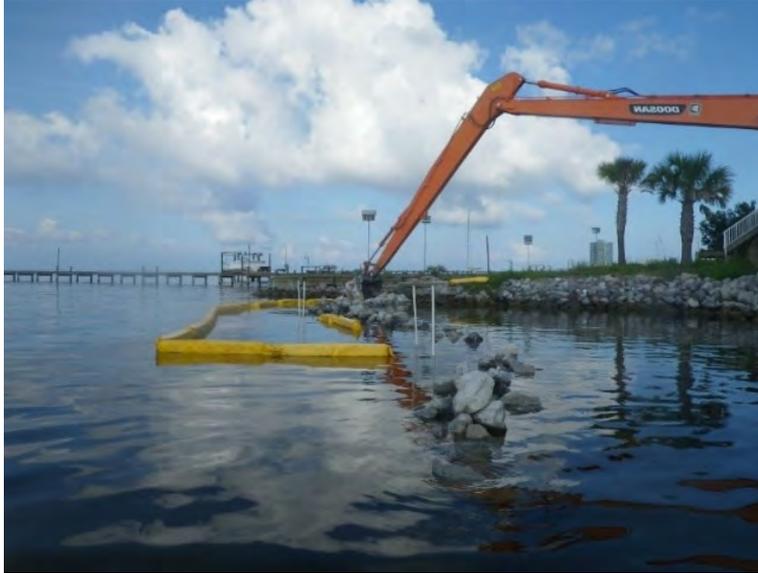
FIGURE 5: PHASE 1 CONSTRUCTION OF THE BREAKWATER

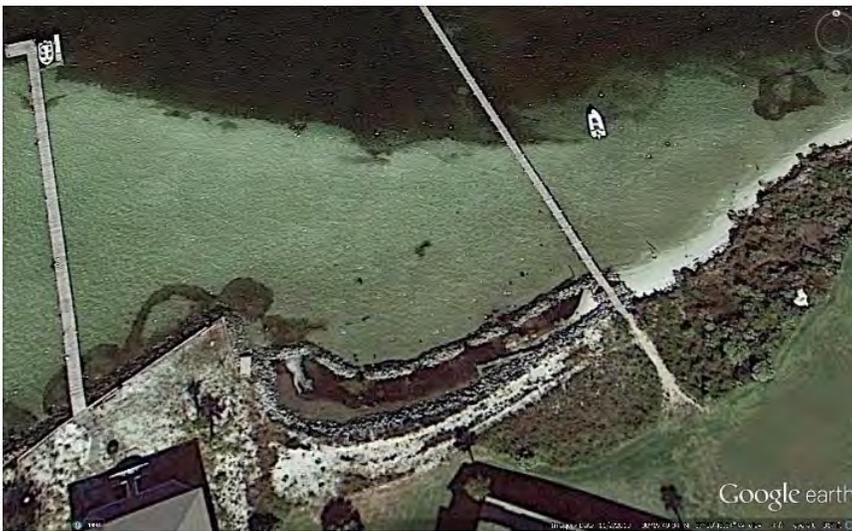
FIGURE 7: AERIAL OF COMPLETION OF PHASE 1

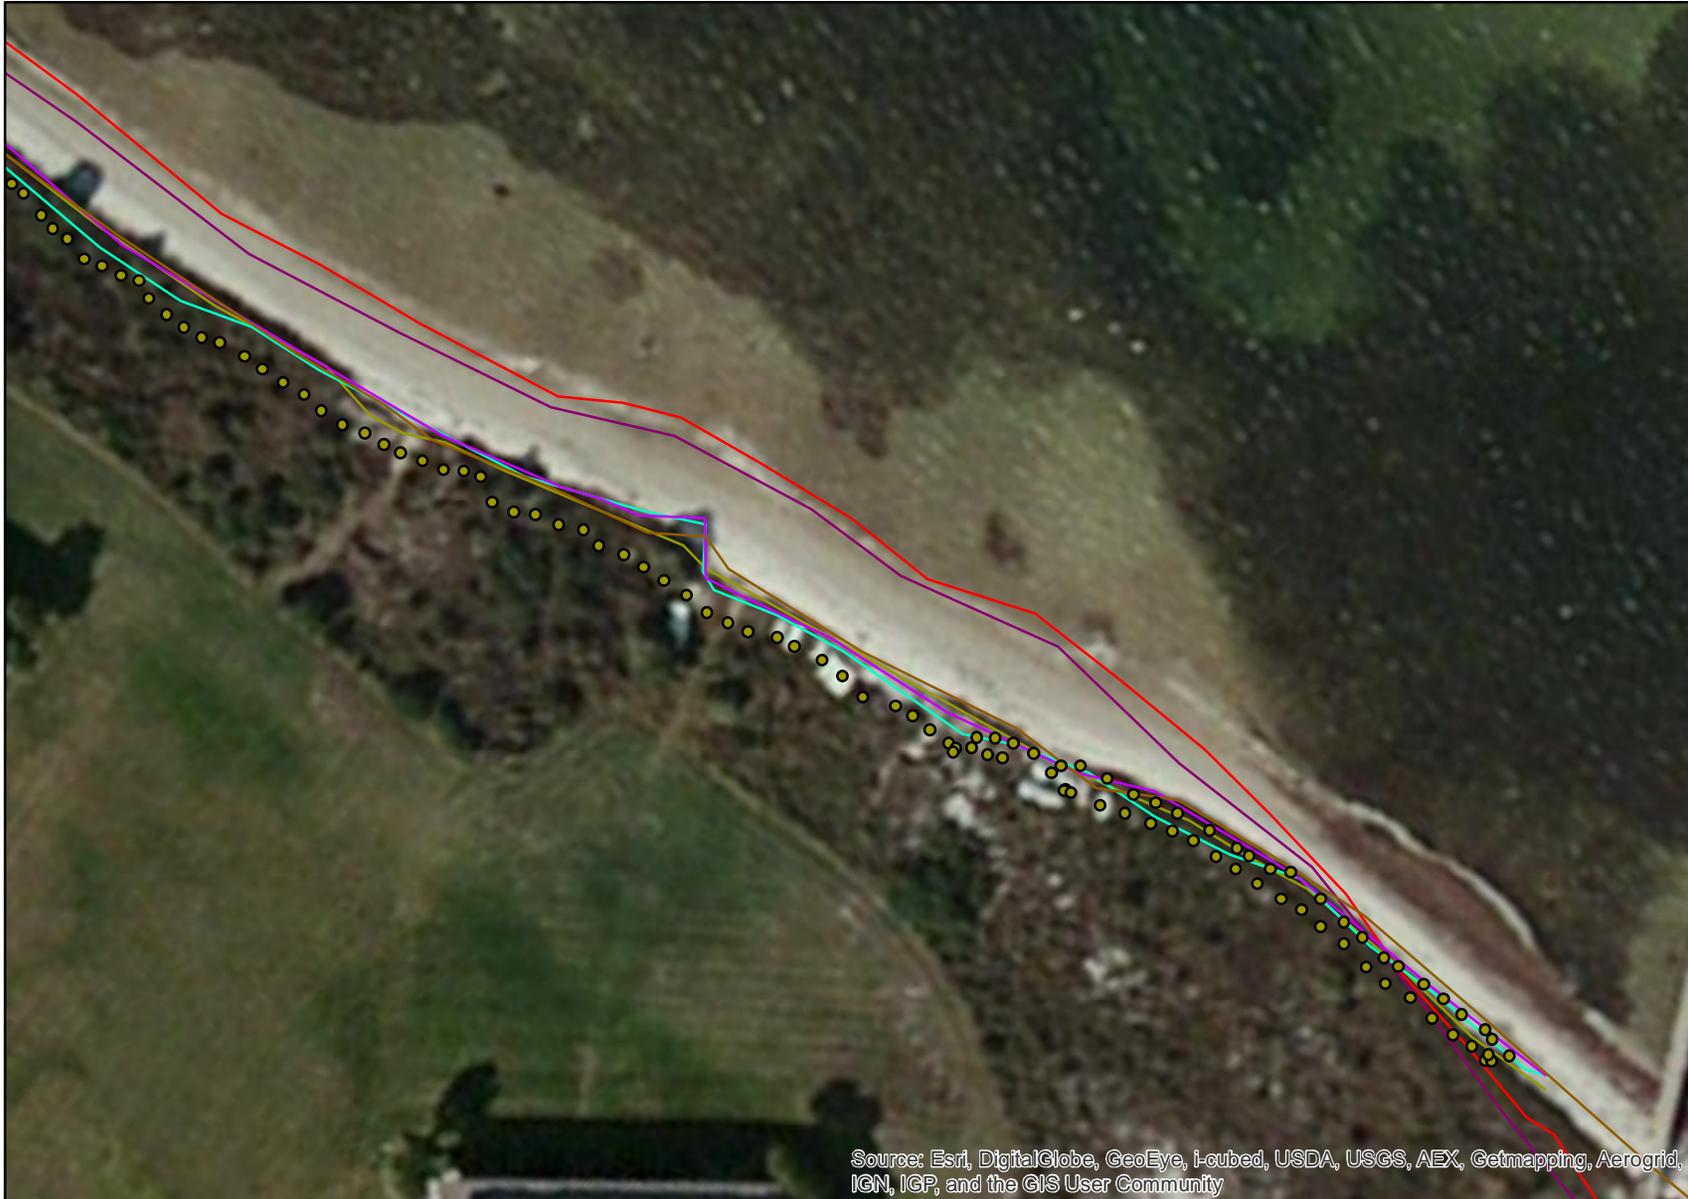
# Santa Rosa Dunes Shoreline Change Section C

Seagrass is a natural stabilizer. Notice in Section C (Figure. 10). The only real erosion is the beach area to the east. The shoreline in front of the seagrass has changed VERY little over the years. Once again this is because of underwater seagrass root system stabilizing the shoreline. If the seagrass ever gets destroyed and boaters keep anchoring in the seagrass, this shoreline area will also face erosion. If the beach recreational area sandy area becomes larger, the sand may also erode, reducing the shoreline.

Section C shows a stable shoreline, but the current salt tolerant plants along the shore need reinforcement, waterward, by wetland plants that can tolerate the saltwater. It is recommended to plant only new wetland vegetation in front of the existing vegetation. This vegetation will help trap sand. Behind this shoreline, it is recommended to remove the dead vegetation by cutting only and replanting more soil appropriate bushes and plants.

The east end of Section C (Fig. 10), is where the property's beach area is. This beach will eventually erode more over time from the lack of stabilization of the root system. To keep the beach area the same size, and prevent any further vegetative stress from trampling, it is important to create a nice vegetative border of bushes to maintain the boundaries of the beach. The bushes are less likely to get trampled and will protect the shoreline grasses. Section C East, is also the highest area of boat anchorings in the seagrass. Distributing educational pamphlets and signs about seagrass and the importance of keeping the root system intact, enforcing the mooring buoys and discouraging anchoring, may help alleviate any impact to the rare inshore grass beds.

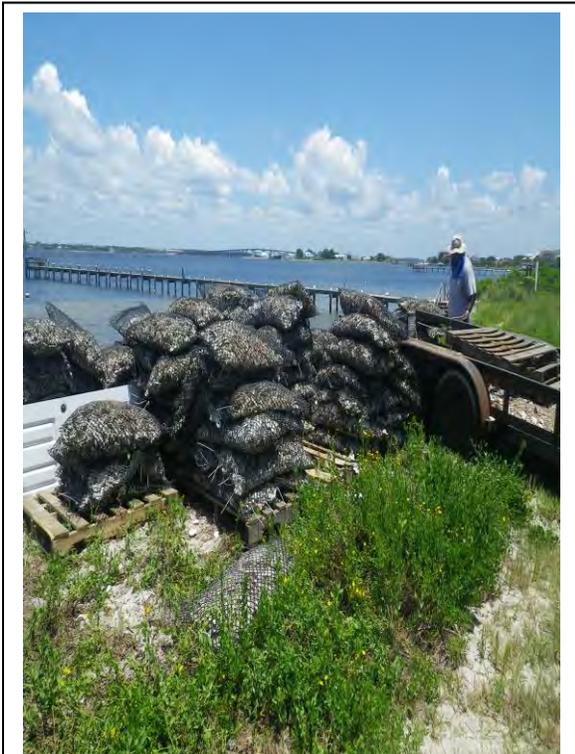
Fig. 3 -Staging recycled oyster shell bags

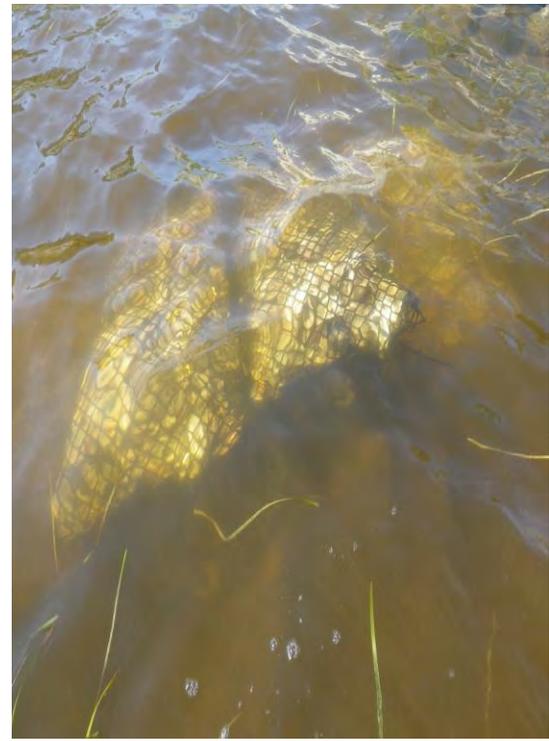
Fig.6 -Foundation to be formed

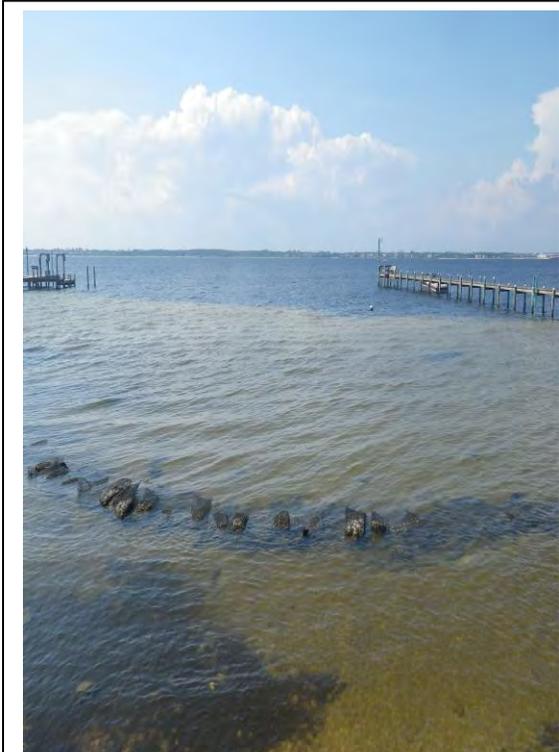
Fig. 7 -Initial hand placement of rocks to test the hydrodynamics of the current

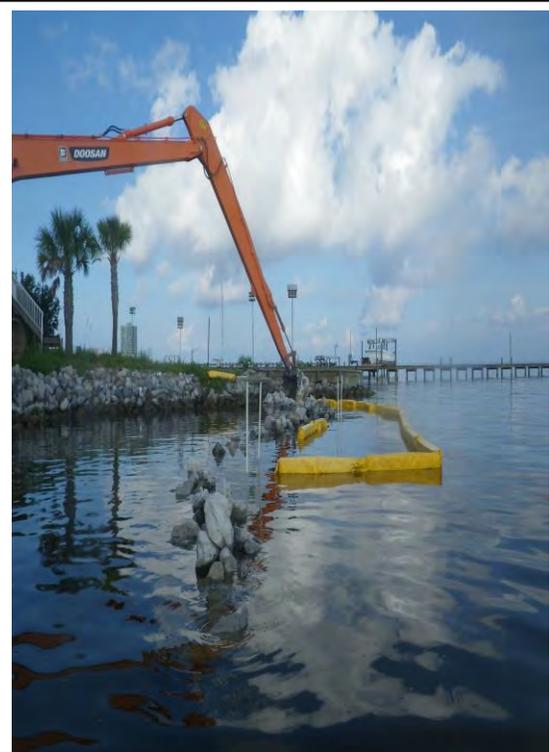
Fig. 8 -Placement of riprap

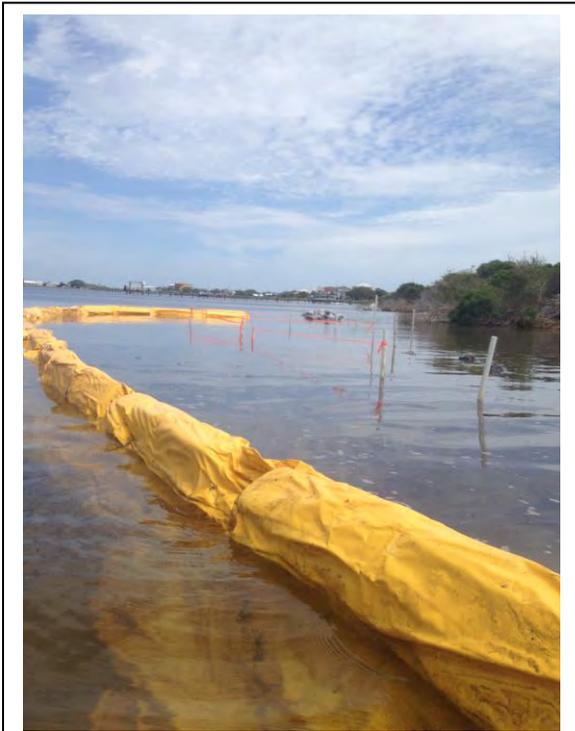
Fig. 10 -Curtain to protect seagrass and water quality

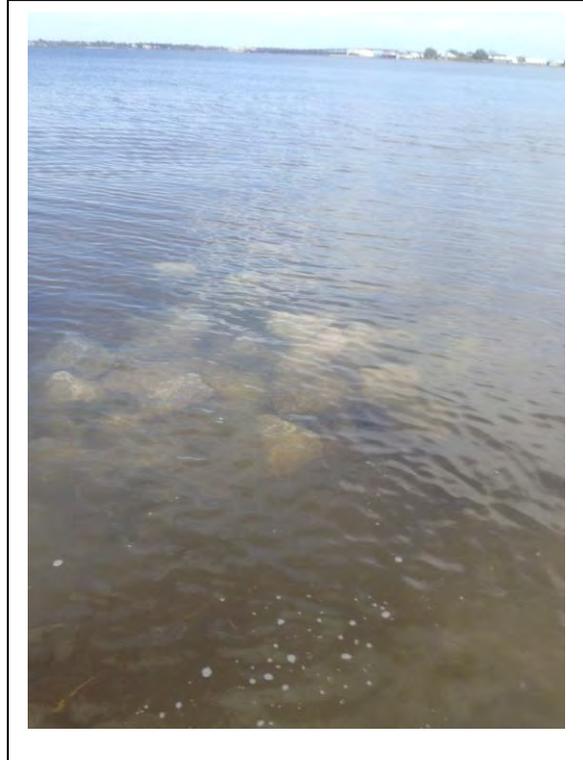
Fig. 14-Placement of rock at high tide

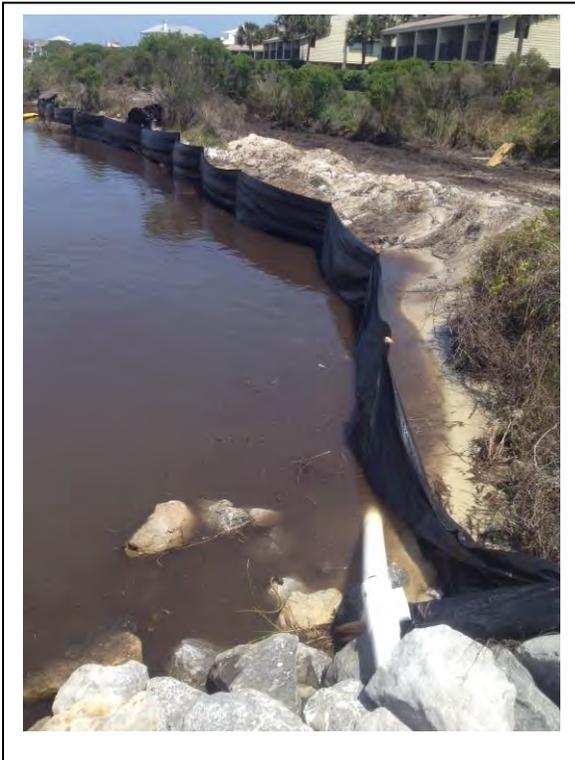
Fig. 15 -Berming of the side to create a slope to protect the property

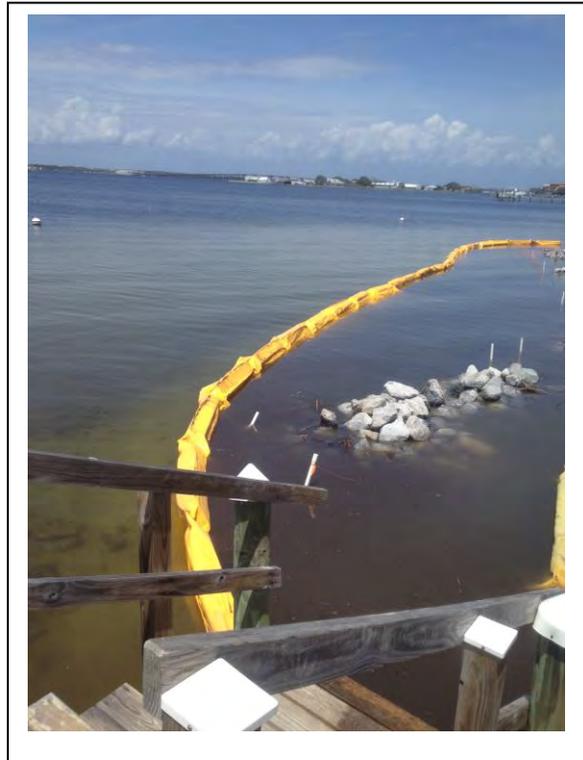
Fig. 16- The turbidity curtain containing the silt and sediment

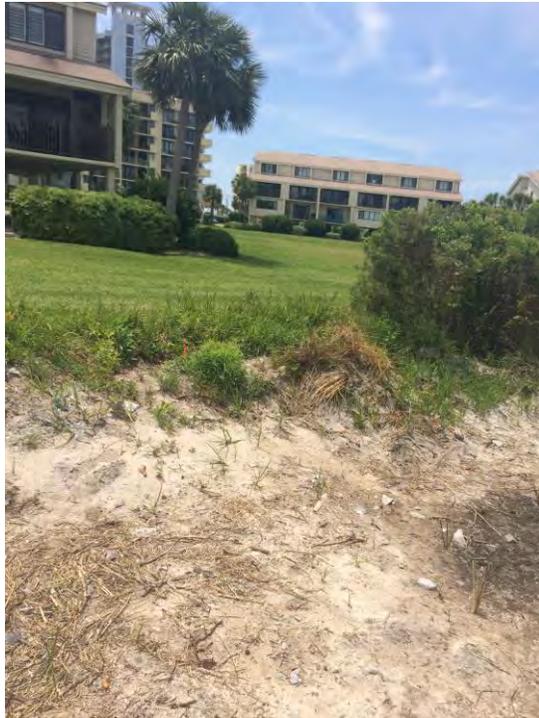
Fig. 29 -Spreading out sand to determine the elevation for the appropriate plants

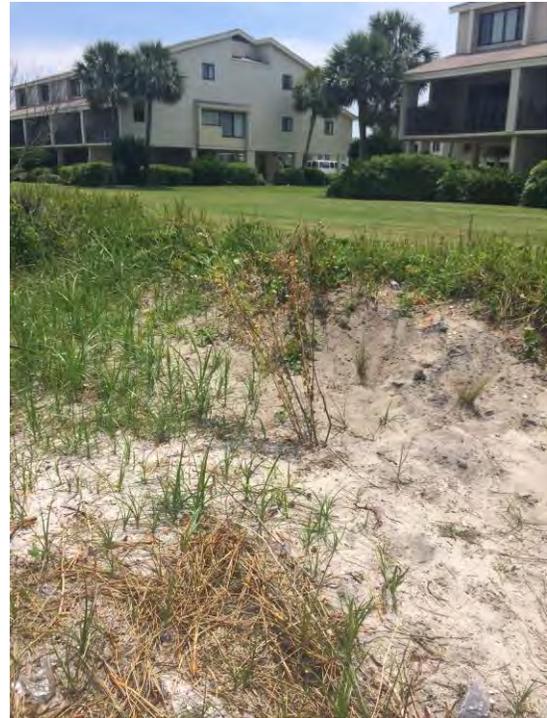
Fig. 30- Area where rip was staged is growing

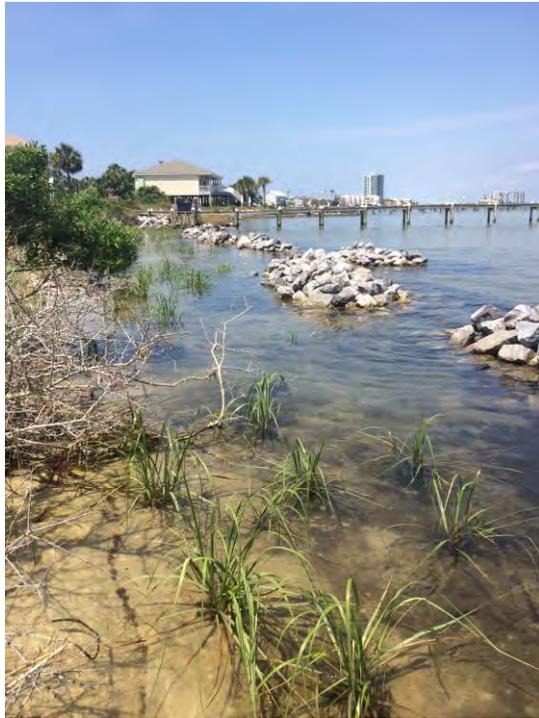
Fig. 33 Mid section left at sea level to flush into wet area

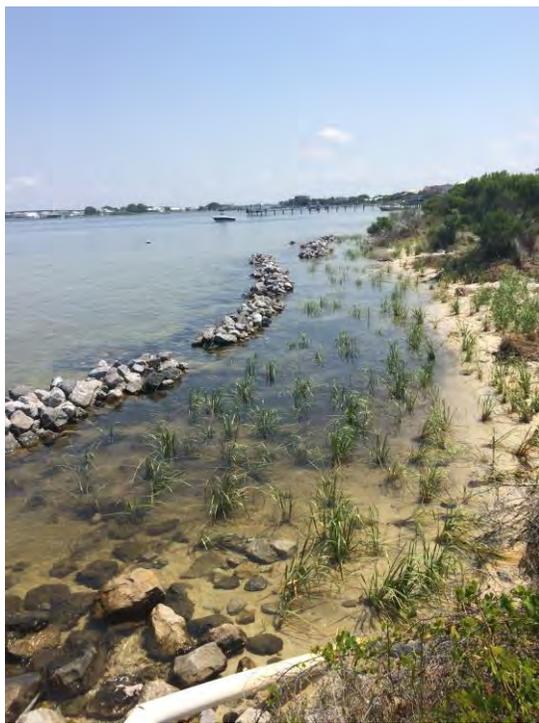
Fig. 35-Finished project left to establish

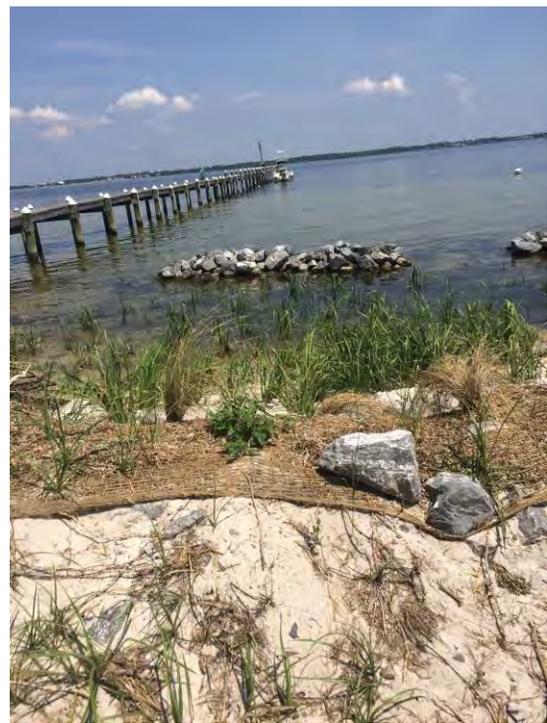
Fig. 36- Meshed mat used to provide additional stabilization to the shoreline

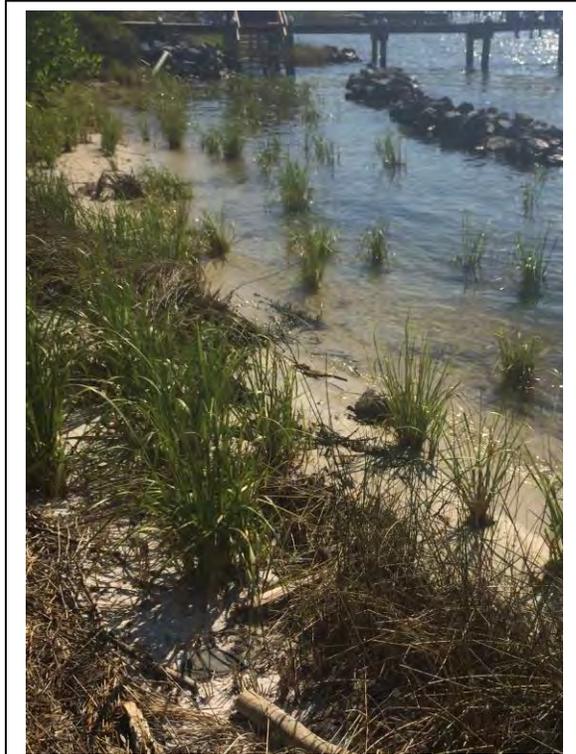
Fig. 40- Phase 2 Project two weeks later
