# Santa Rosa Dunes Condominium

Shoreline Stabilization Project

For the Santa Rosa Dunes Homeowners Association

By Heather Reed, Ecological Consulting Services

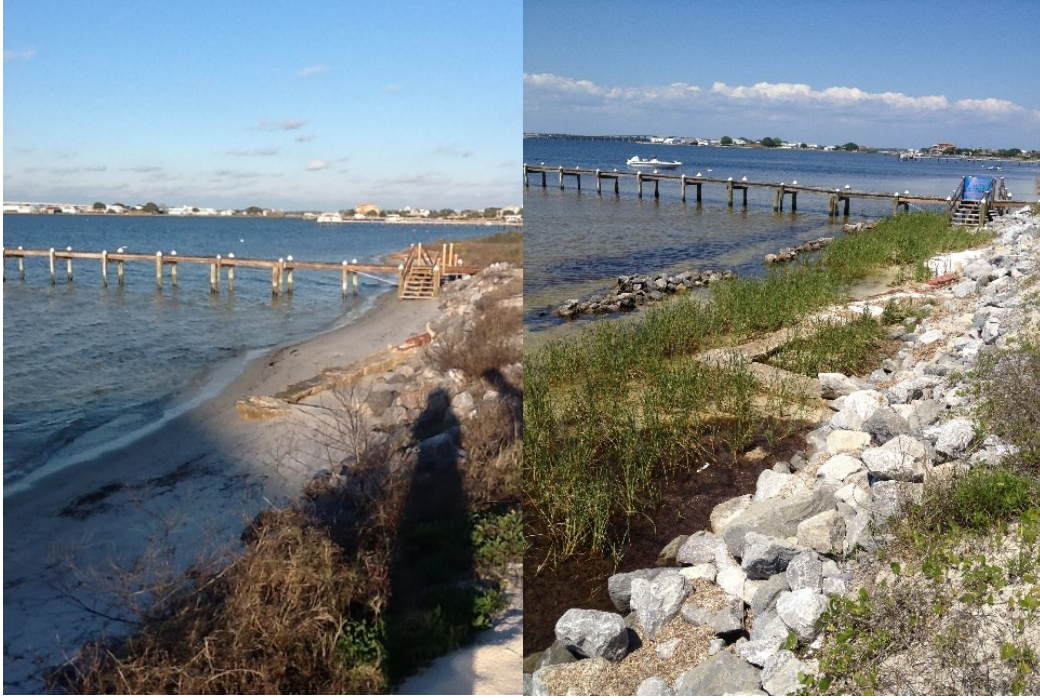
FIGURE 6: BEFORE PHOTO OF PHASE 1 2011 AND AFTER PHOTO 2015

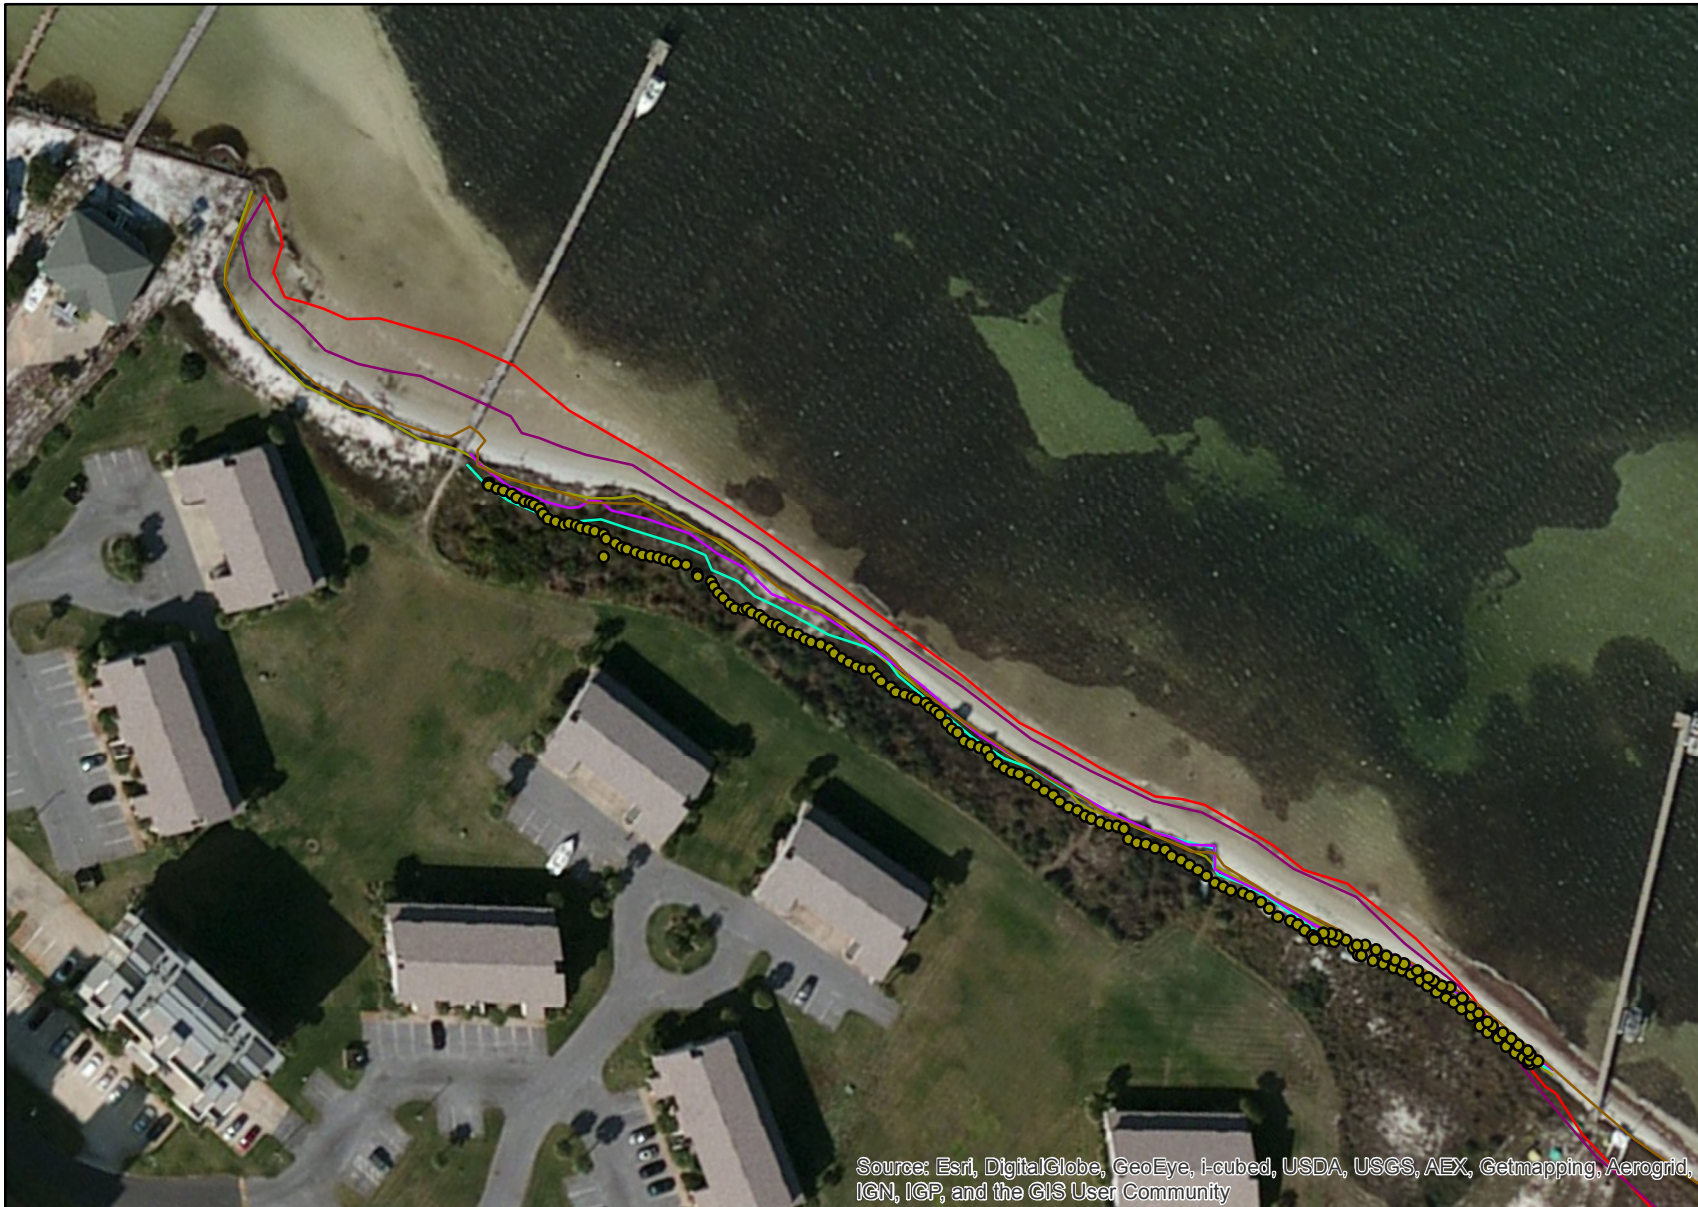
# Santa Rosa Dunes Shoreline Change Full View

The shoreline change is represented by colored lines; each line has a date associated with it. For example, 1994 is red, 2012 is gold, etc. There were no legible aerials for 2010 and 2011. There is no readily available aerials of the same elevation to measure prior to 1994. The most erosion occurs from 1994 to 2012. The purple line for 2013 shows the location of the shoreline near the existing breakwater.

**FIGURE 2: SANTA ROSA DUNES SHORELINE CHANGE FROM 1994 TO 2016.**

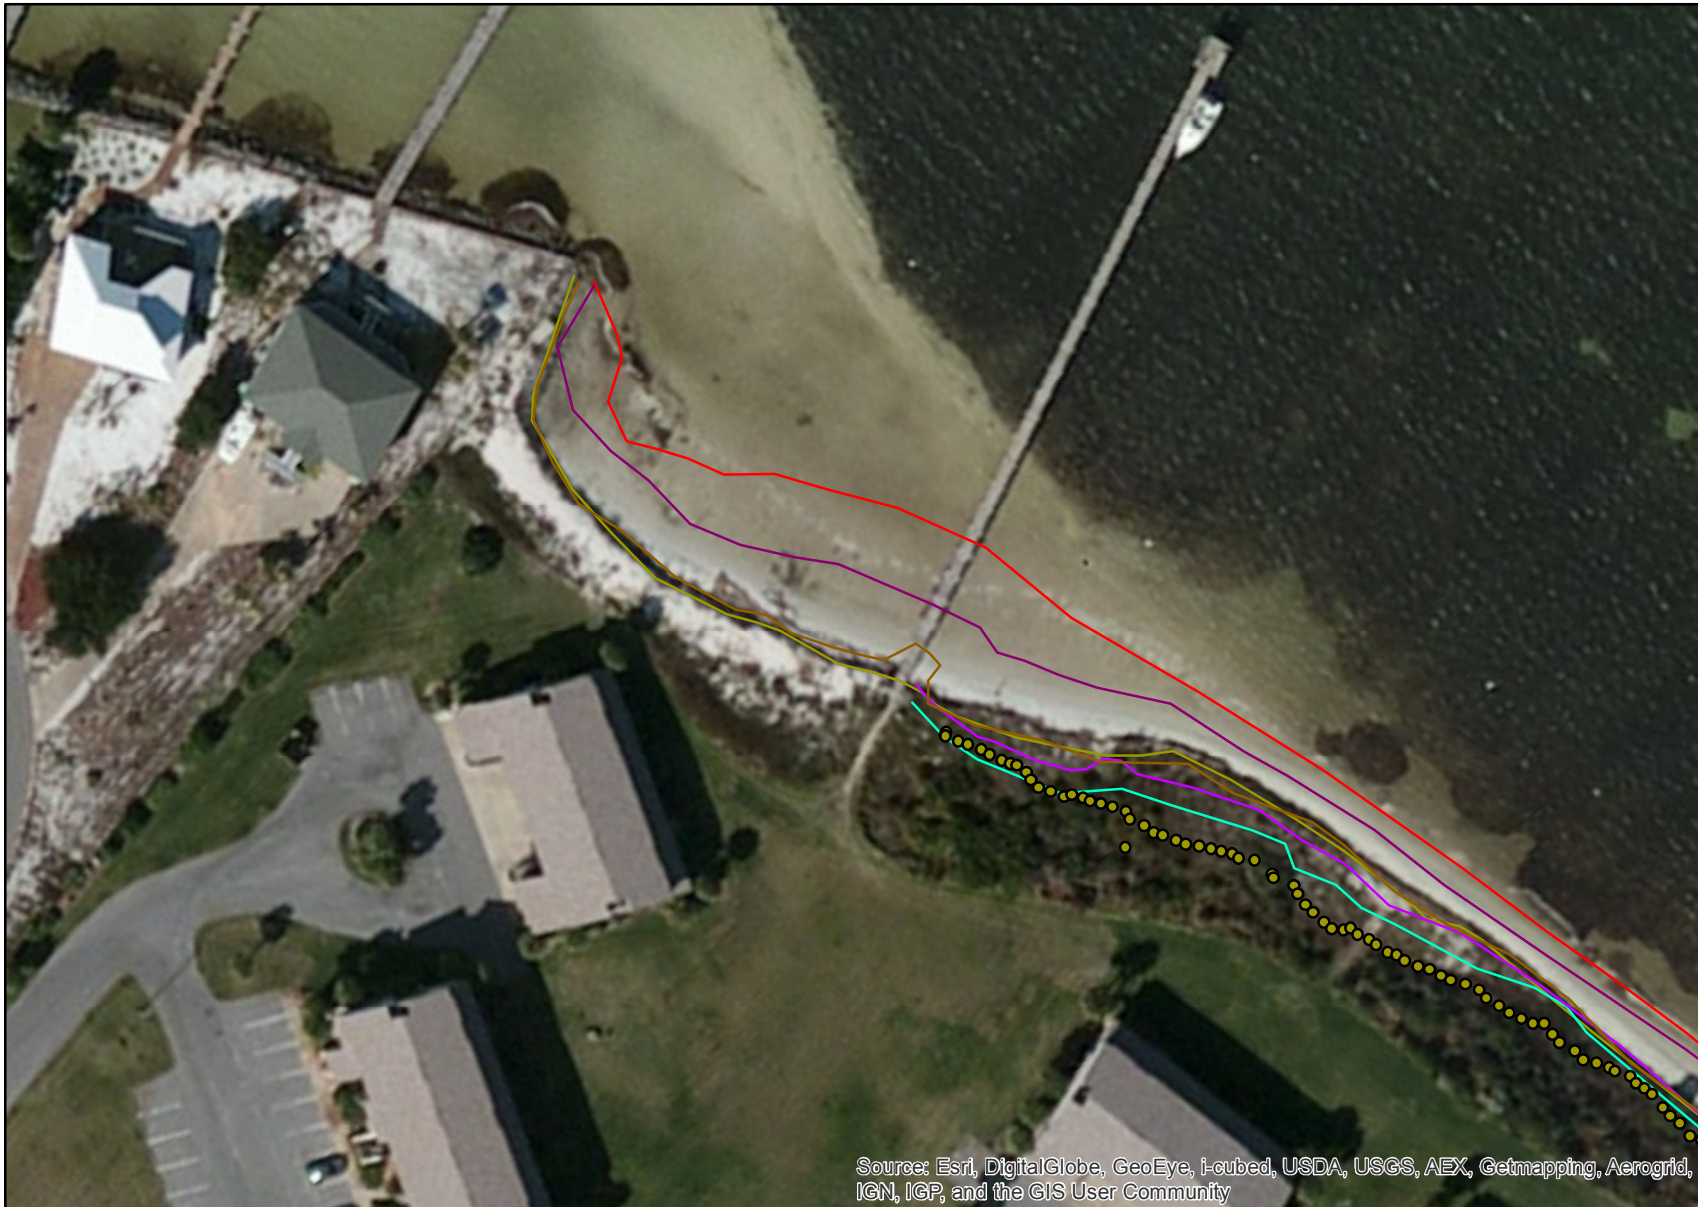
# Santa Rosa Dunes Shoreline Change Section A

The riprap was affecting the shoreline from the topside and the bottom side. Overtime the riprap continued to slide down the slope of the western shoreline and scoured from the lower part of the tidal floor underneath the rip rap. As the scouring continued, the heavy rip rap on the western side slid down the bank and exposed the upland area on top of the slope, to wind erosion. The riprap located under the bridge was the end point of placement. This placement mosly caused the same affect of the adjacent seawall and continued to scour the property to the east.

FIGURE 3: SHORELINE CHANGE FROM 1994-2016 FOR SECTION A WESTERN SIDE

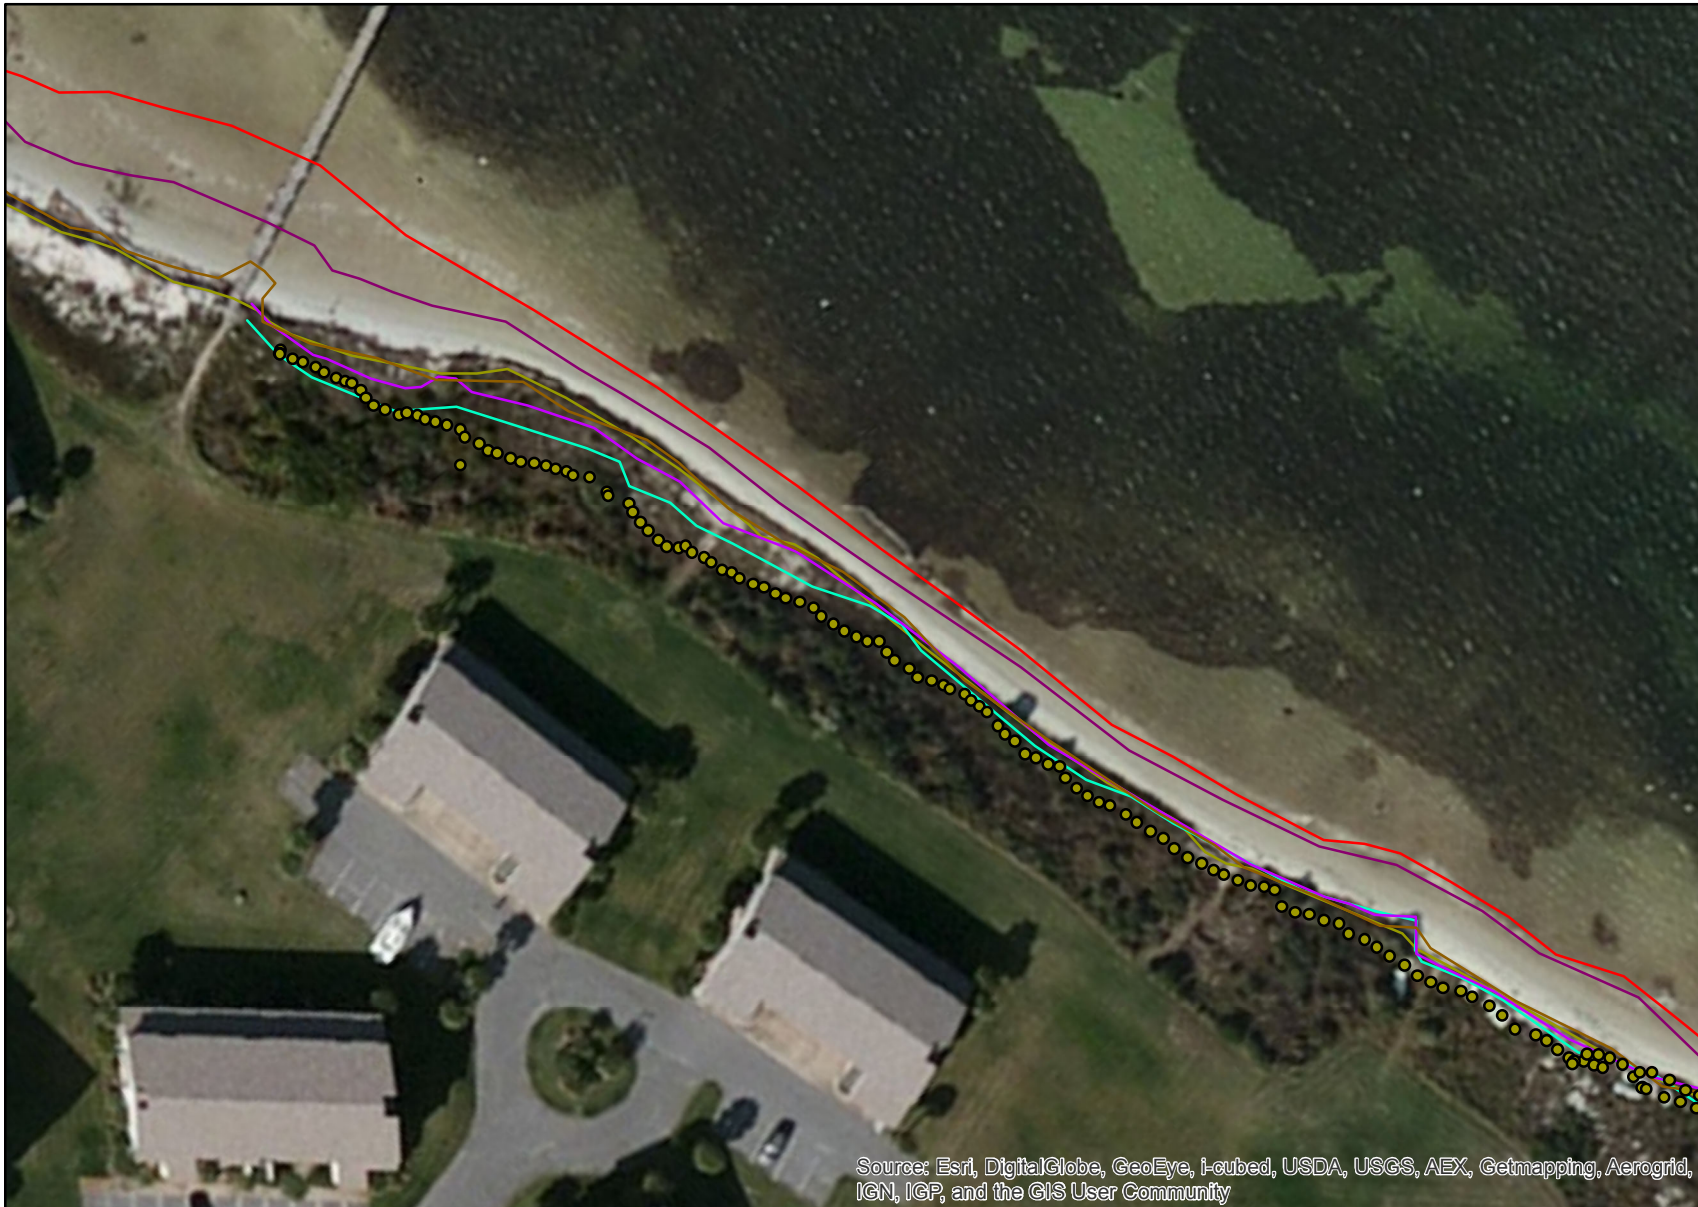
# Santa Rosa Dunes Shoreline Change Section B

FIGURE 8: SHORELINE CHANGE FOR SECTION B IS EAST OF THE EXISTING DOCK FROM 1994- 2016

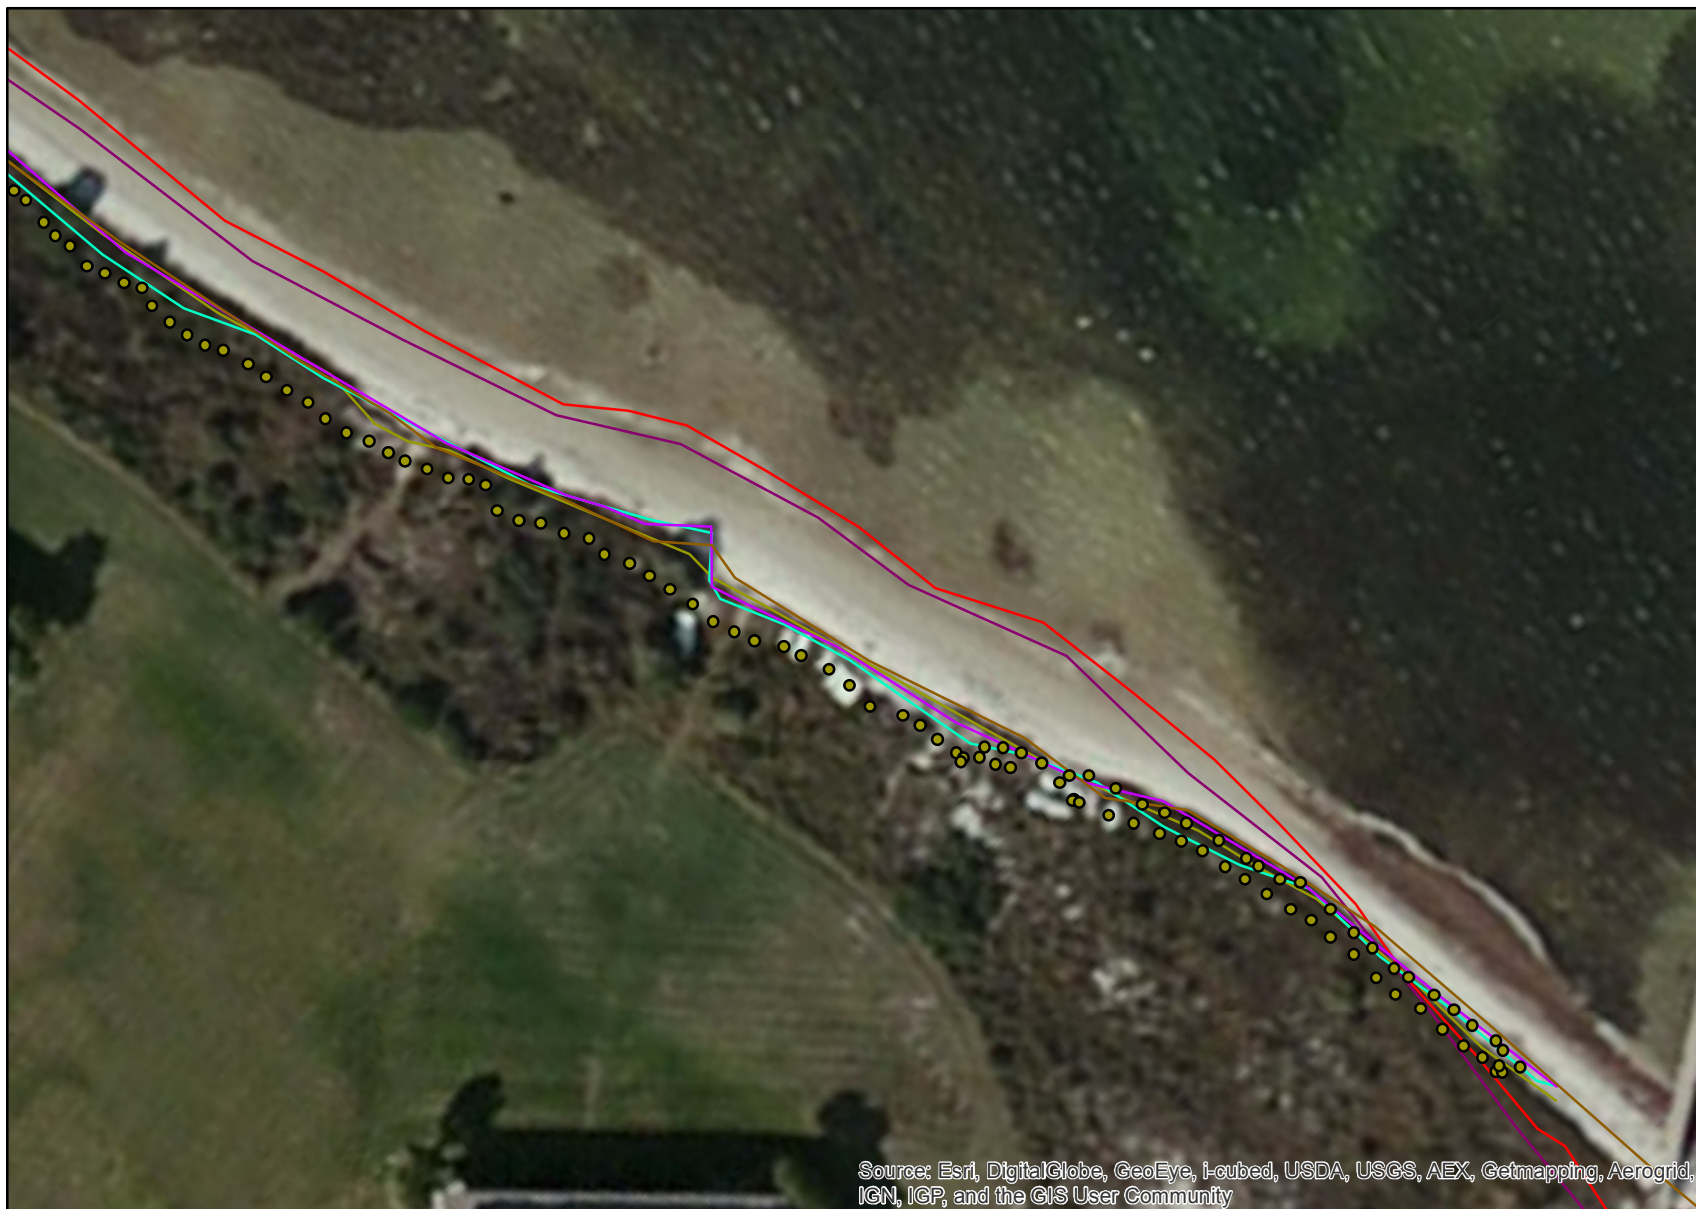
# Santa Rosa Dunes Shoreline Change Section C

Seagrass is a natural stabilizer. Notice in Section C (Figure. 10). The only real erosion is the beach area to the east. The shoreline in front of the seagrass has changed VERY little over the years. Once again this is because of underwater seagrass root system stabilizing the shoreline. If the seagrass ever gets destroyed and boaters keep anchoring in the seagrass, this shoreline area will also face erosion. If the beach recreational area sandy area becomes larger, the sand may also erode, reducing the shoreline.

FIGURE 10: SHORELINE CHANGE OF THE EASTERN SECTION OF THE PROPERTY

The east end of Section C (Fig. 10), is where the property's beach area is. This beach will eventually erode more over time from the lack of stabilization of the root system. To keep the beach area the same size, and prevent any further vegetative stress from trampling, it is important to create a nice vegetative border of bushes to maintain the boundaries of the beach. The bushes are less likely to get trampled and will protect the shoreline grasses. Section C East, is also the highest area of boat anchorings in the seagrass. Distributing educational pamphlets and signs about seagrass and the importance of keeping the root system intact, enforcing the mooring buoys and discouraging anchoring, may help alleviate any impact to the rare inshore grass beds.

It is suggested to create small wetlands in front of and behind the shore to have a secondary reinforcement in case the existing brackish vegetation fails. The current vegetation along Section C is not the primary vegetation for underwater stabilization. The root system along the shoreline is sustainable at this time, but long term, with the constant exposure to saltwater, the existing vegetation cannot survive and die off and can loosen the soil. This loose soil is susceptible to continued erosion which cause more property loss.

As long as the seagrass beds are not disturbed or damaged, it is expected the seagrass will keep the far eastern end from eroding at a fast rate. By planting more emergent shoreline vegetation in a strategic manner, more of the Santa Rosa, Dunes property can be protected long term and for future generations to come.

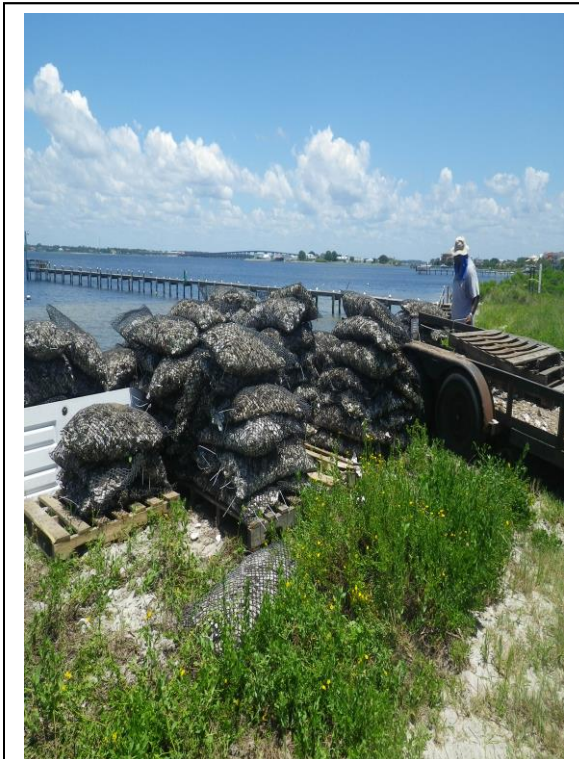
Fig. 3 -Staging recycled oyster shell bags

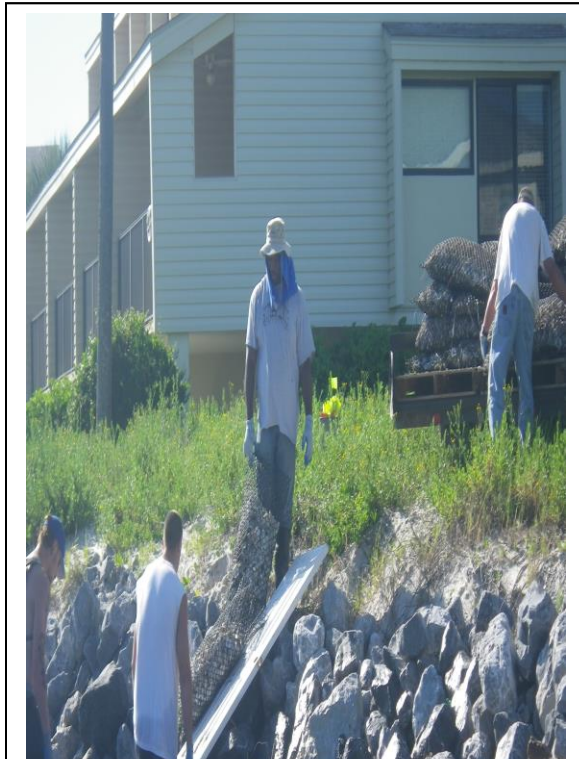
Fig. 4 -Least destructive method to property to tranport oyster shell bags- slide

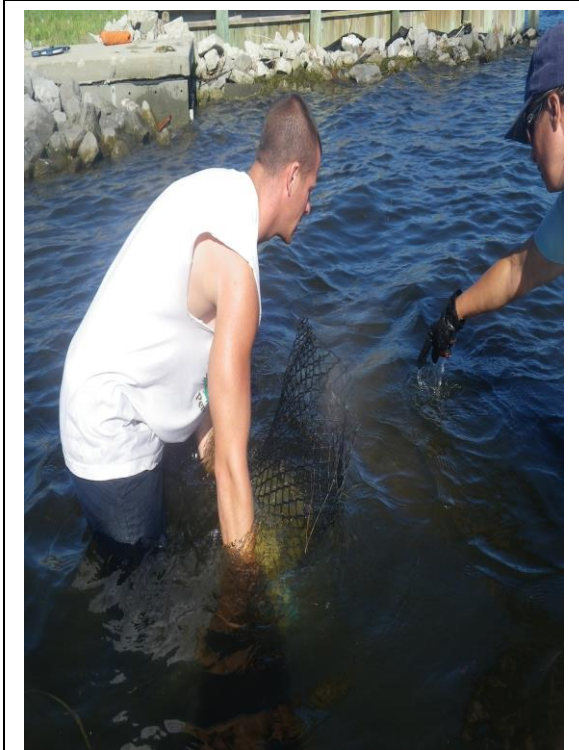
Fig. 5 -Placement of oyster shell bags

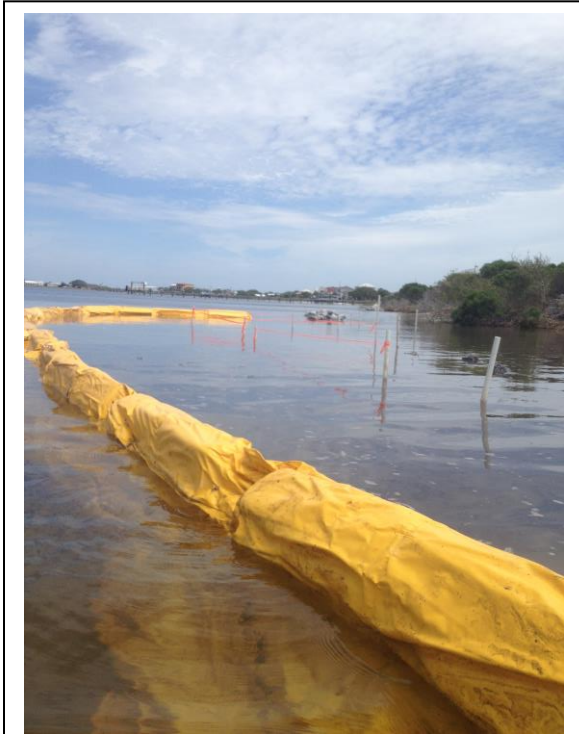
Fig. 10 -Curtain to protect seagrass and water quality

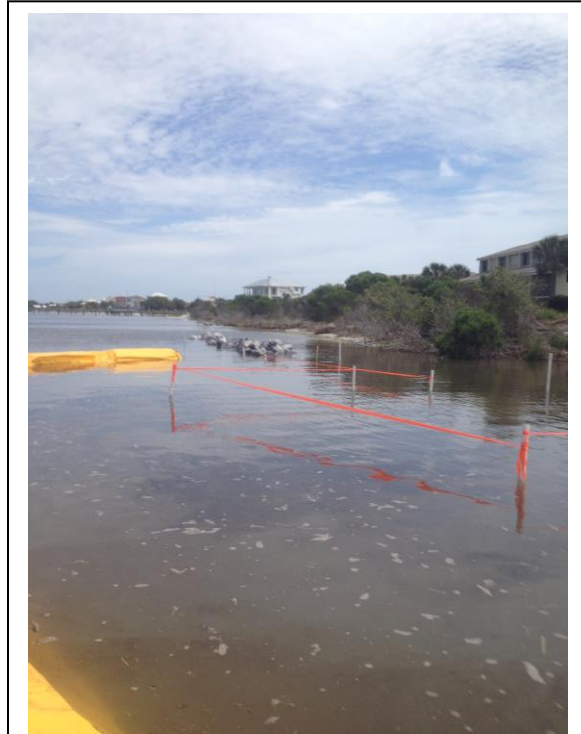
Fig. 11 Survey markers for footprint

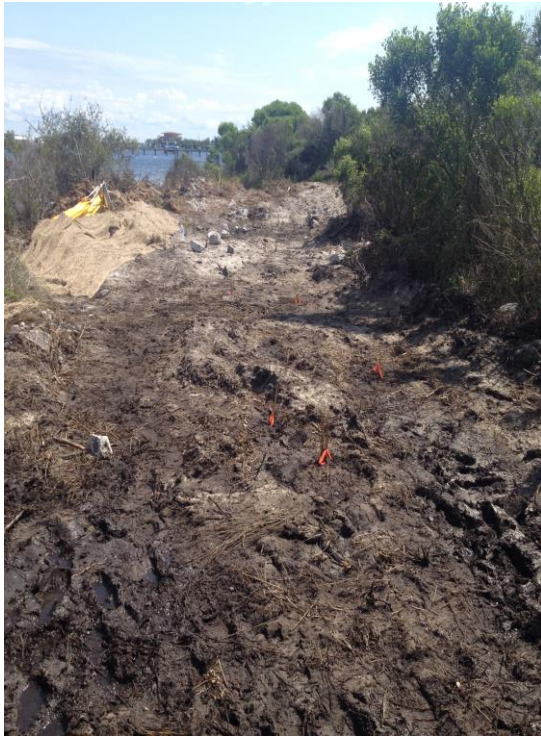
Fig. 21- Cleared field for new vegetation

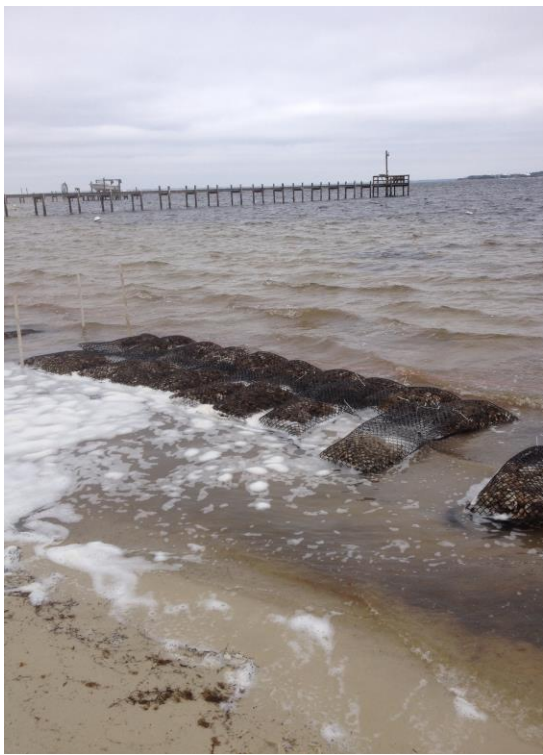
Fig. 25- Setting up oyster reef foundation

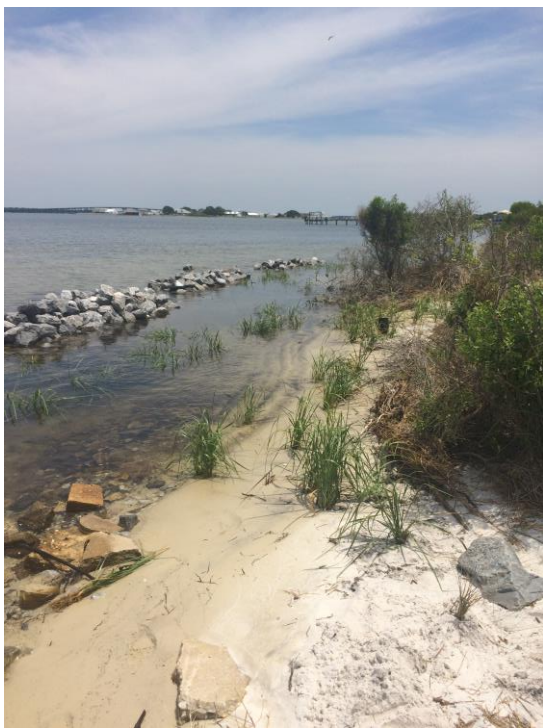
Fig. 27- Planting phases

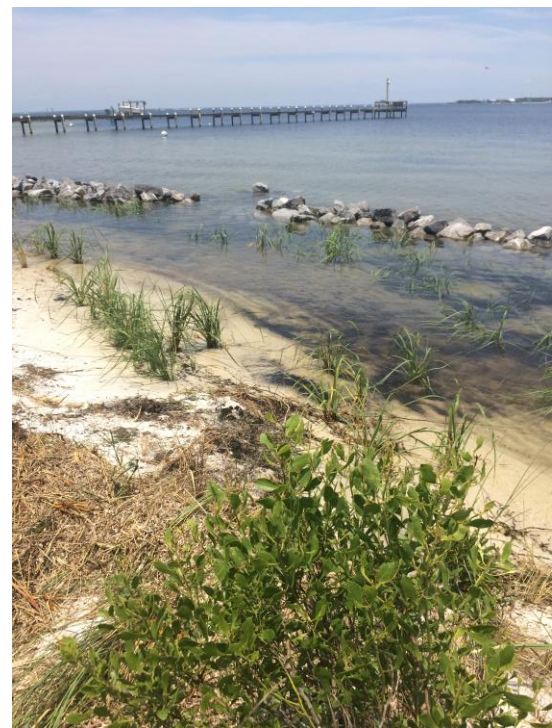
Fig. 28 Planting phases

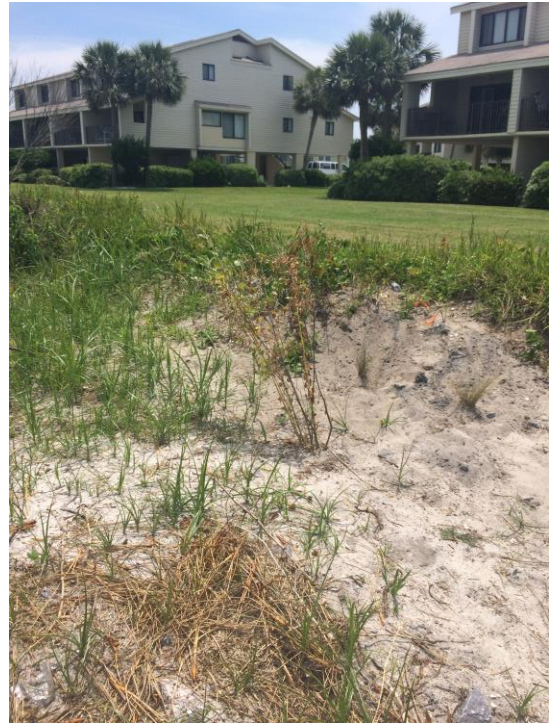
Fig. 30- Area where rip was staged is growing

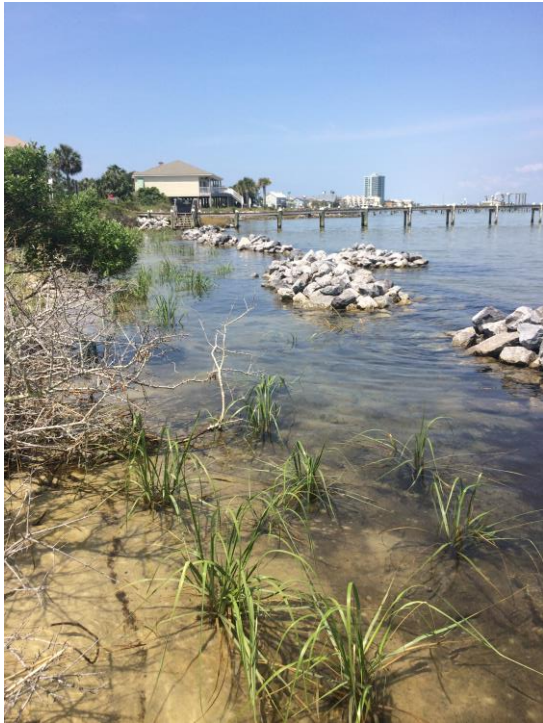
Fig. 33 Mid section left at sea level to flush into wet area
